# Your Inspection Report

6150 N Sample Ave, Suite 7A  
Chicago, IL

**INSPECTION DATE:**  
Sunday, May 14, 2017

RE: Report No. 1068  
6150 N Sample Ave, 7A  
Chicago, IL

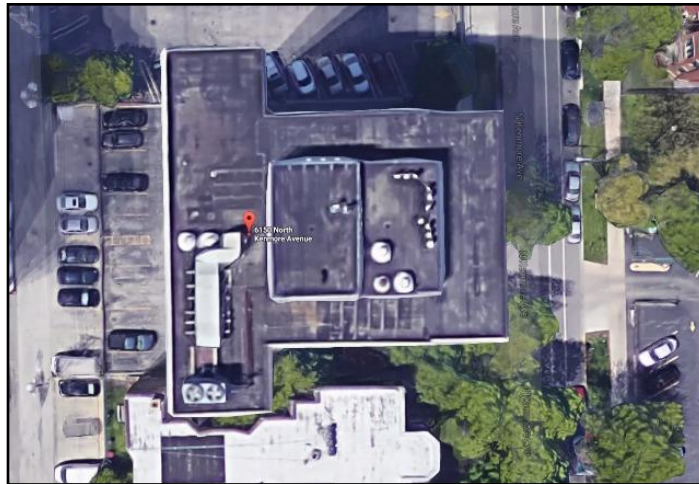
1. Satellite picture

1. Condition: • [Near end of life expectancy](#)

Implication(s): Chance of water damage to contents, finishes and/or structure

Task: Further evaluation Request disclosure

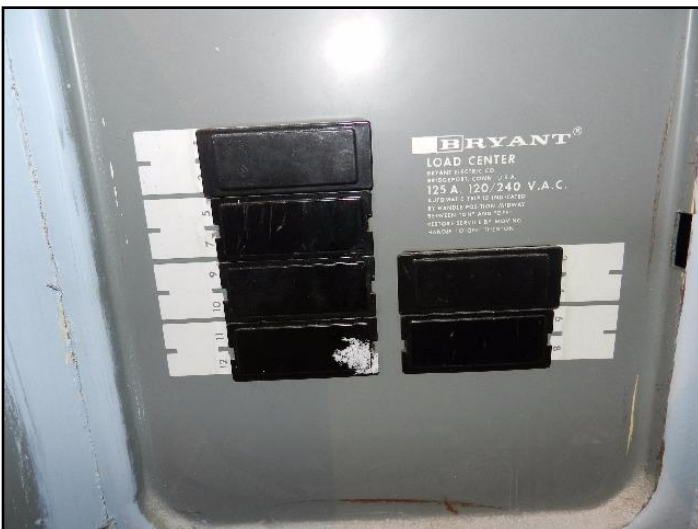
**3. Condition:** • [No fuses or breakers for subpanel \(pony panel\)](#)

**Implication(s):** Fire hazard | Electric shock

2. No fuses or breakers for subpanel (pony...

**Task:** Further evaluation Request disclosure Upgrade

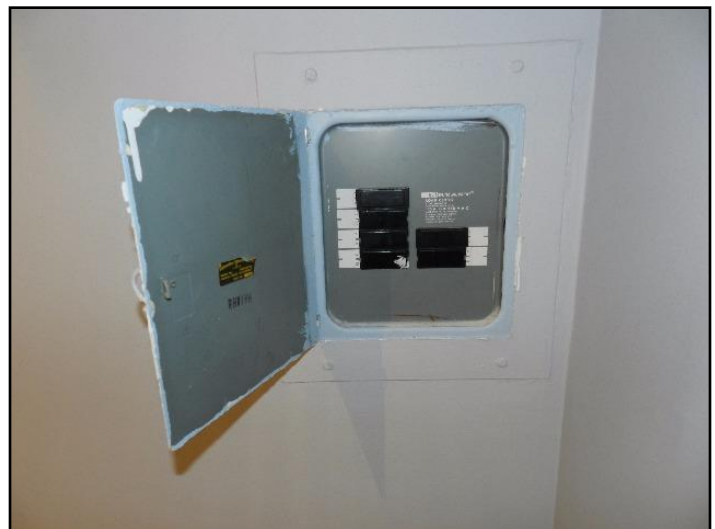
3. No fuses or breakers for subpanel (pony...

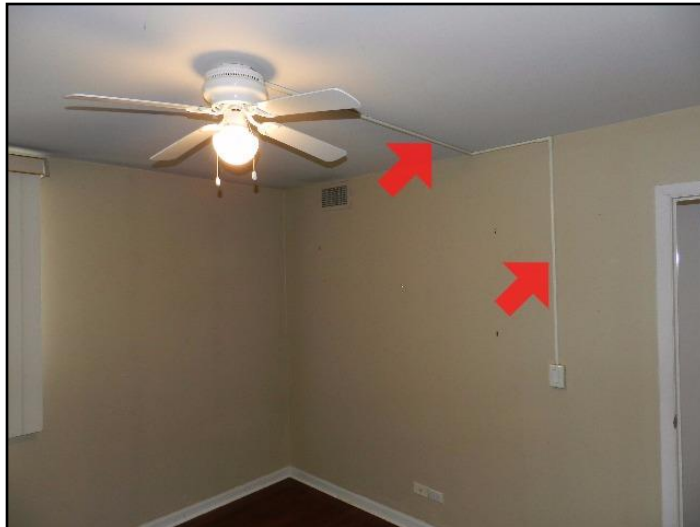
**4. Condition:** • [Exposed on walls or ceilings](#)

Conduit required

**Implication(s):** Electric shock

**Location:** Bathroom

4. Exposed on walls or ceilings

**Task:** Replace Correct

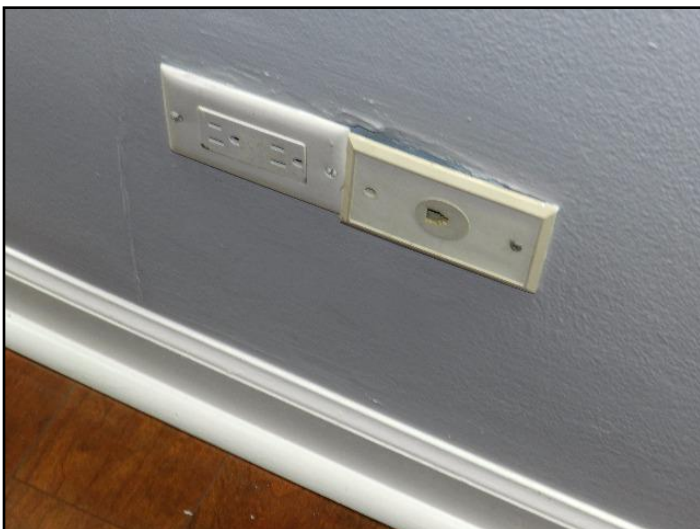
**5. Condition:** • [Loose](#)

**Implication(s):** Electric shock | Fire hazard

**Location:** Various Bedroom Master Bedroom

5. Loose

**Task:** Repair or replace

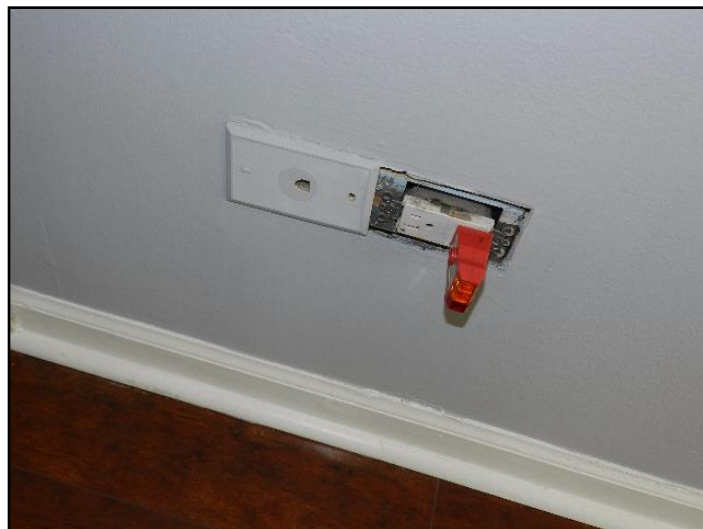
6. Loose

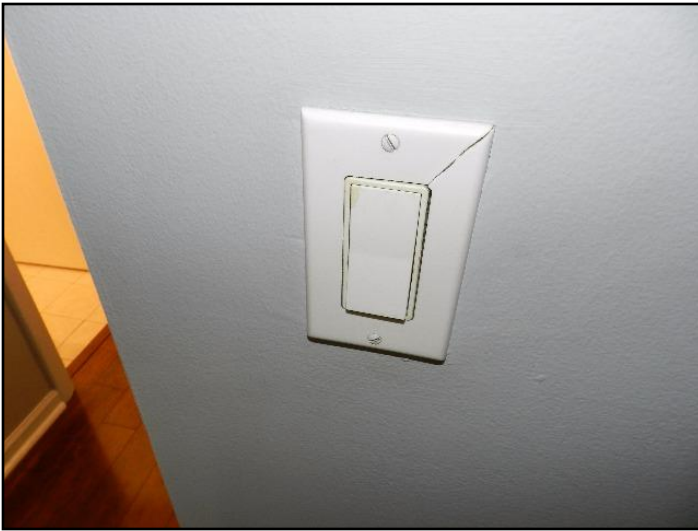
7. Cracked

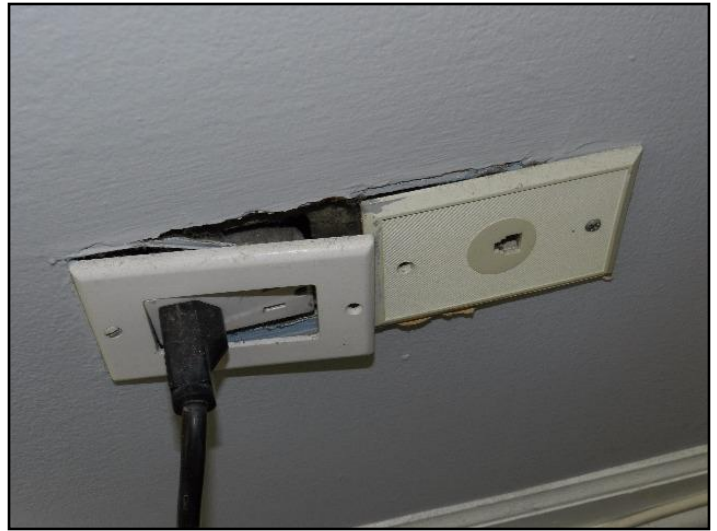
8. Loose

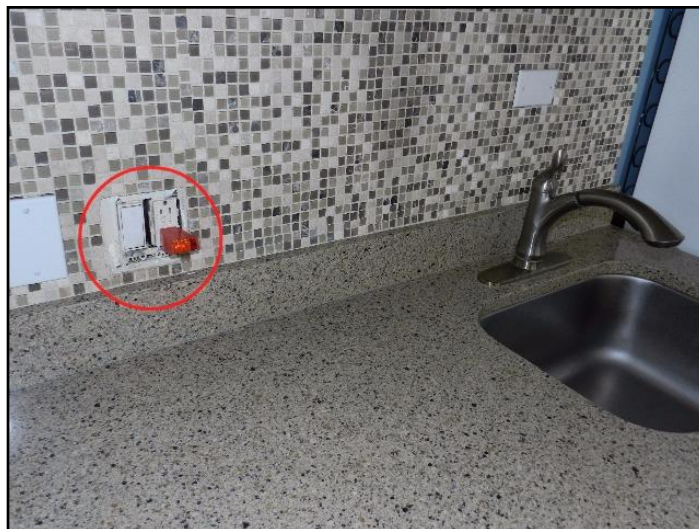
9. Missing cover

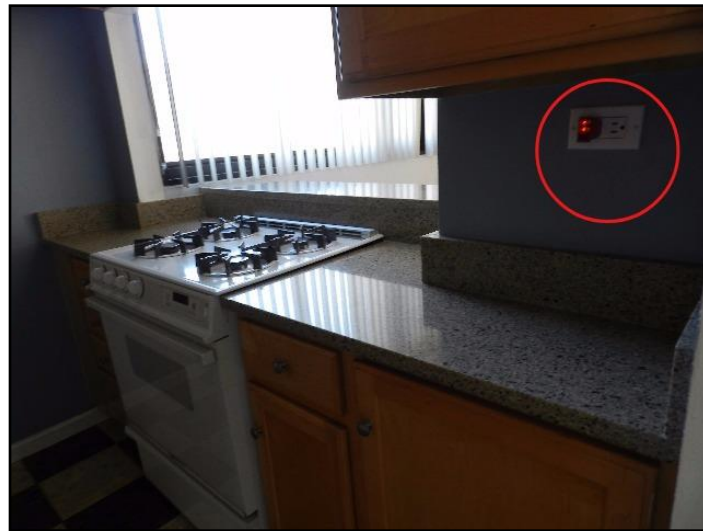
6. Condition: • [No GFCI/GFI \(Ground Fault Circuit Interrupter\)](#)

Implication(s): Electric shock

Location: Kitchen

10. No GFCI/GFI (Ground Fault Circuit...

Task: Repair or replace

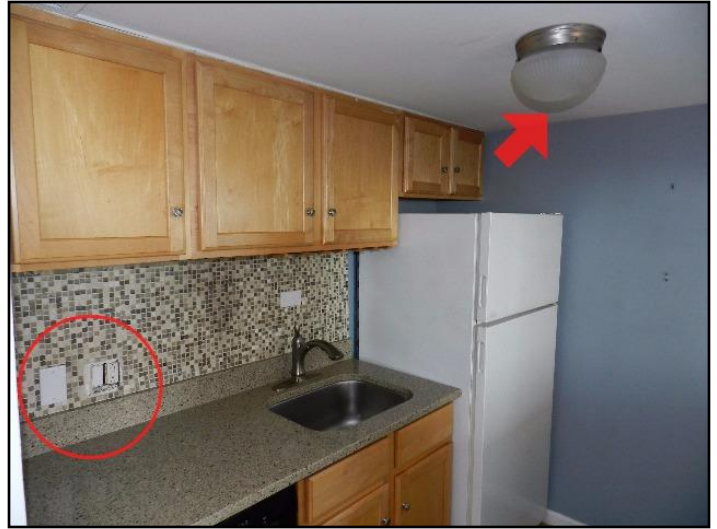
7. Condition: • [Inoperative](#)

Implication(s): Inadequate lighting

12. *Inoperative*

Task: Repair or replace Further evaluation

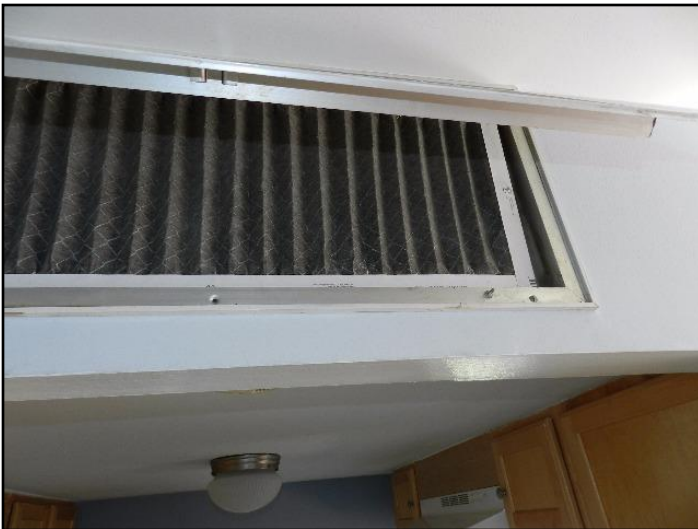
8. • Dirty filters

Location: Living room, Master Bedroom

13. Dirty

Task: Replace

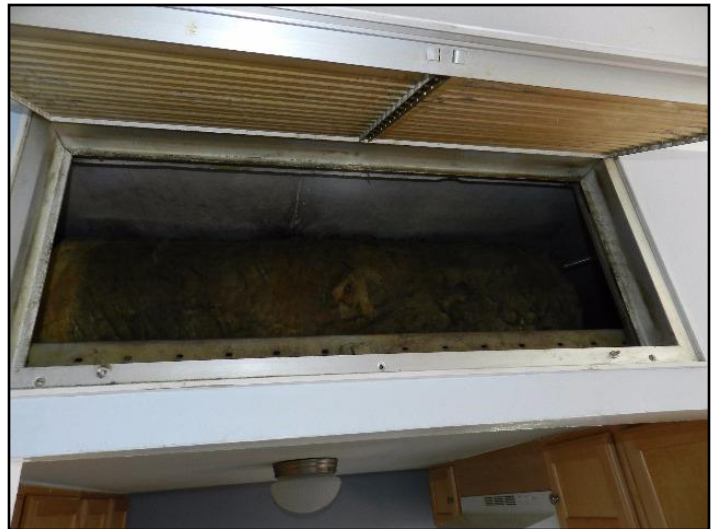
14. Dirty

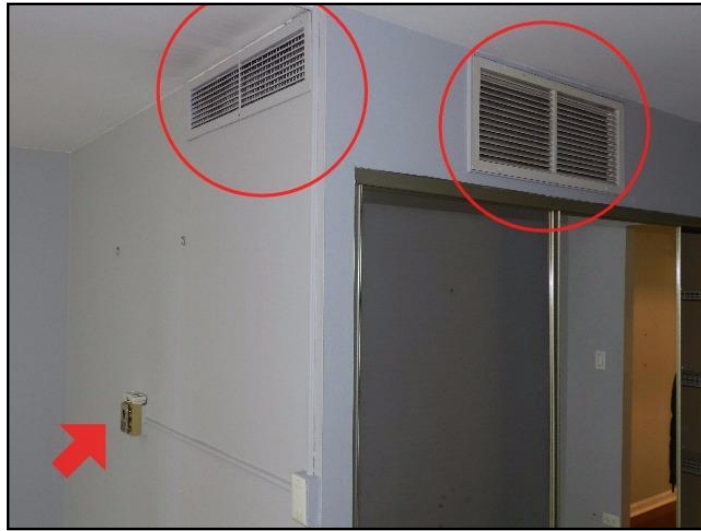
9. • Inoperative Heating and Air Conditioning / Fan problems

Location: Master Bedroom

15. Inoperative HVAC

Task: Repair or replace Further evaluation

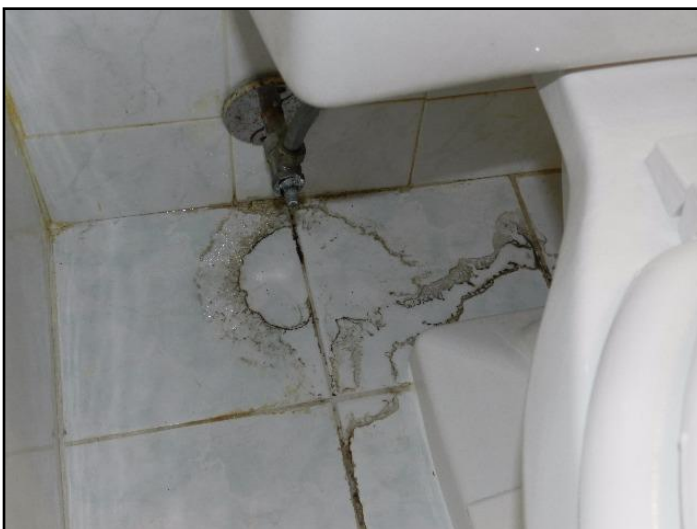
**12. Condition:** • [Leak](#)  
**Implication(s):** Sewage entering the building  
**Location:** Bathroom Master Bathroom Laundry  
**Task:** Replace  
**Time:** Immediate

16. Leak

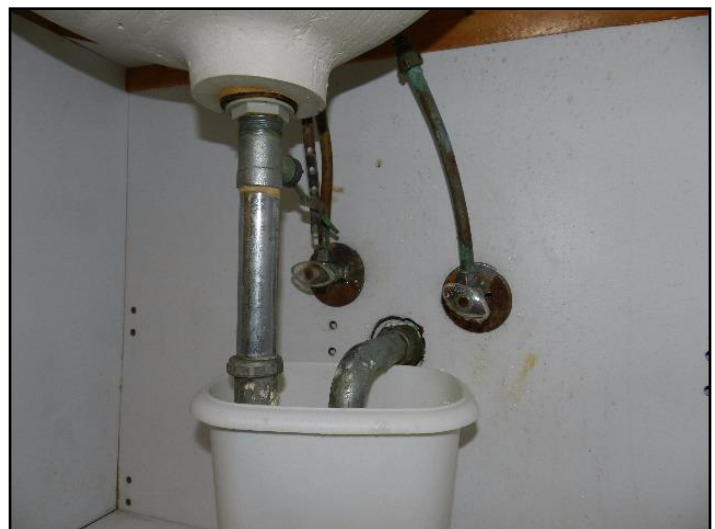
17. Leak

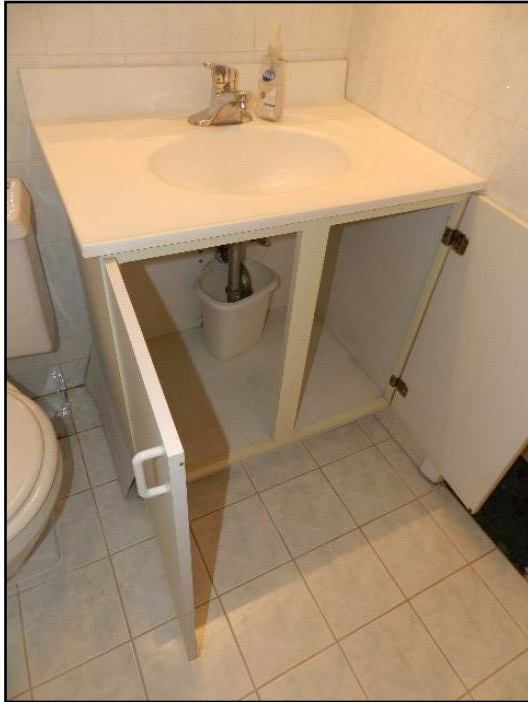
18. Leak

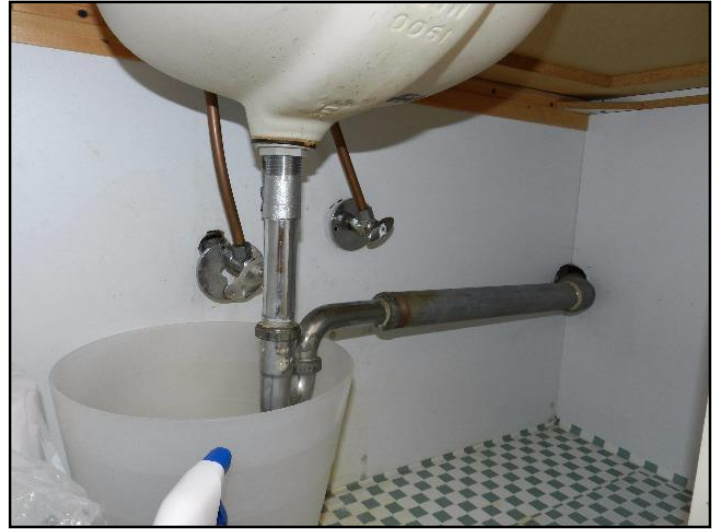
19. Leak

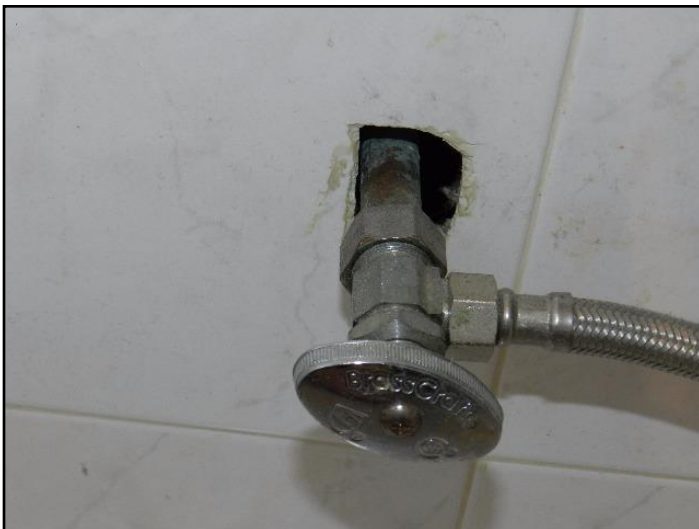
20. Cover needed

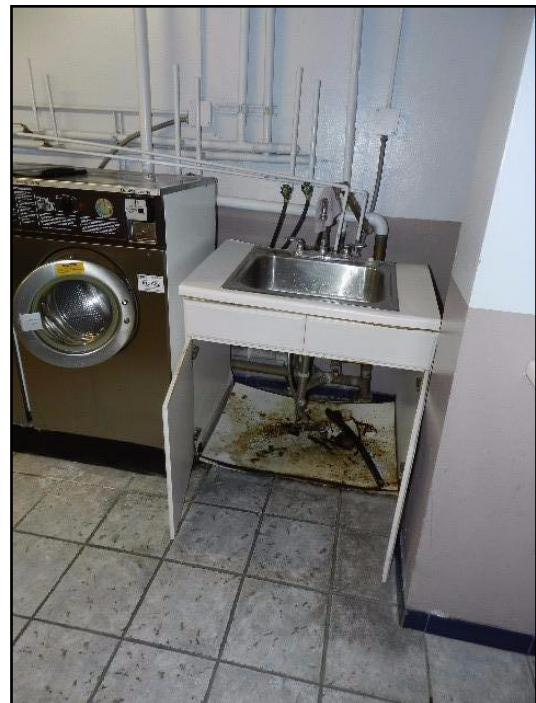
21. Leak @ Laundry Sink

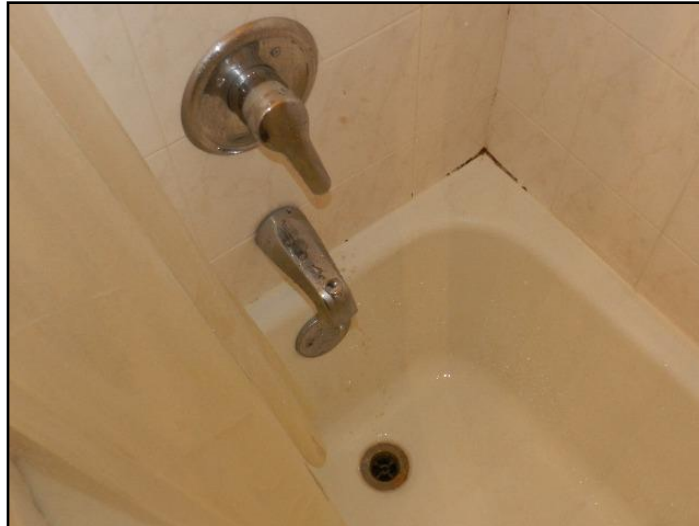
13. Condition: • [Caulking loose, missing or deteriorated](#)

Drain stop missing, loose faucet

**Implication(s):** Chance of water damage to contents, finishes and/or structure

**Location:** Bathroom

**22.** *Caulking loose, missing or deteriorated*

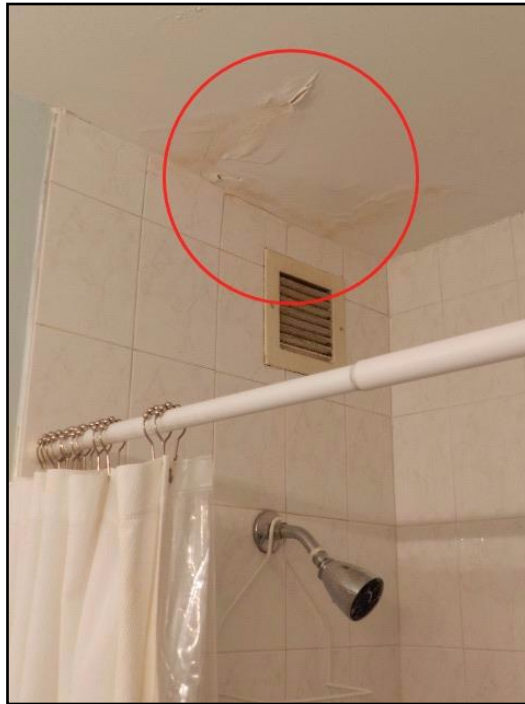
15. **Condition:** • [Water damage](#)

**Implication(s):** Chance of movement

**Location:** Bathroom

23. Water damage

**Task:** Repair Monitor

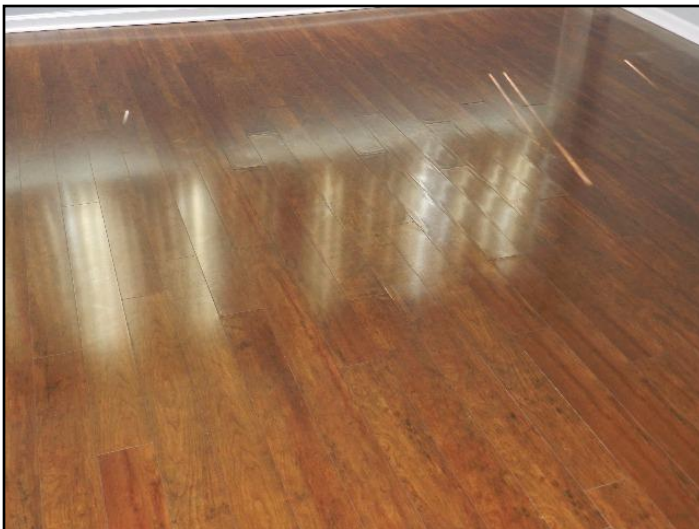
17. Condition: • [Warped](#)

Implication(s): Trip or fall hazard

Location: Living Room Master Bedroom

24. Warped

Task: Replace

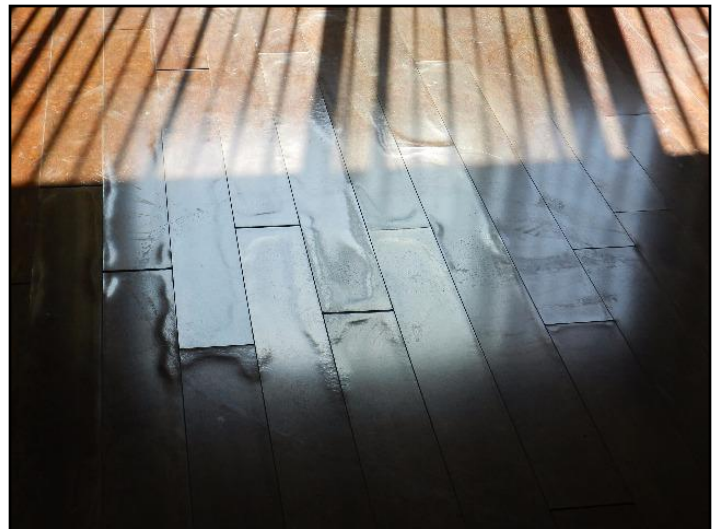
25. Warped

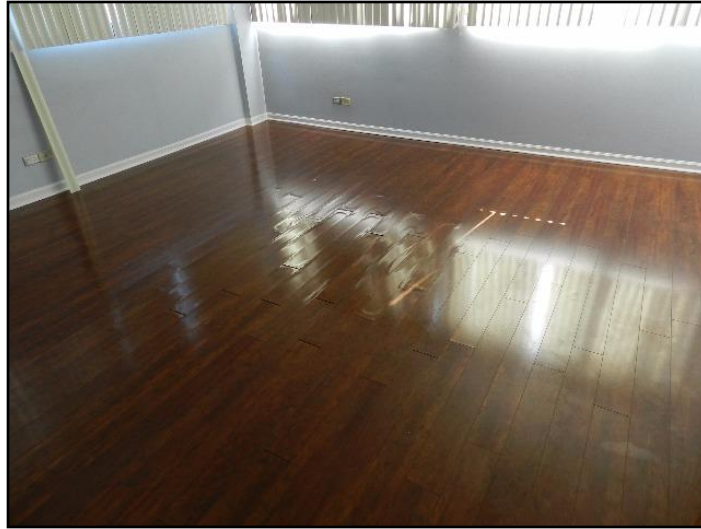
26. Warped

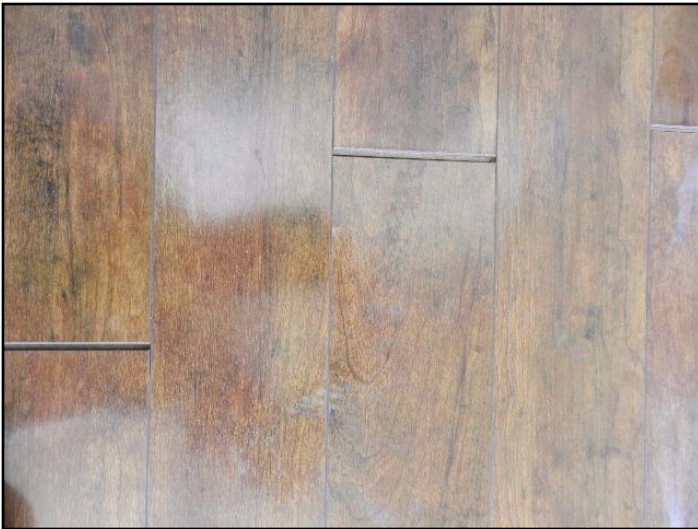
19. Condition: • [Exposed tongues](#)

Implication(s): Reduced system life expectancy

27. Exposed tongues

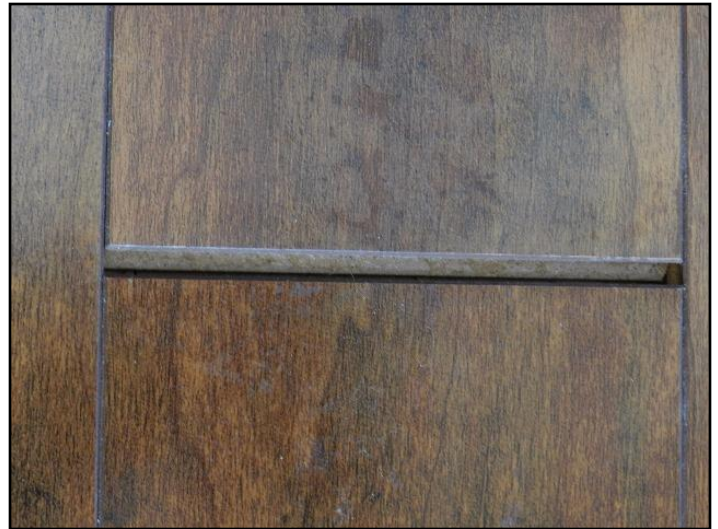
28. Exposed tongues

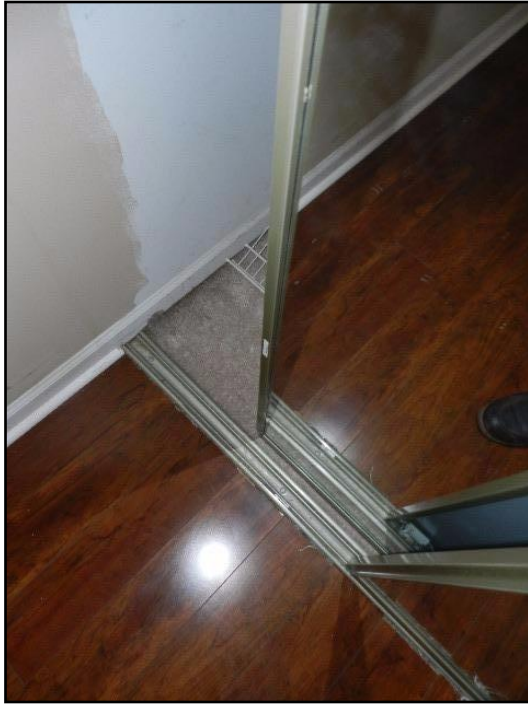
20. Condition: • [Loose or poor fit](#)

Implication(s): Chance of damage to finishes and structure

Location: Bedroom Master Bedroom

29. Loose or poor fit

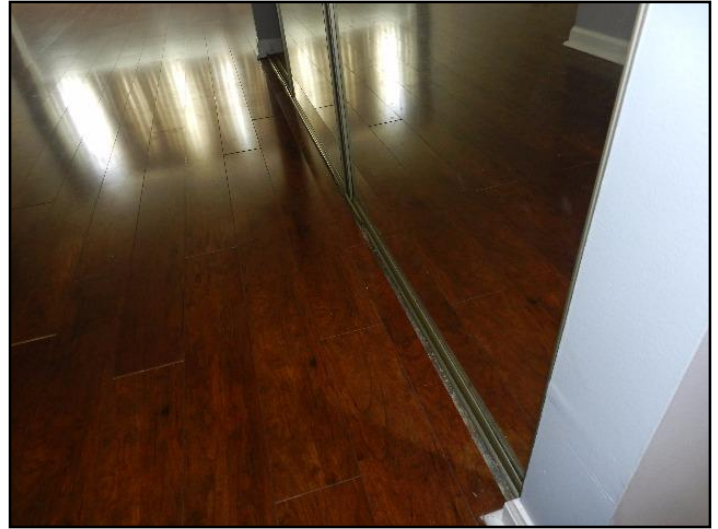
30. Loose or poor fit

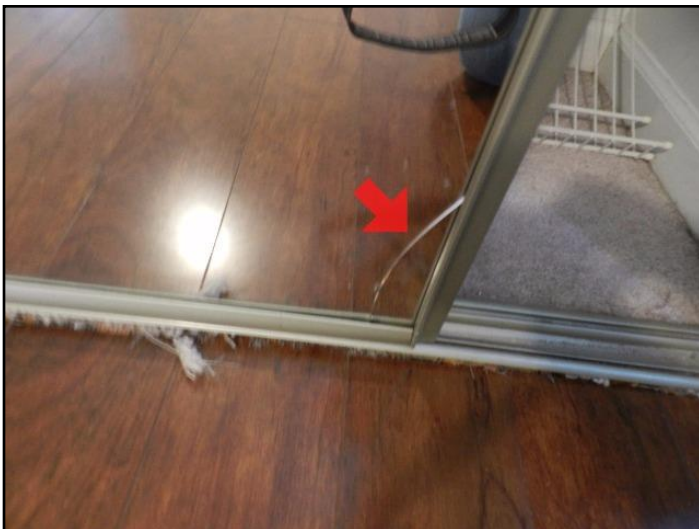
21. Condition: • [Cracked](#)

Location: Bedroom Foyer

31. Cracked

Task: Replace

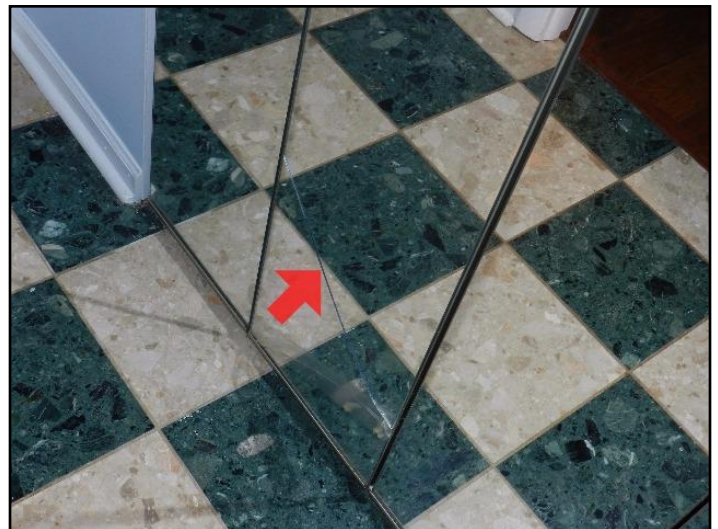
32. Cracked

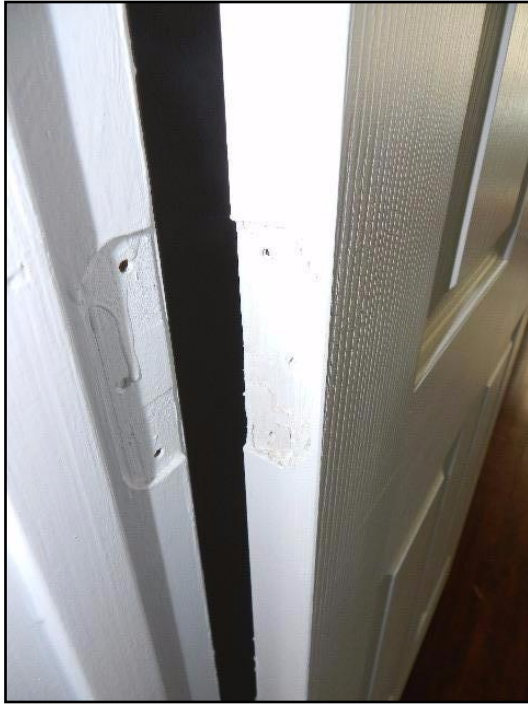
22. Condition: • [Missing](#)

Implication(s): System inoperative or difficult to operate

33. Hinges missing

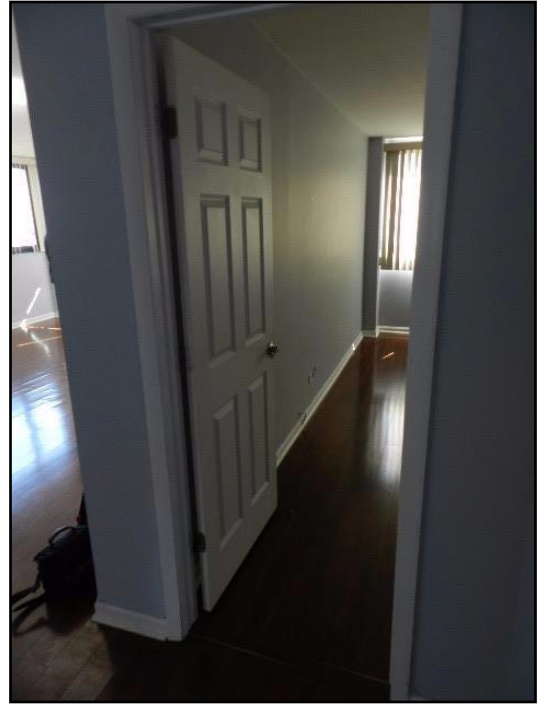
34. Hinges missing

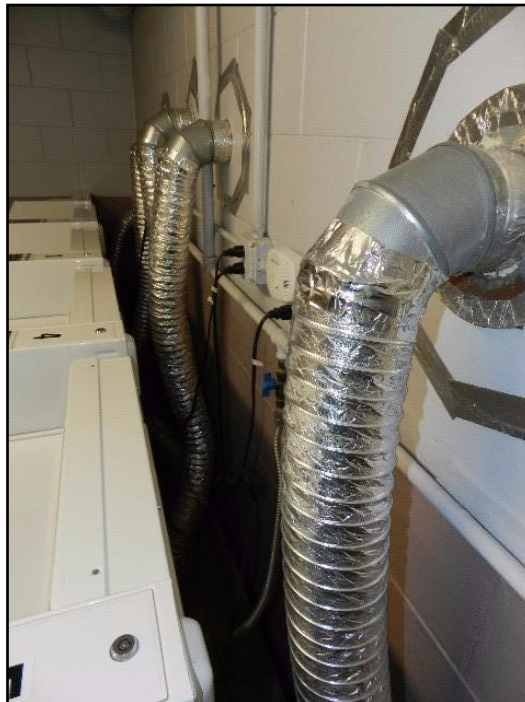
23. Condition: • Dryer vent material not smooth wall

Implication(s): Equipment ineffective | Fire hazard

35. Dryer vent material not smooth wall
