Your Inspection Report

5246 North Sample St
Chicago, IL

INSPECTION DATE:
Wednesday, January 24, 2018

RE: Report No. 1078
5246 North Sample St
Chicago, IL

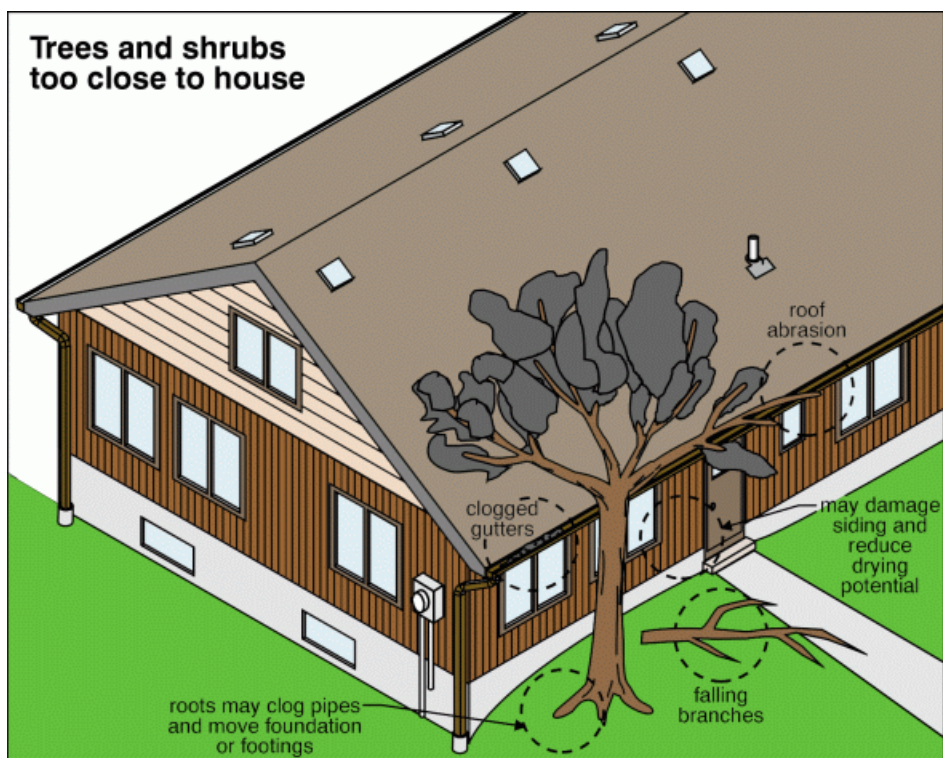
1. **Condition:** • Tree branches touching roof

Location: Damage

Task: Service Clean Correct

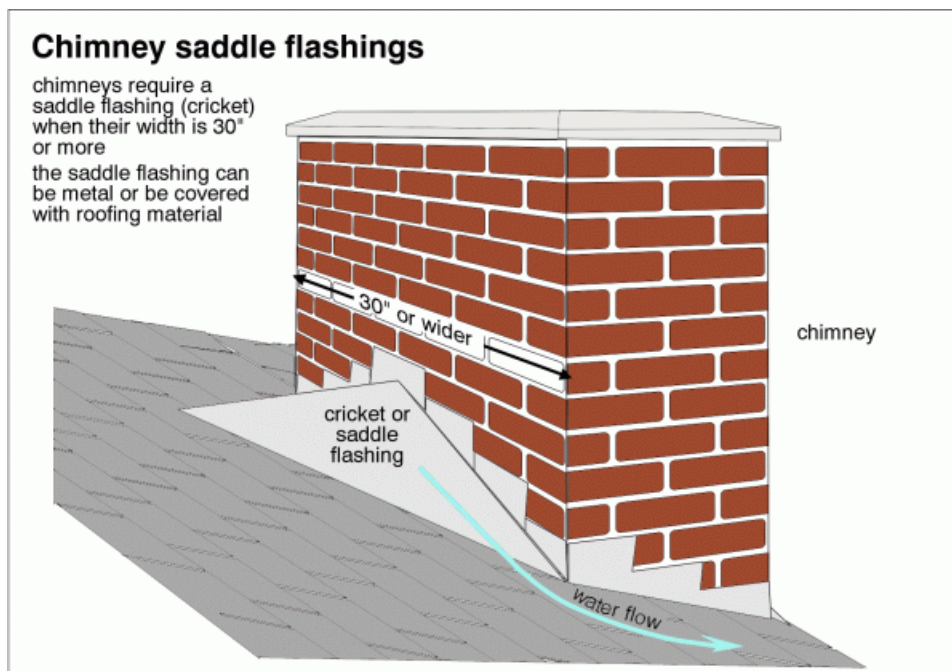
2. Cricket missing, loose, damaged

2. Condition: • [Cricket missing, loose, damaged](#)

Implication(s): Chance of water damage to contents, finishes and/or structure

Task: Repair or replace Provide Protect

Time: Immediate

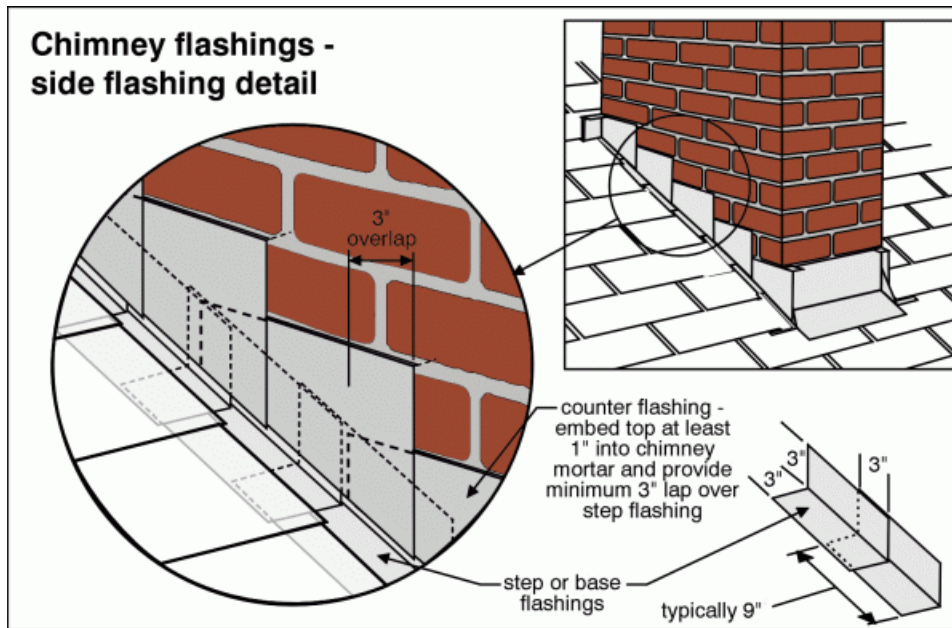
3. Condition: • [Side flashings not set into shingles properly](#)

Implication(s): Chance of water damage to contents, finishes and/or structure

3. Side flashings not set into shingles properly

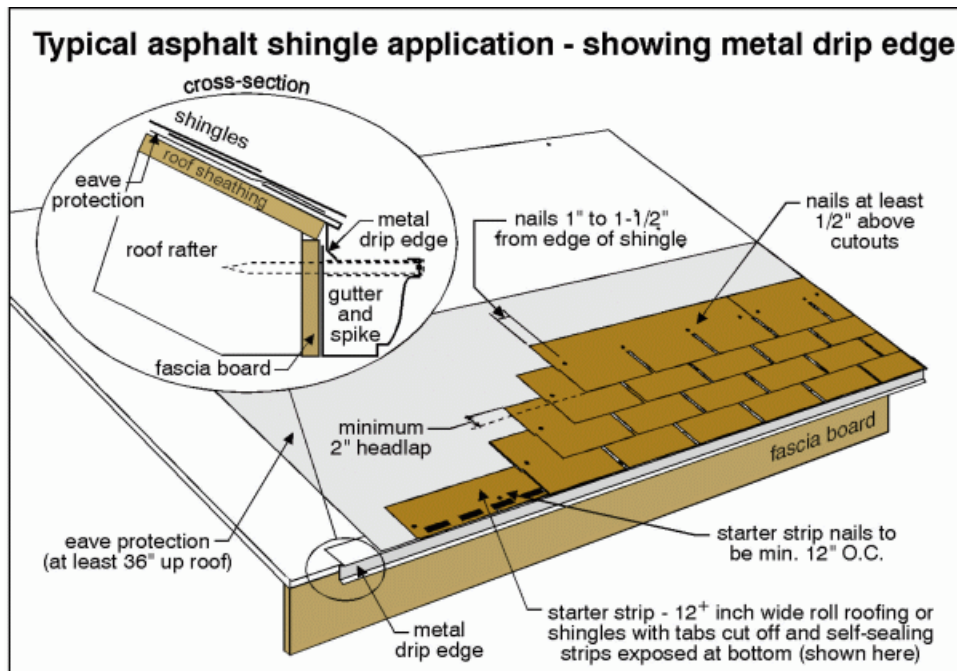
4. Condition: • [Missing](#)

Implication(s): Chance of water damage to contents, finishes and/or structure

4. Missing flashing and cap

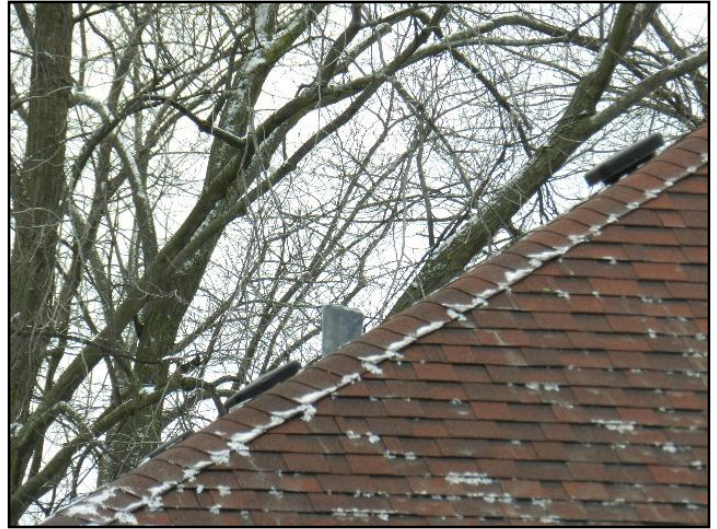
5. Condition: • [Missing](#)

Missing (2) two vent boot flashings and vent caps

Implication(s): Chance of water damage to contents, finishes and/or structure

5. Missing

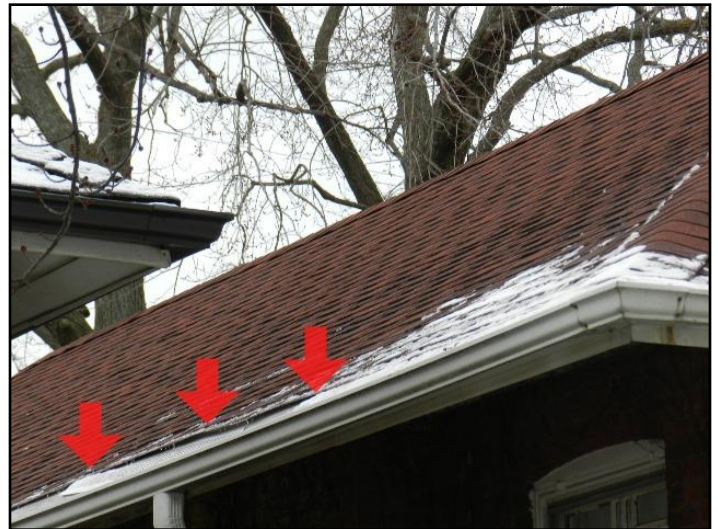
7. Loose or damaged

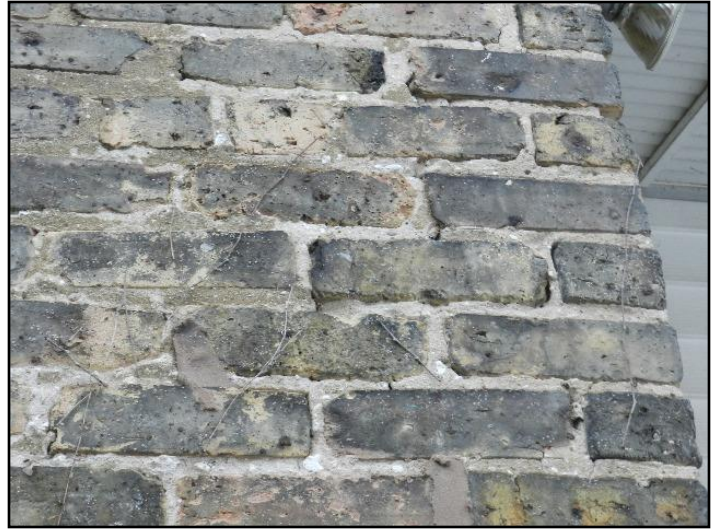
8. Condition: • [Masonry deterioration](#)

10. Masonry deterioration

Task: Repair or replace

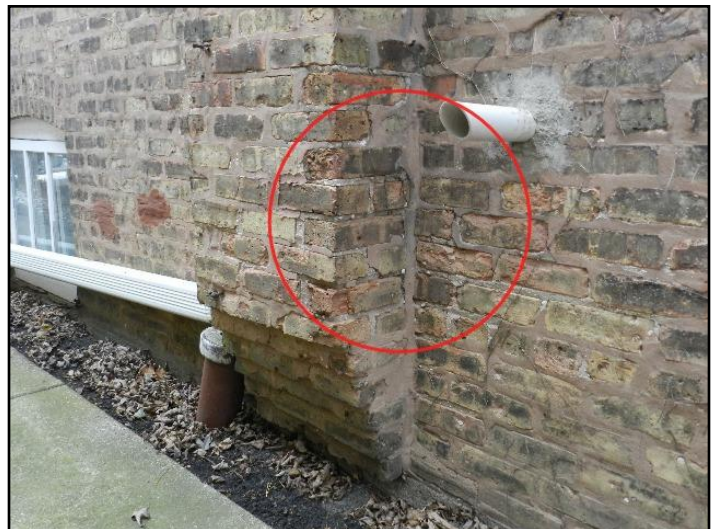
12. Sulfuric acid fumes damaging masonry

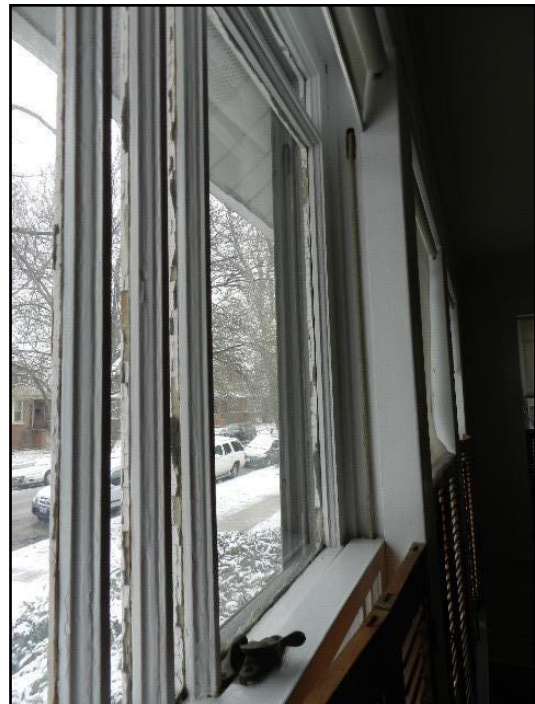
9. Condition: • [Air leaks](#)

15. Air leaks, does not lock

Task: Replace

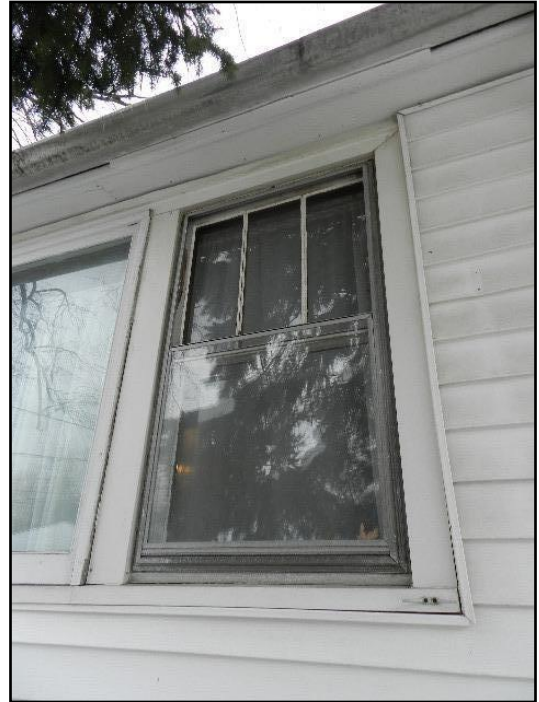
17. Air leaks

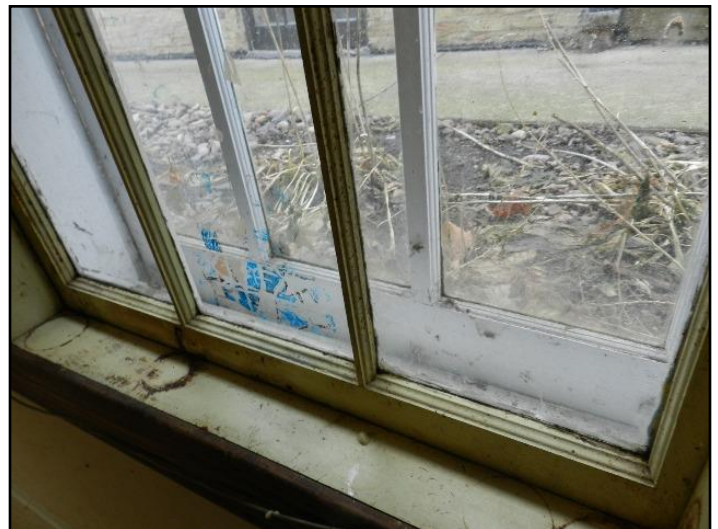
19. Air, water leaks

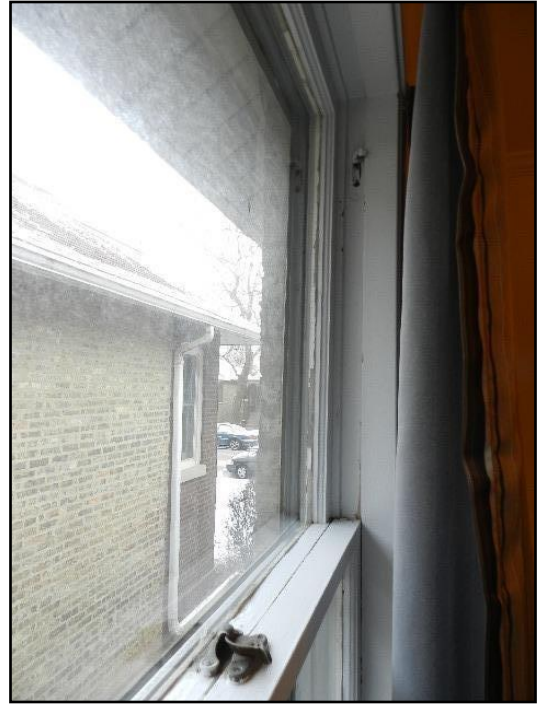
21. Air leaks, does not lock

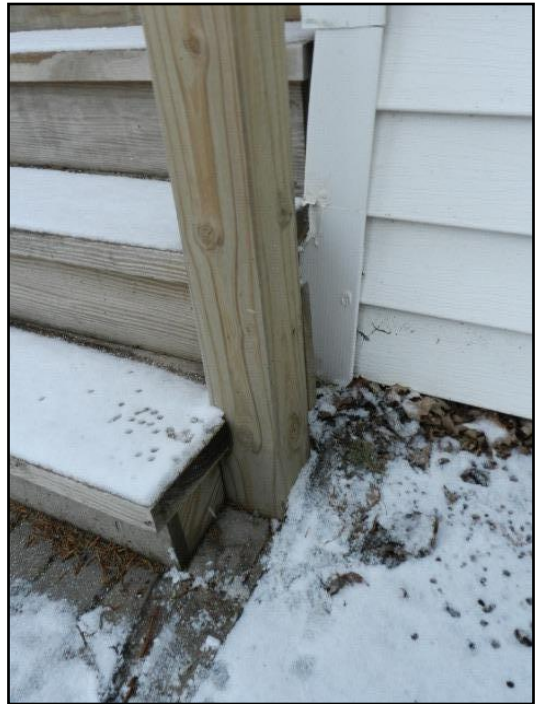
10. Condition: • [Rot](#)

23. No footing, wood/soil contact

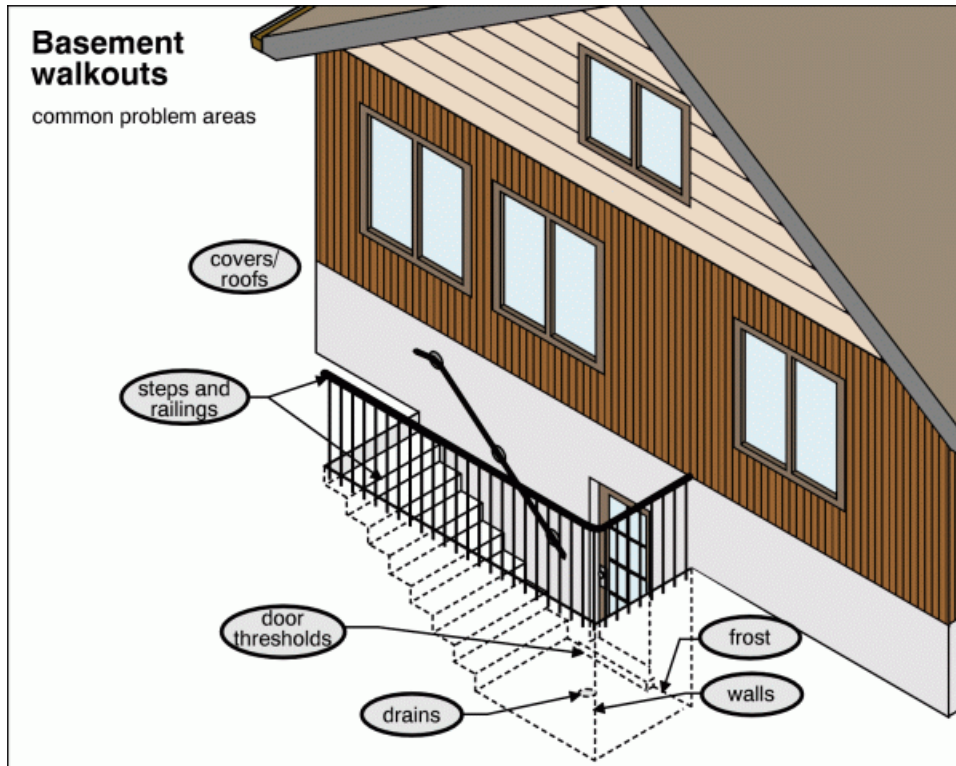
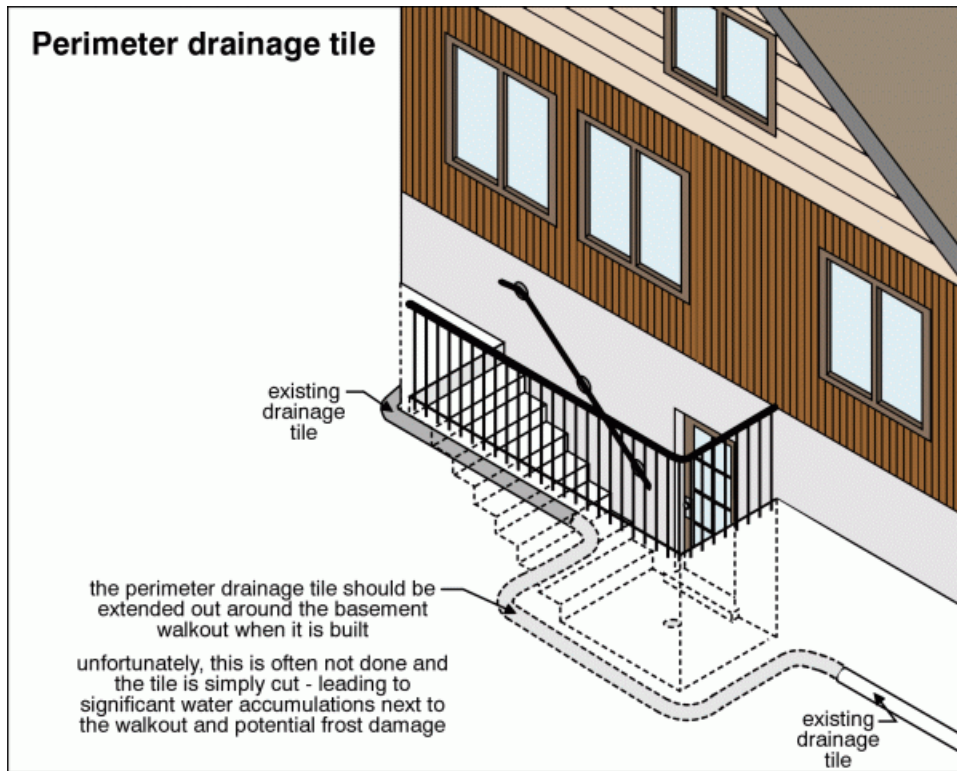
11. Condition: • [Drains missing, clogged or undersized](#)

Implication(s): Chance of water damage to contents, finishes and/or structure

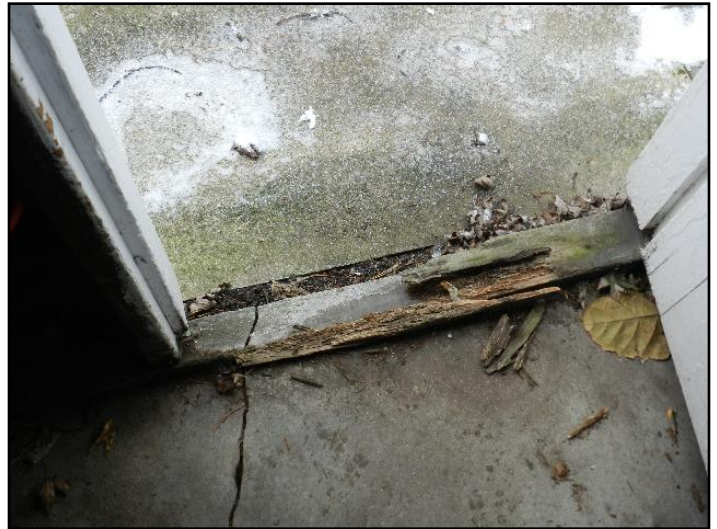
18. Condition: • Rot

Implication(s): Material deterioration

32. Rot

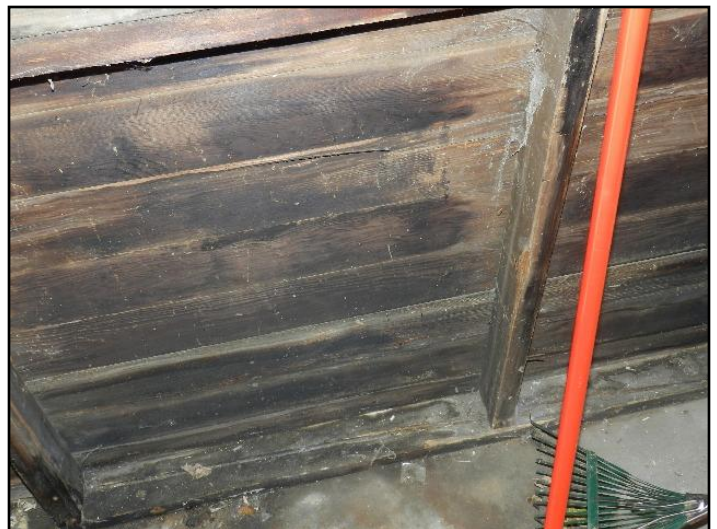
34. Rot

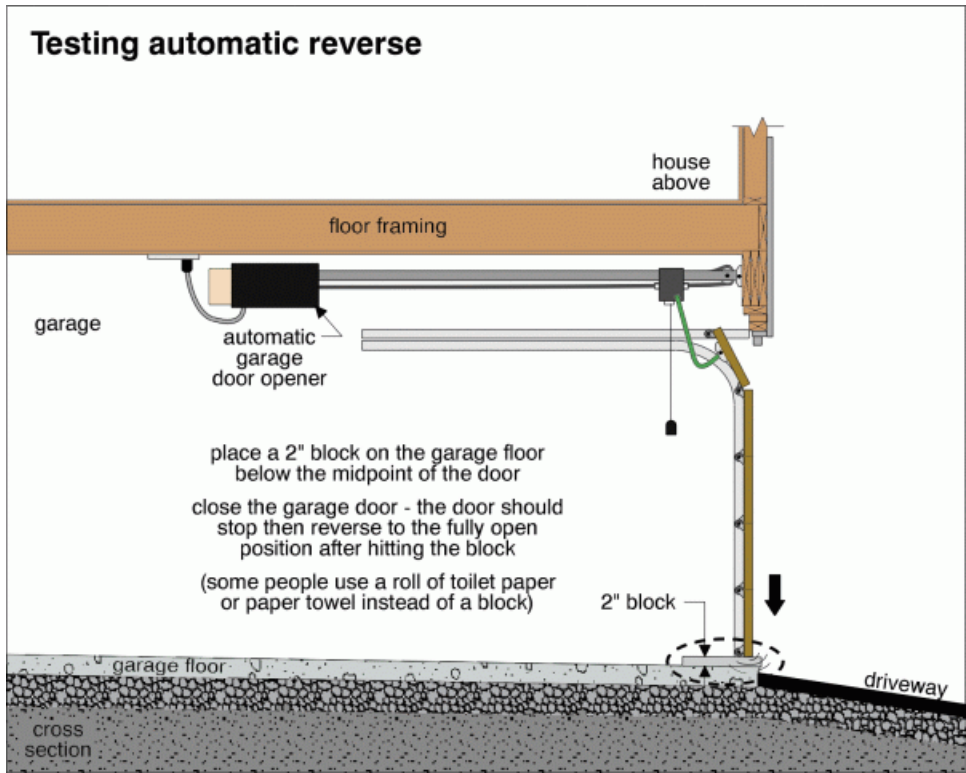
20. Condition: • [Fails to auto reverse](#)

Implication(s): Physical injury

Task: Replace

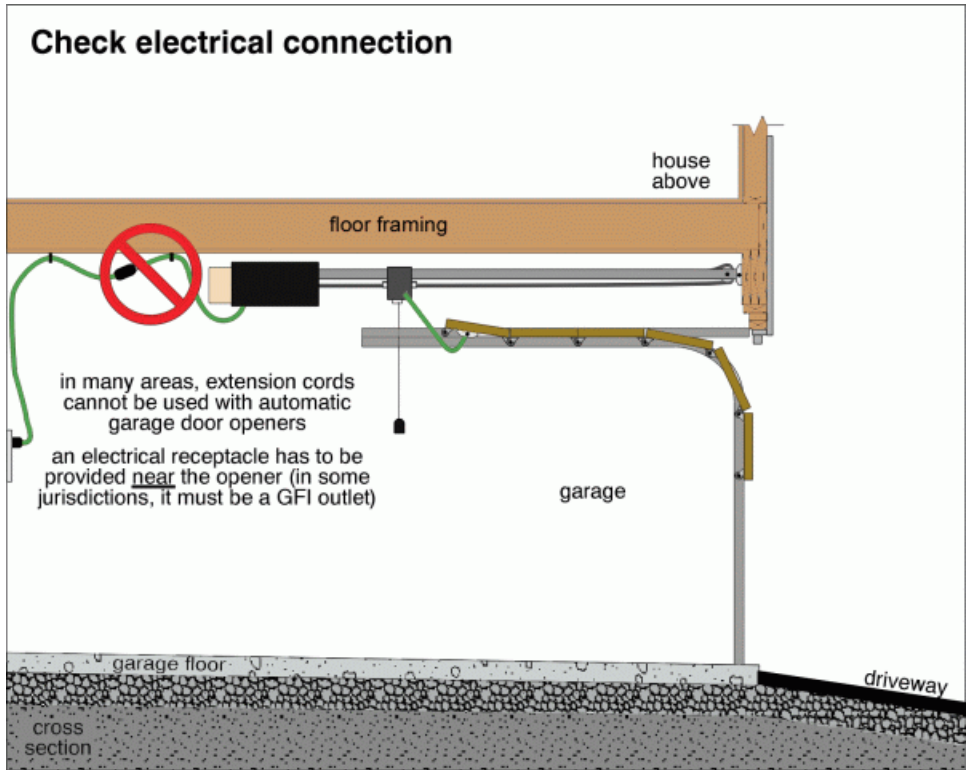
21. Condition: • [Extension cord for opener](#)

Implication(s): Electric shock

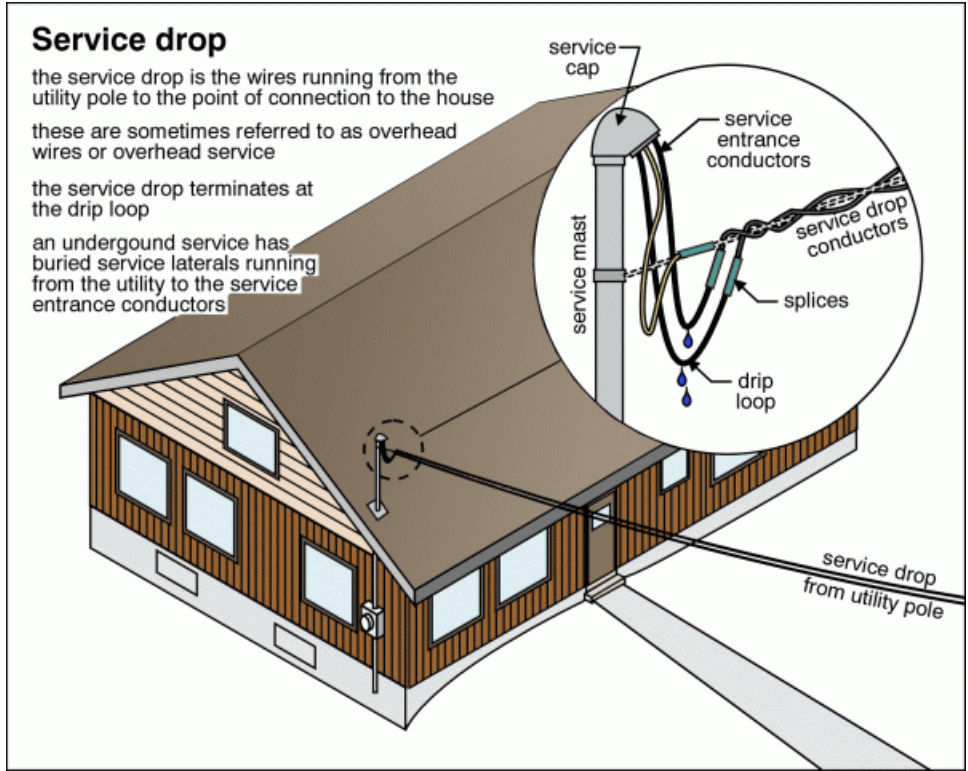
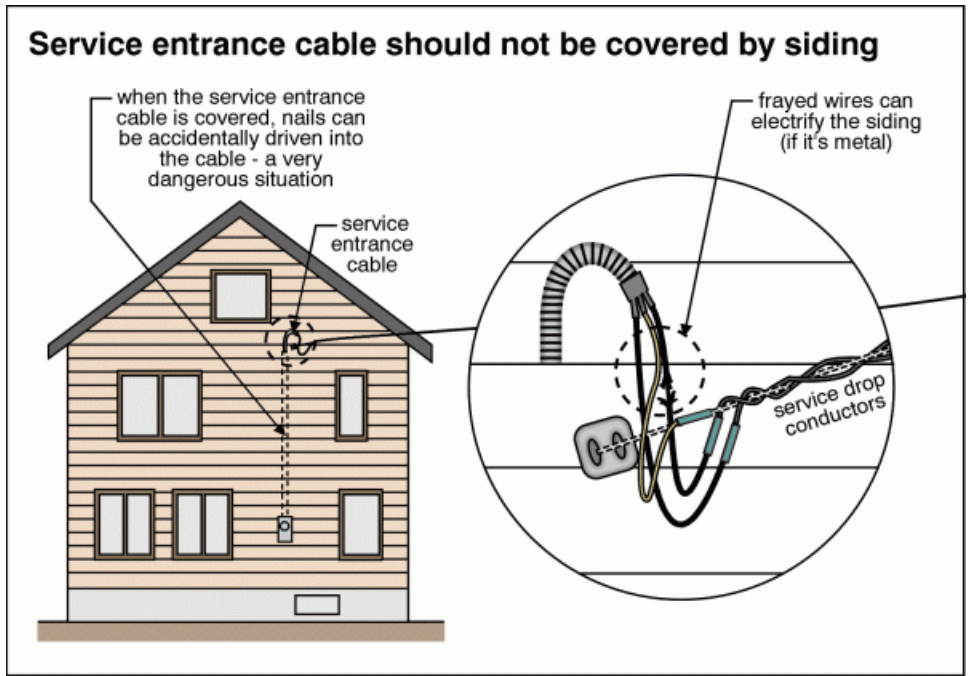
26. Condition: • [Damaged, frayed wires](#)

Implication(s): Electric shock | Interruption of electrical service

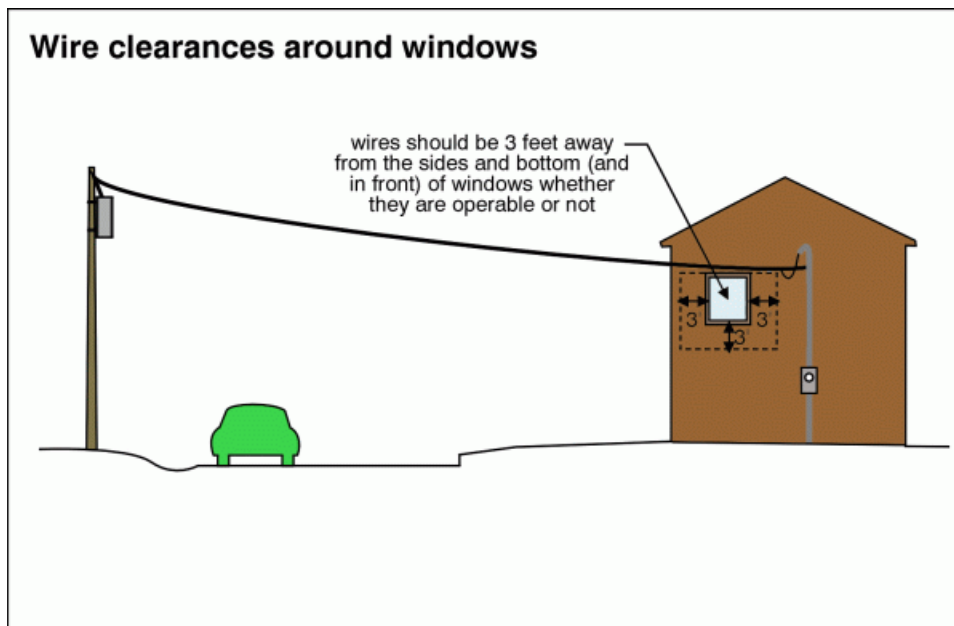
28. Condition: • [Inadequate window or door clearance](#)

Implication(s): Electric shock

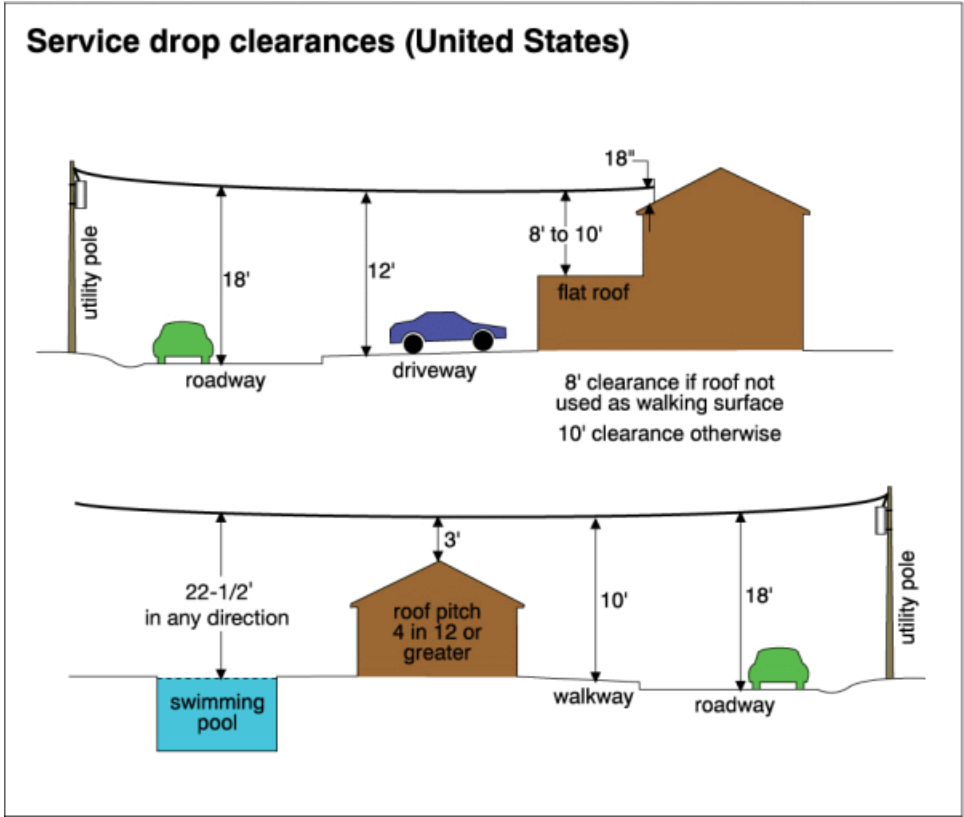
29. Condition: • [Height over roof](#)

30. Condition: • [Height over deck](#)

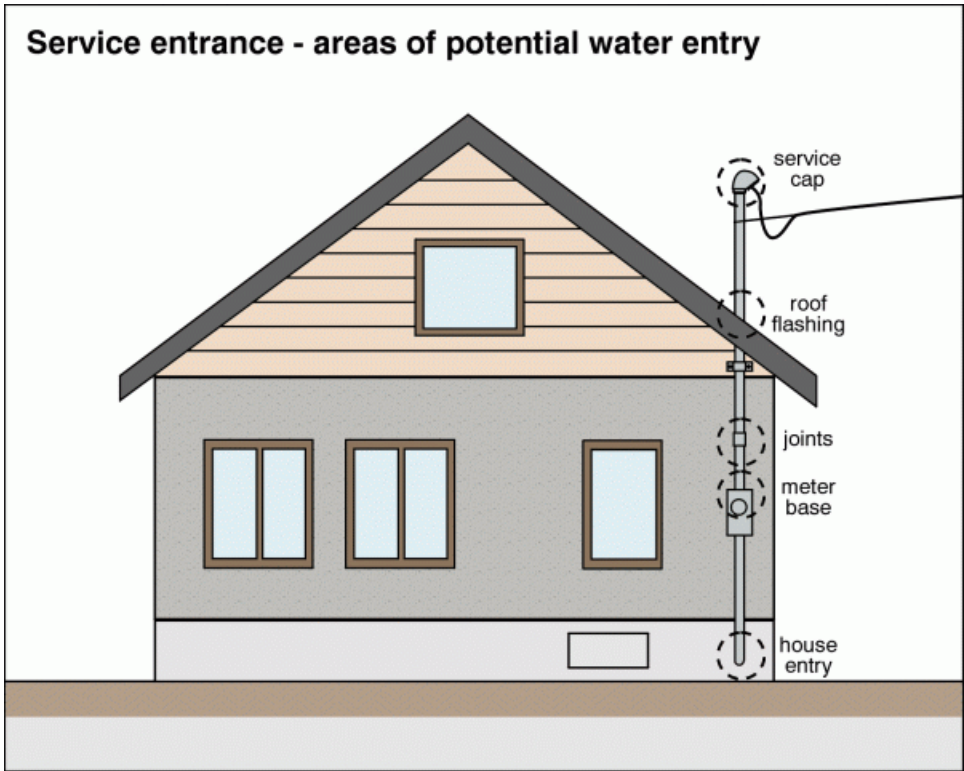
33. Condition: • [Conduit or cable not weather-tight](#)

Implication(s): Shock hazard or interruption of electrical service | Electric shock

41. Conduit or cable not weather-tight

Task: Replace

Time: Immediate

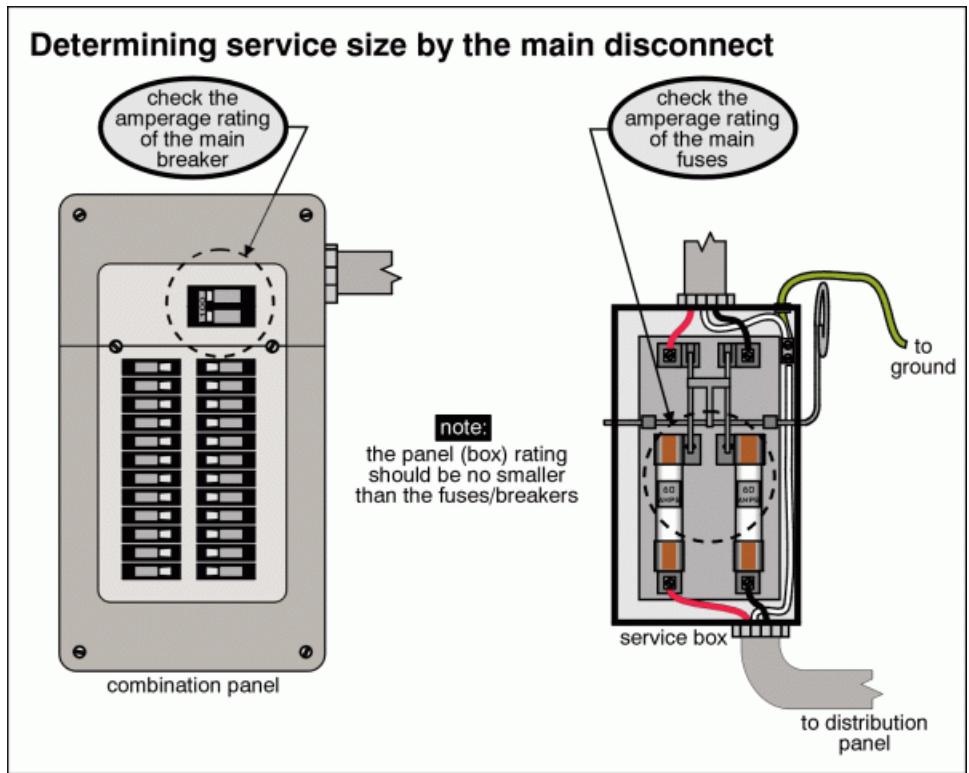
34. Condition: • [Box rating too small](#)

Implication(s): Equipment overheating | Fire hazard

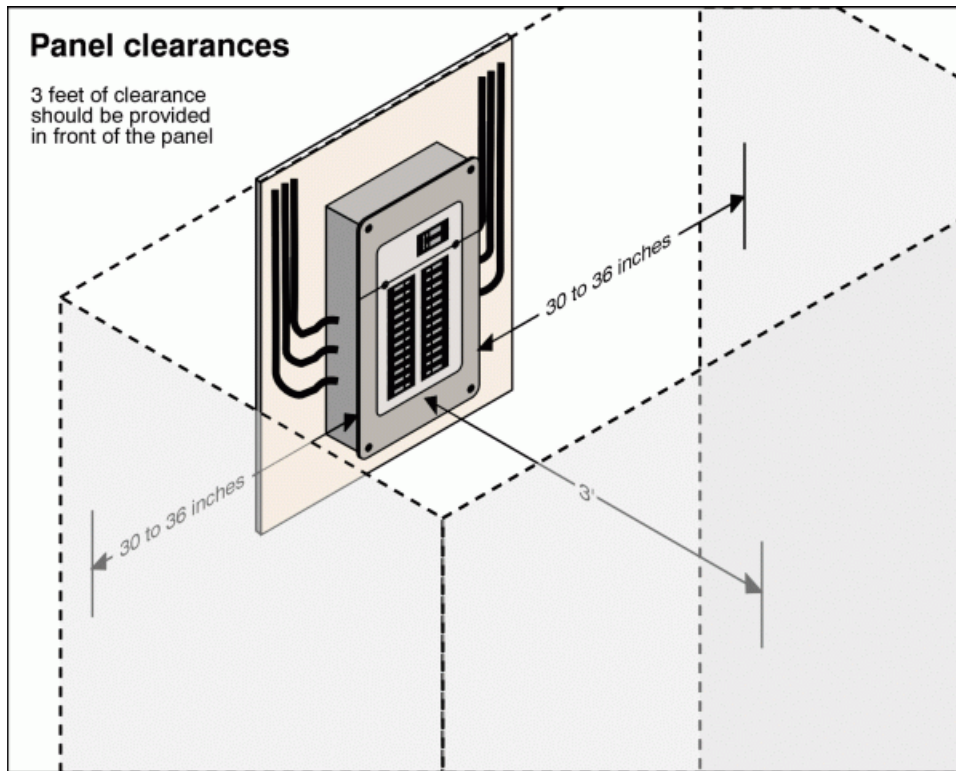
35. Condition: • [Poor access](#)

Implication(s): Difficult to service

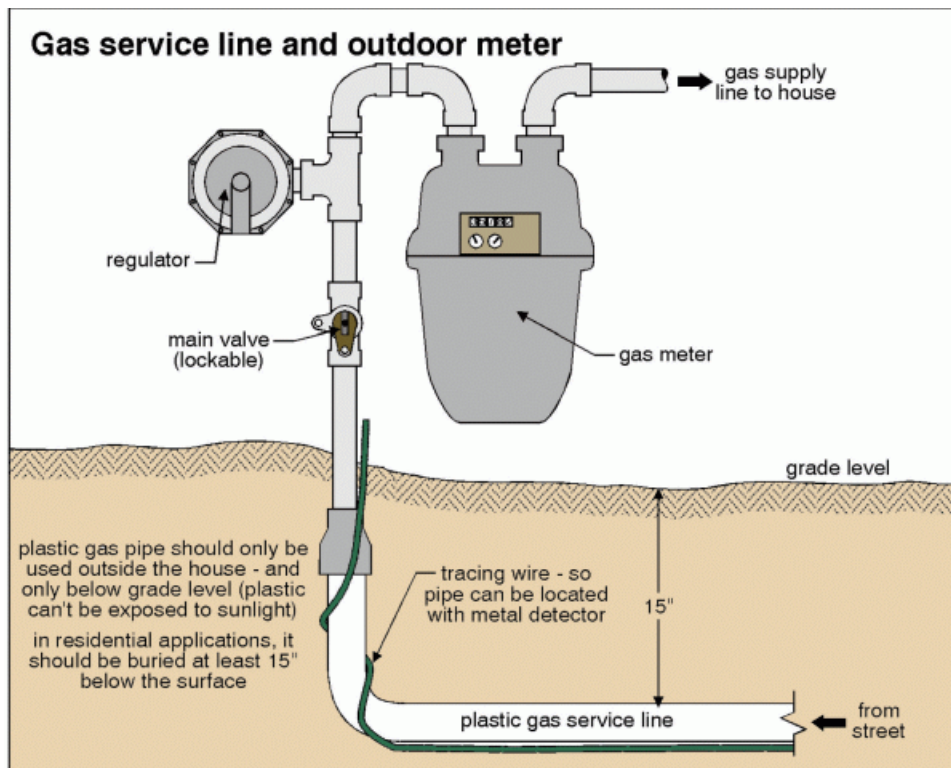
47. Condition: • [Leak](#)

Location: Front Basement

Task: Further evaluation

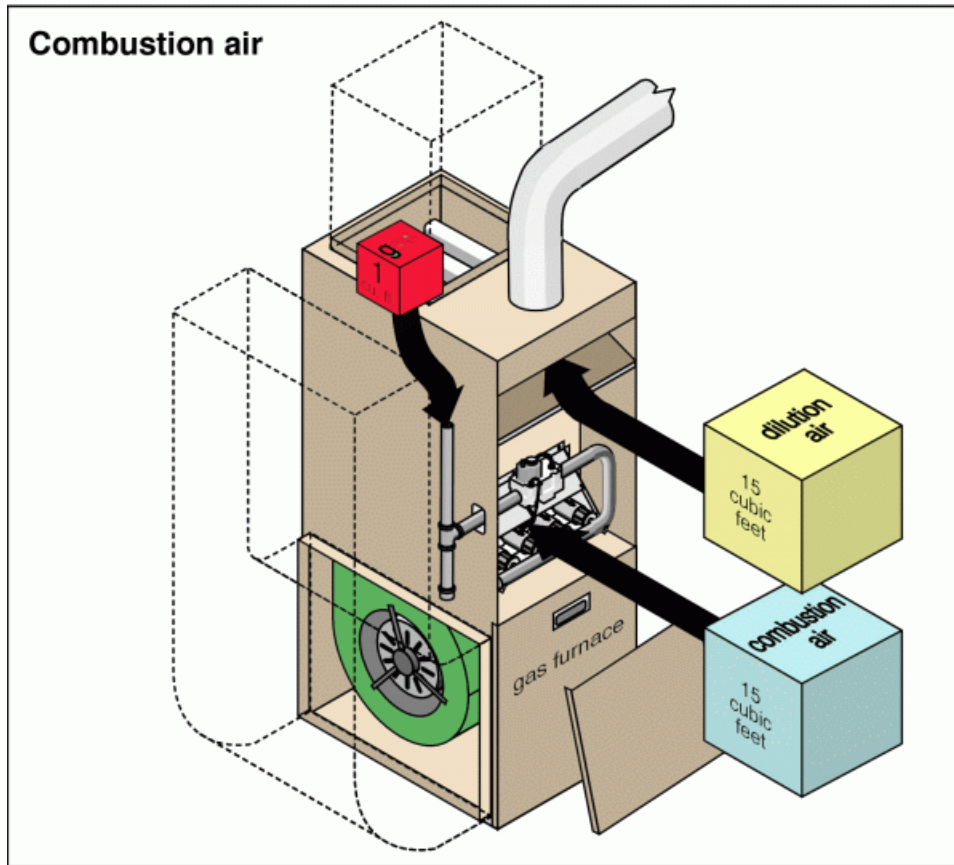
48. Condition: • [Inadequate combustion air](#)

Implication(s): Equipment not operating properly | Hazardous combustion products entering home | Increased heating costs | Reduced comfort | Increased operating costs

49. Inadequate combustion air

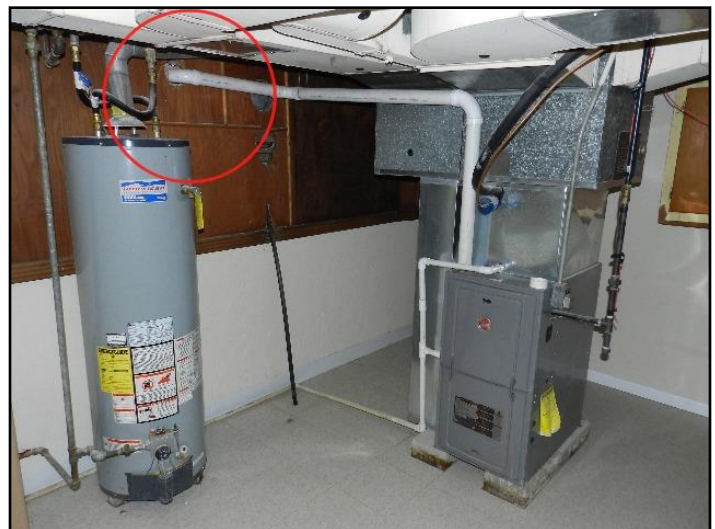
49. Condition: • [Poor vent location, arrangement](#)

Implication(s): Equipment not operating properly | Equipment inoperative | Hazardous combustion products entering home

51. Poor vent location, arrangement

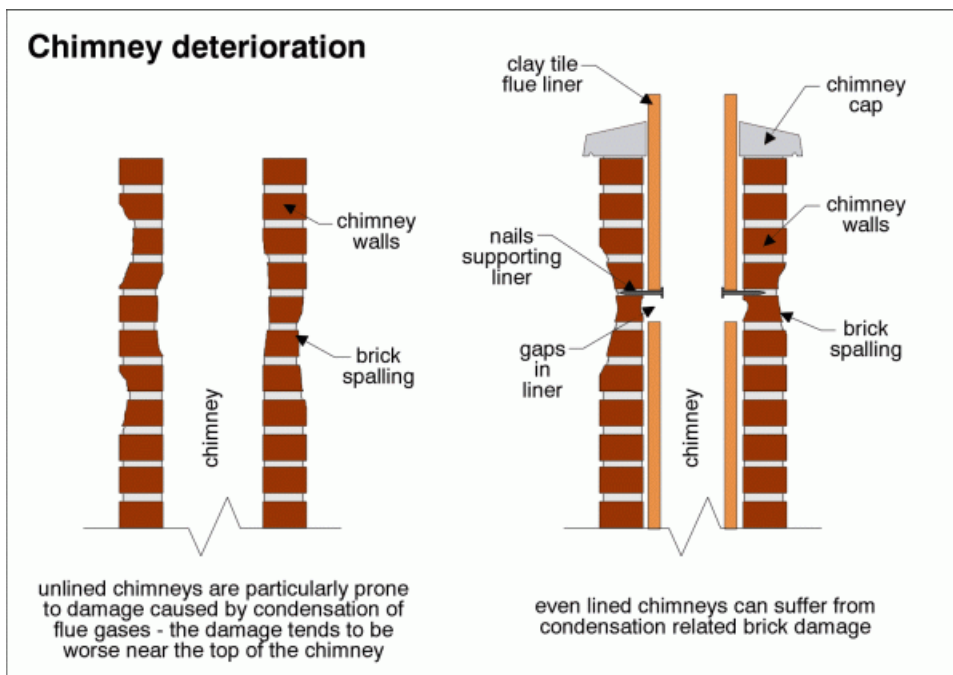
53. Condition: • [Loose, missing or deteriorated mortar](#)

Implication(s): Material deterioration

53. Loose, missing or deteriorated mortar

Task: Repair

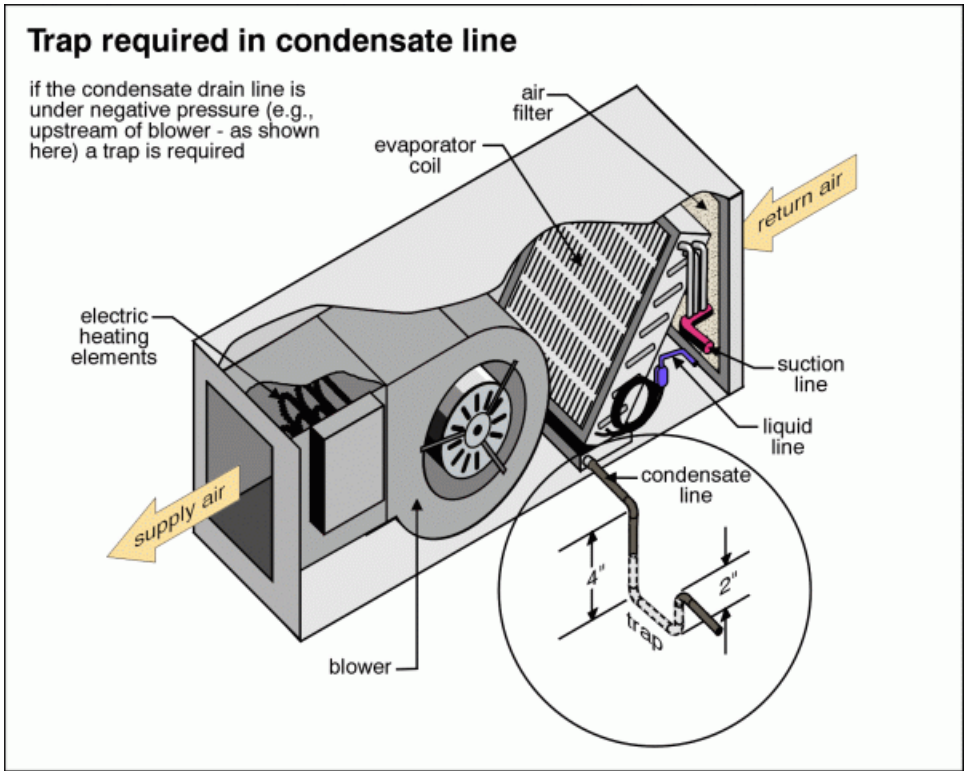
56. Condition: • [No trap](#)

Implication(s): Chance of water damage to contents, finishes and/or structure | Damage to equipment

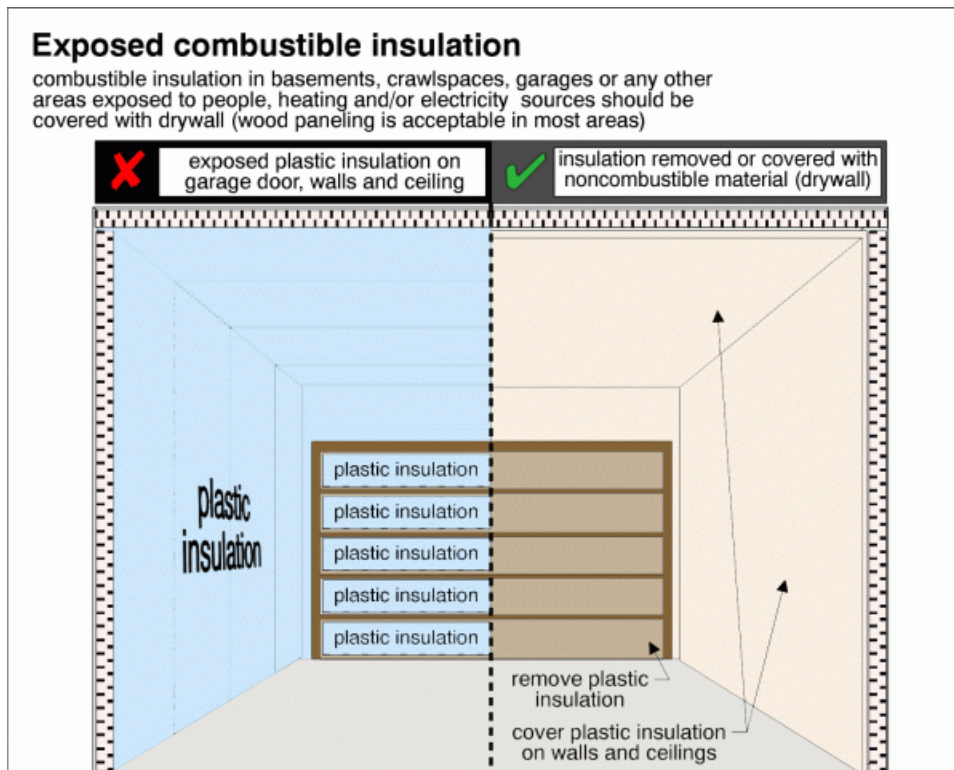
65. Condition: • [Exposed combustible insulation](#)

Implication(s): Increased fire hazard

Location: Throughout Sunroom Porch

Task: Repair or replace

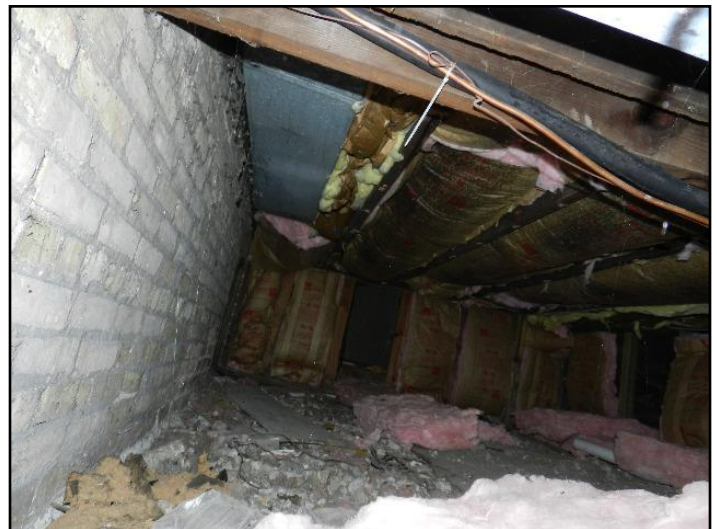
69. Exposed combustible insulation

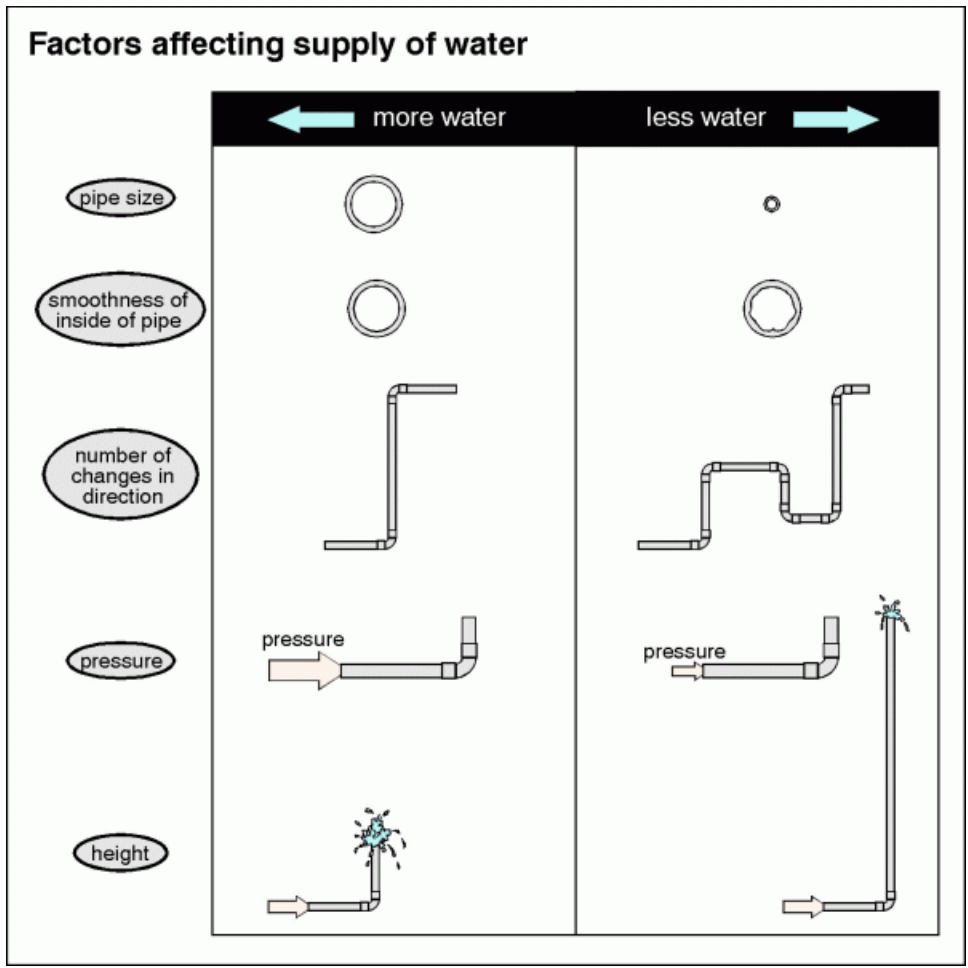
67. Condition: • [Low pressure](#)

Implication(s): Reduced water pressure and volume

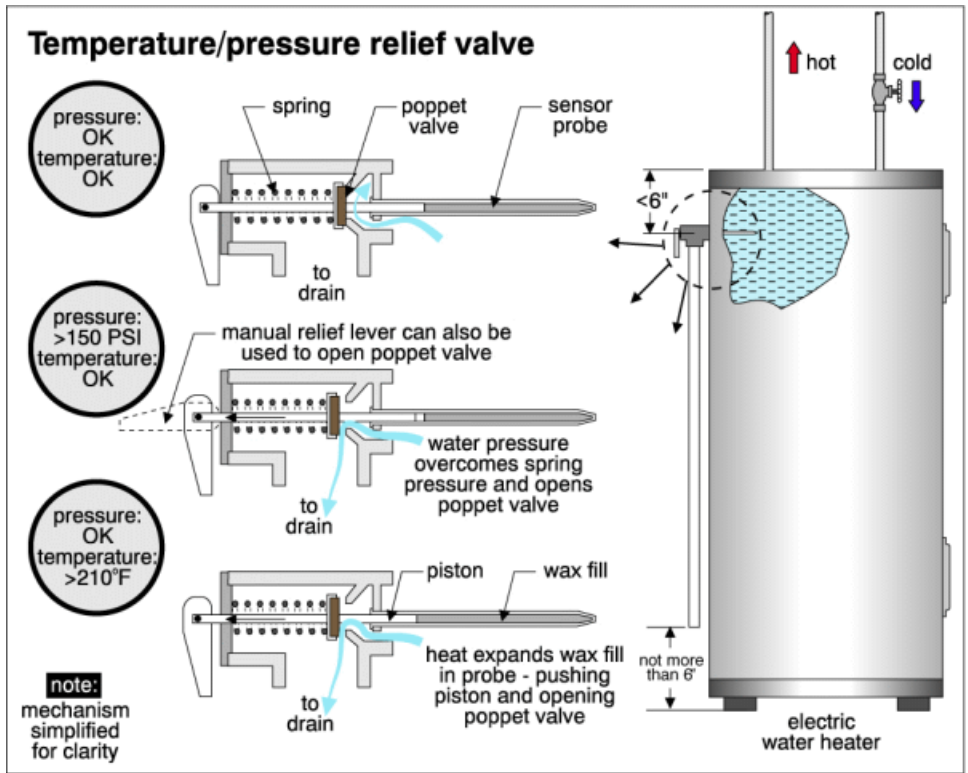
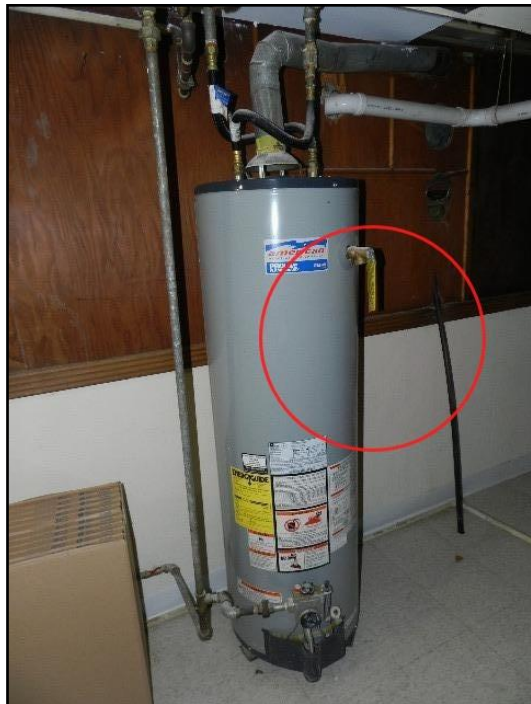
76. Discharge tube missing

Task: Repair or replace Provide

Time: Immediate
