Your Inspection Report

5246 North Sample St
Chicago, IL

INSPECTION DATE:
Wednesday, January 24, 2018

RE: Report No. 1078
5246 North Sample St
Chicago, IL

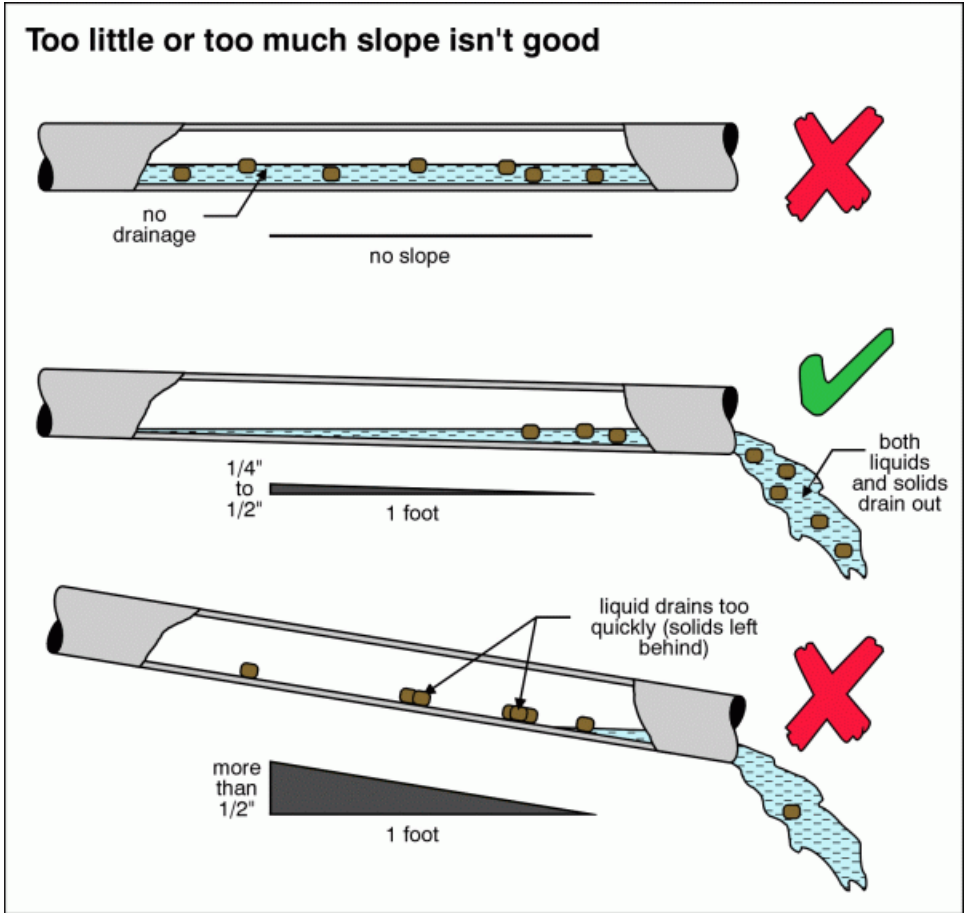
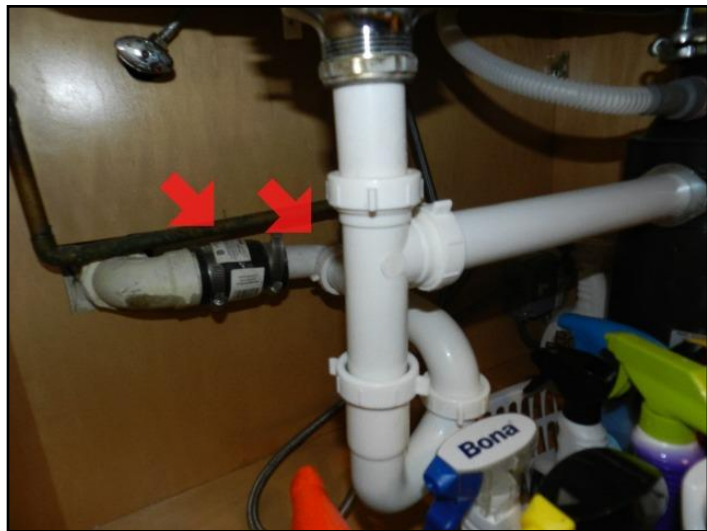
78. Negative slope to drain, PVC piping

Task: Replace

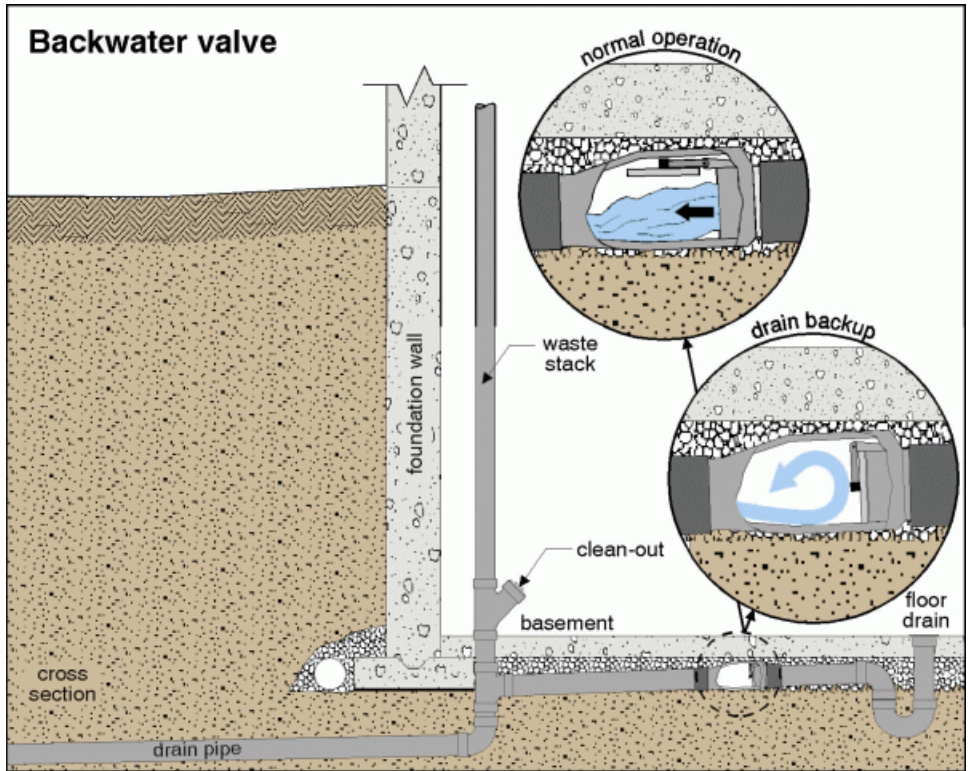
83. Uncapped drain to sewer, possible backup

Task: Repair or replace Monitor Clean Protect

Time: Immediate

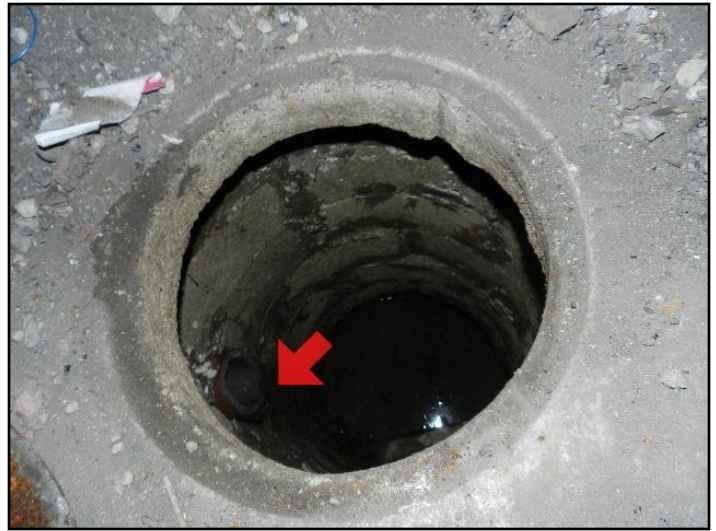
86. Backup, no check valve

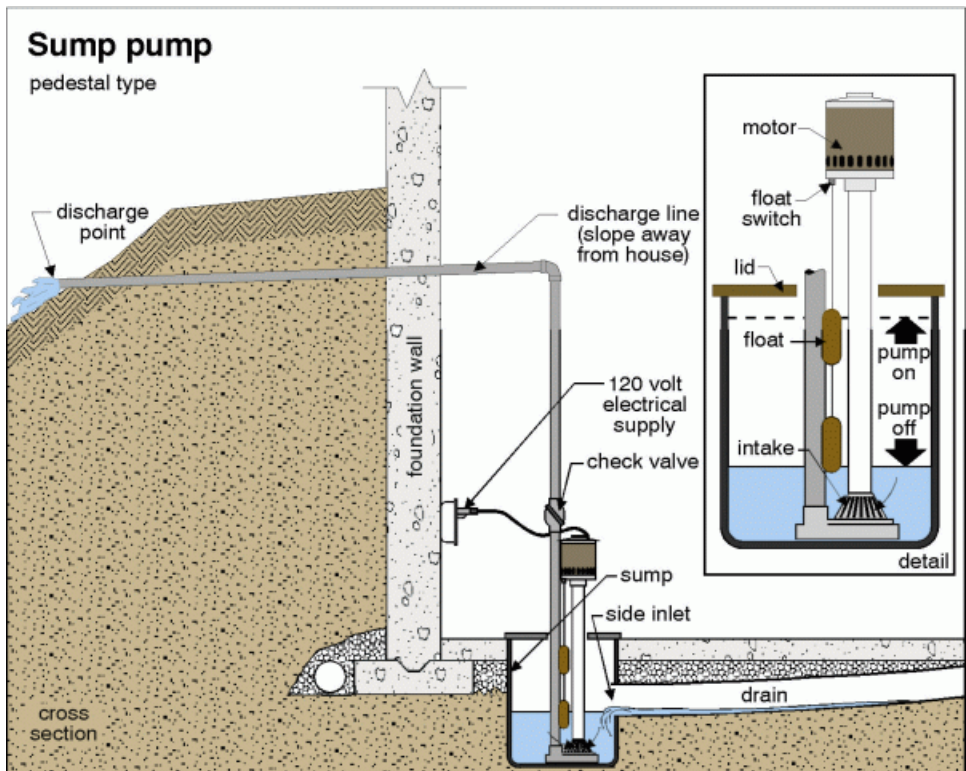
82. Condition: • [Missing](#)

Task: Provide

Cost: Major

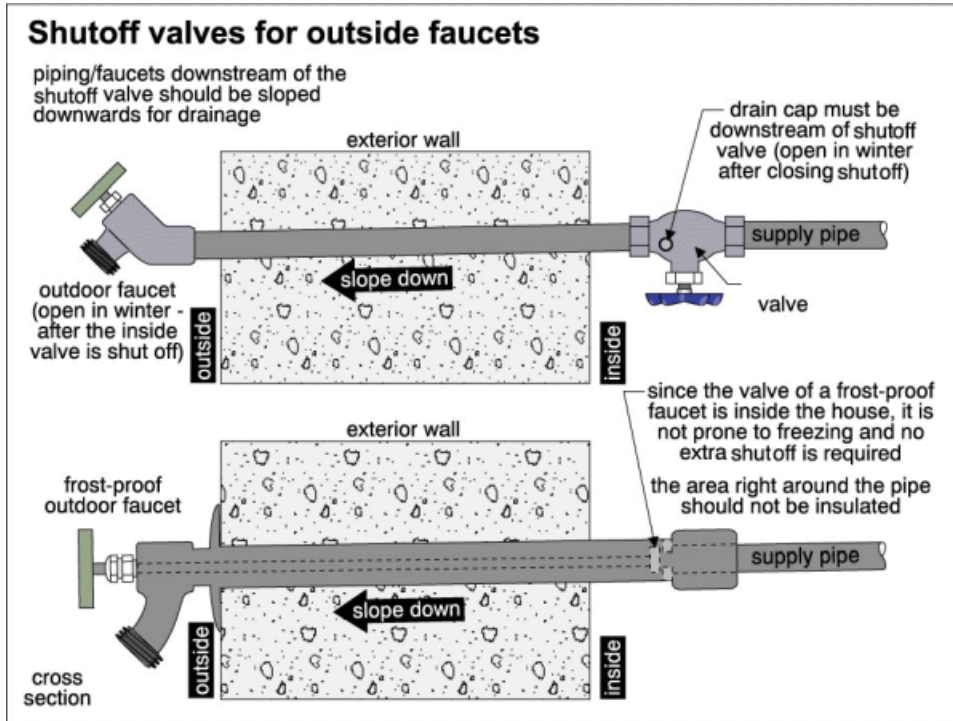
83. Condition: • [Loose](#)

Implication(s): Reduced system life expectancy

87. Loose

Task: Correct

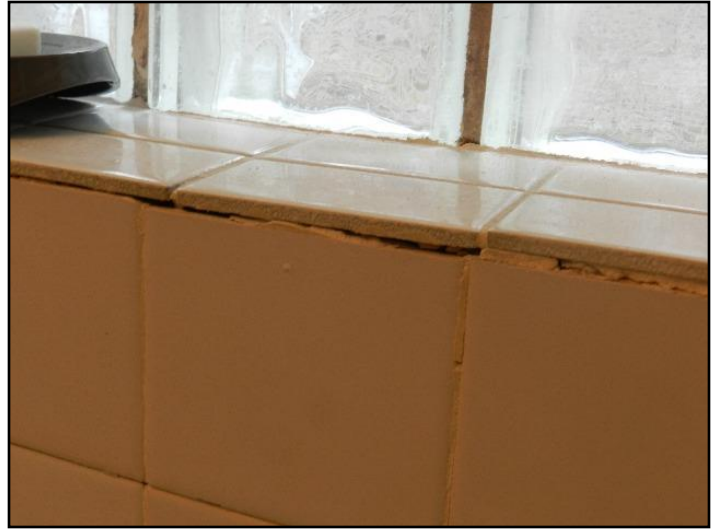
89. Grout loose, missing or deteriorated

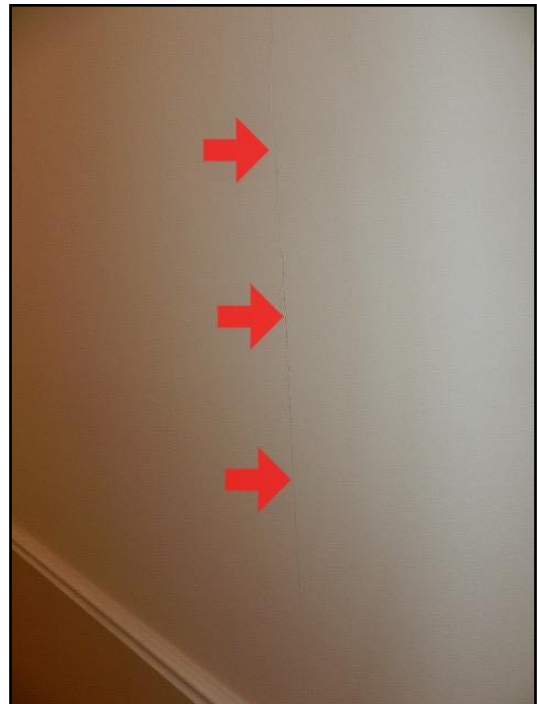
93. Cracked

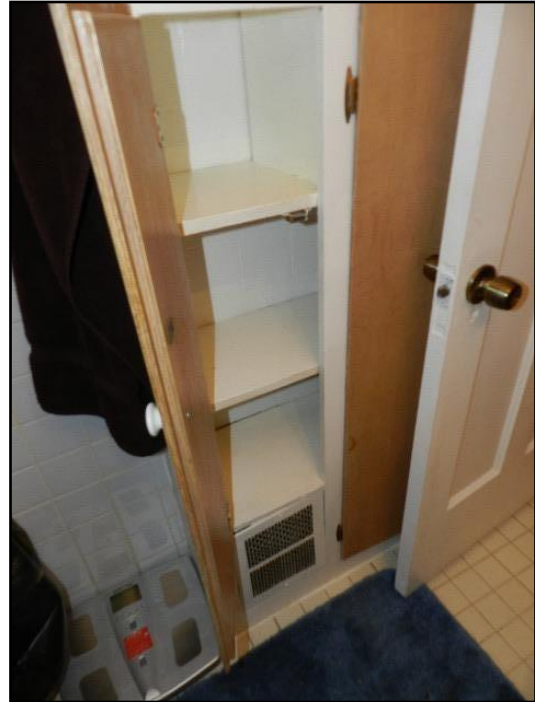
96. Trip hazard

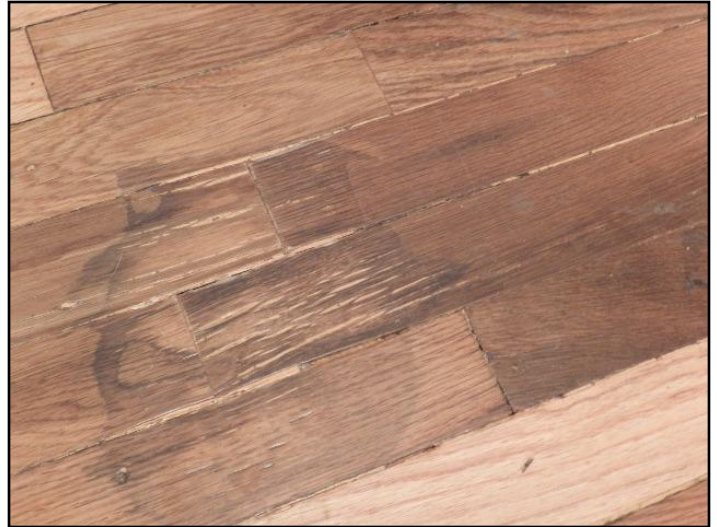
98. Dog urine stains/damage

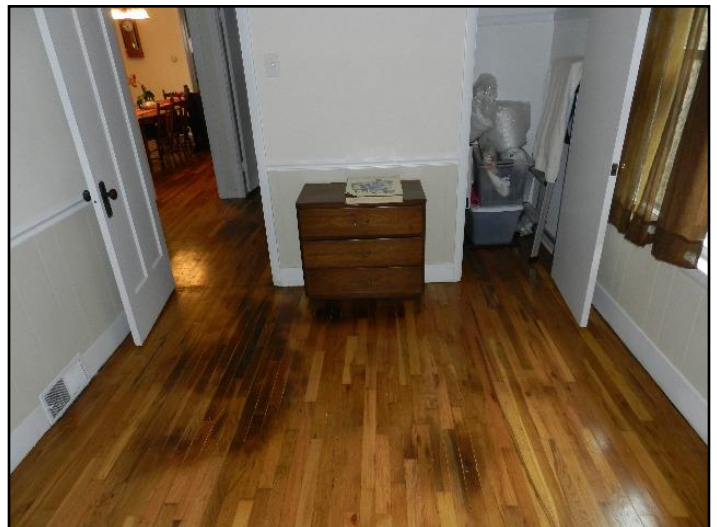
100. Dog urine stains/damage

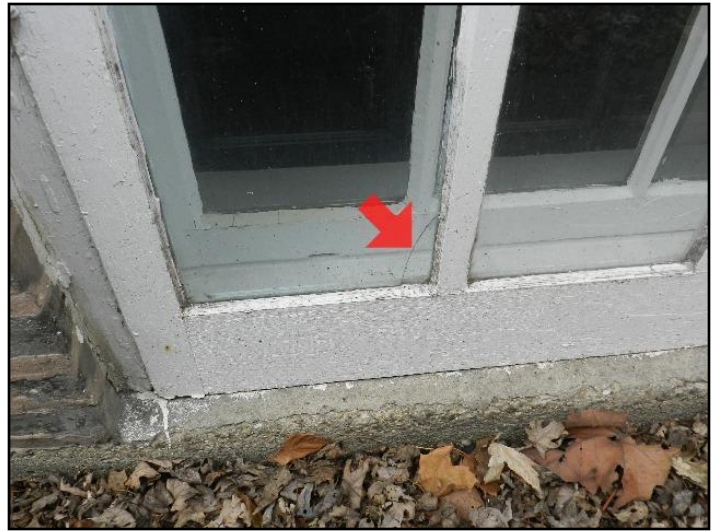
105. Cracked

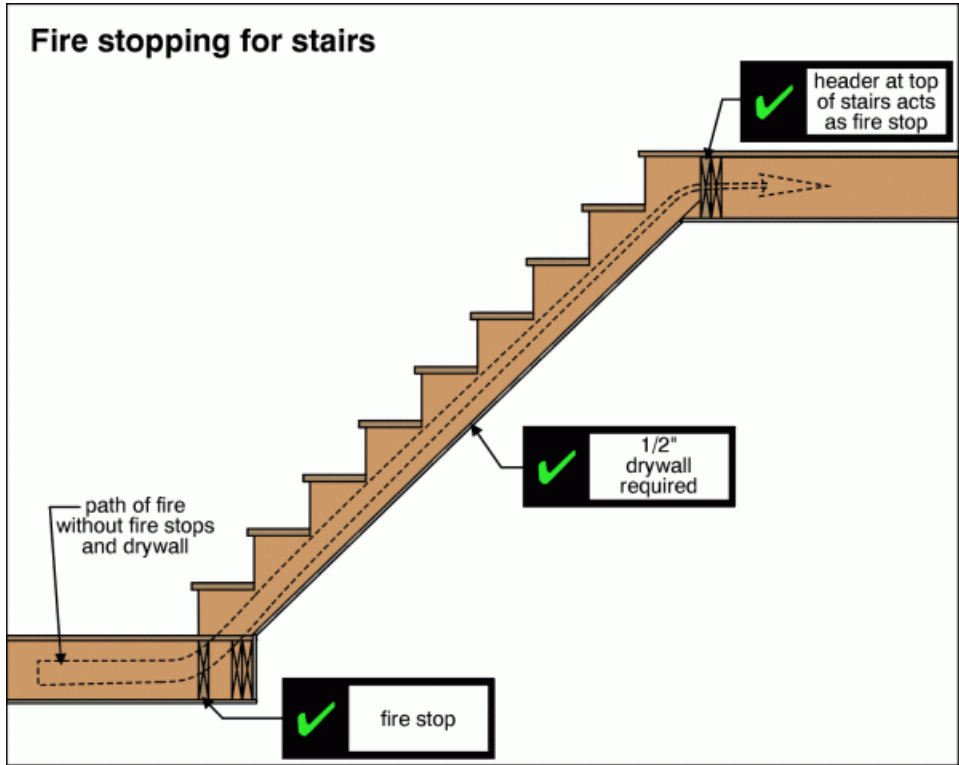
109. Drywall missing or incomplete on underside...

Task: Repair or replace Upgrade Protect

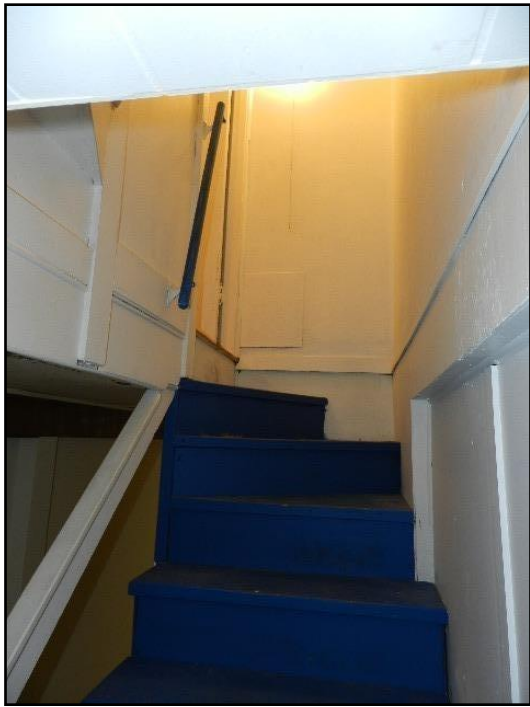
113. Rise excessive

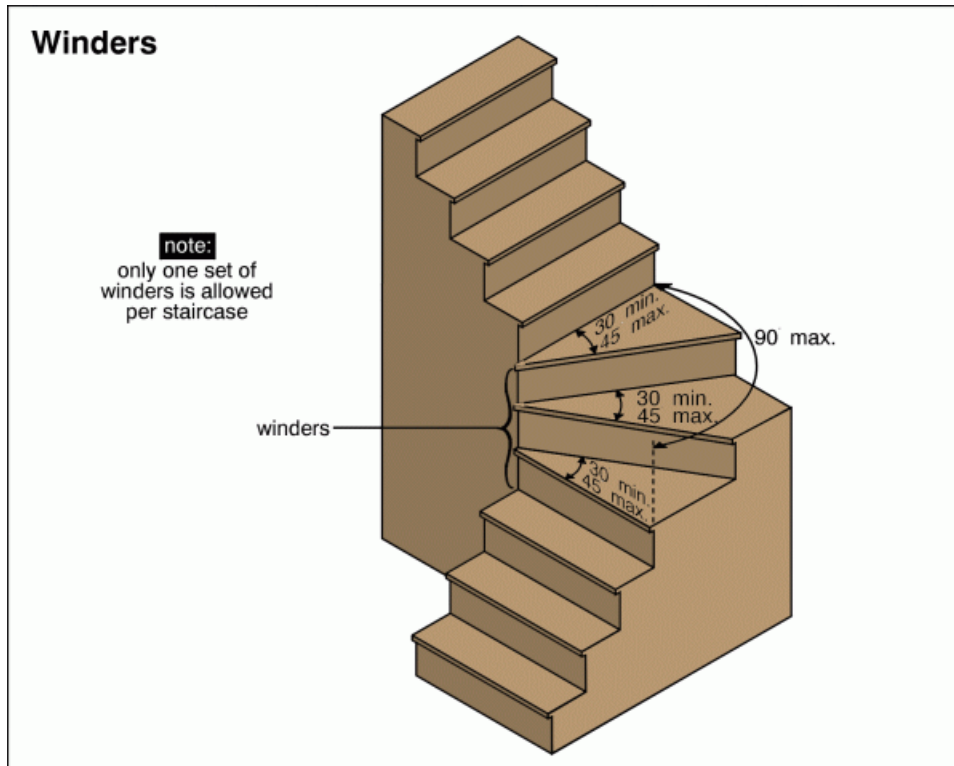
102. Condition: • [Worn or damaged](#)
Implication(s): Weakened structure | Trip or fall hazard

Implication(s): Trip or fall hazard

Task: Replace Demolish

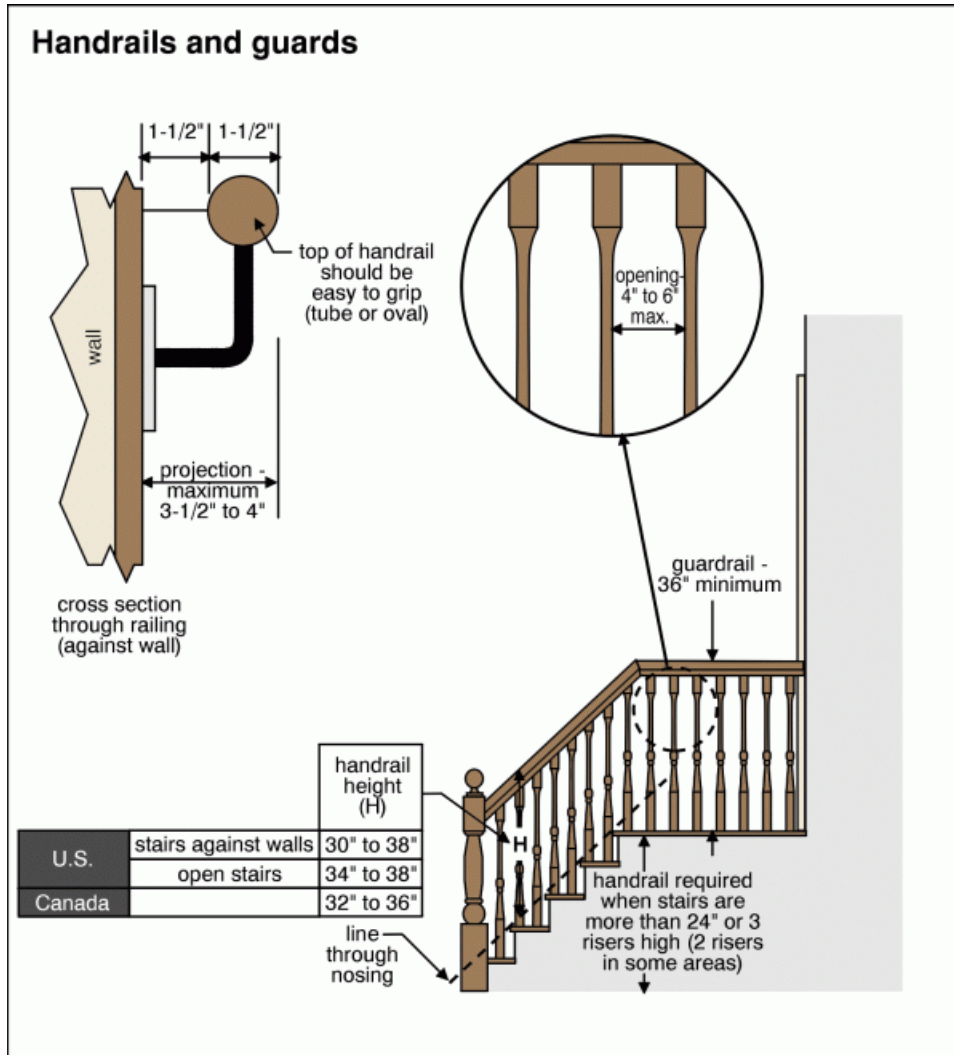
105. Condition: • [Missing](#)

Implication(s): Fall hazard

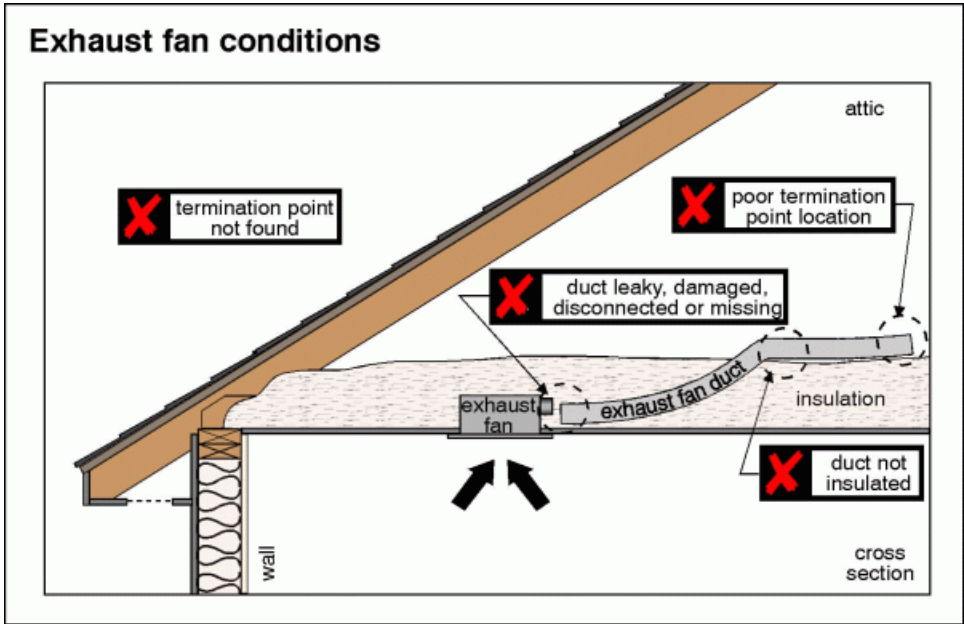
106. Condition: • Not vented to exterior

Implication(s): Chance of condensation damage to finishes and/or structure

115. Not vented to exterior

Task: Correct Upgrade

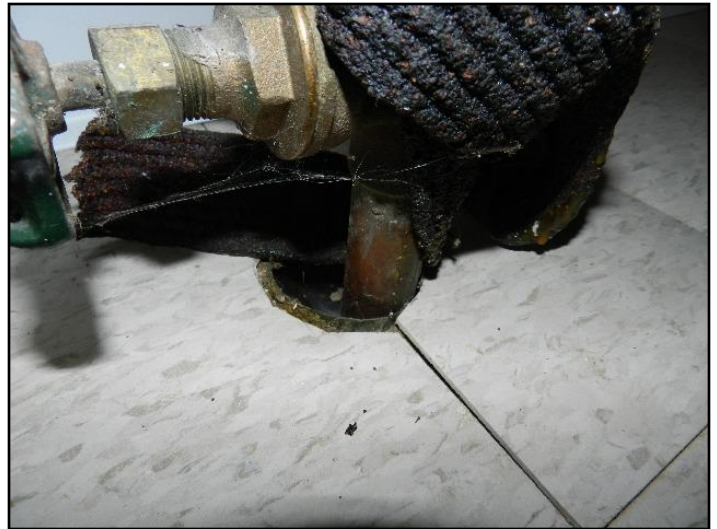
117. Loose floor tiles

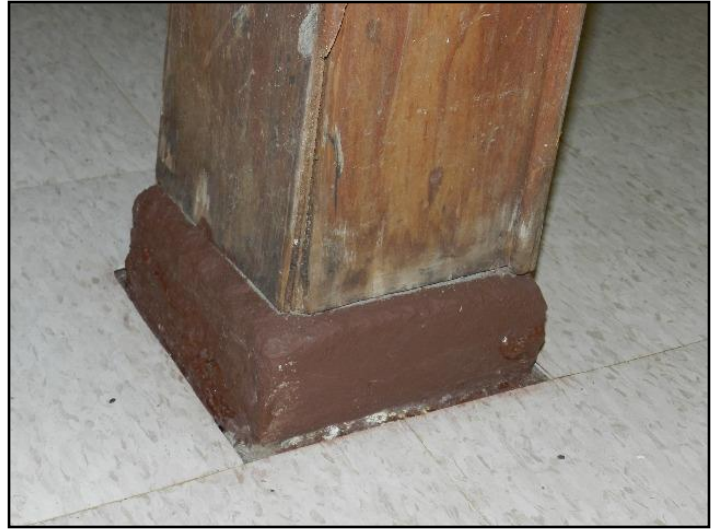
120. Rot

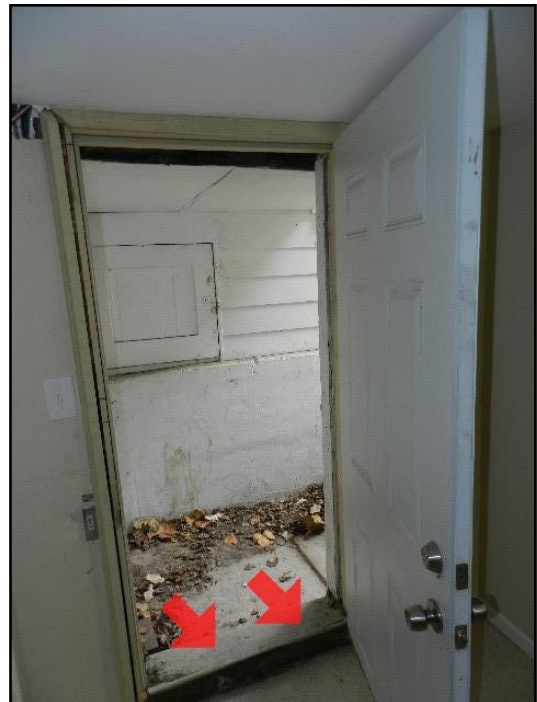
122. Possible leakage entry from basement door

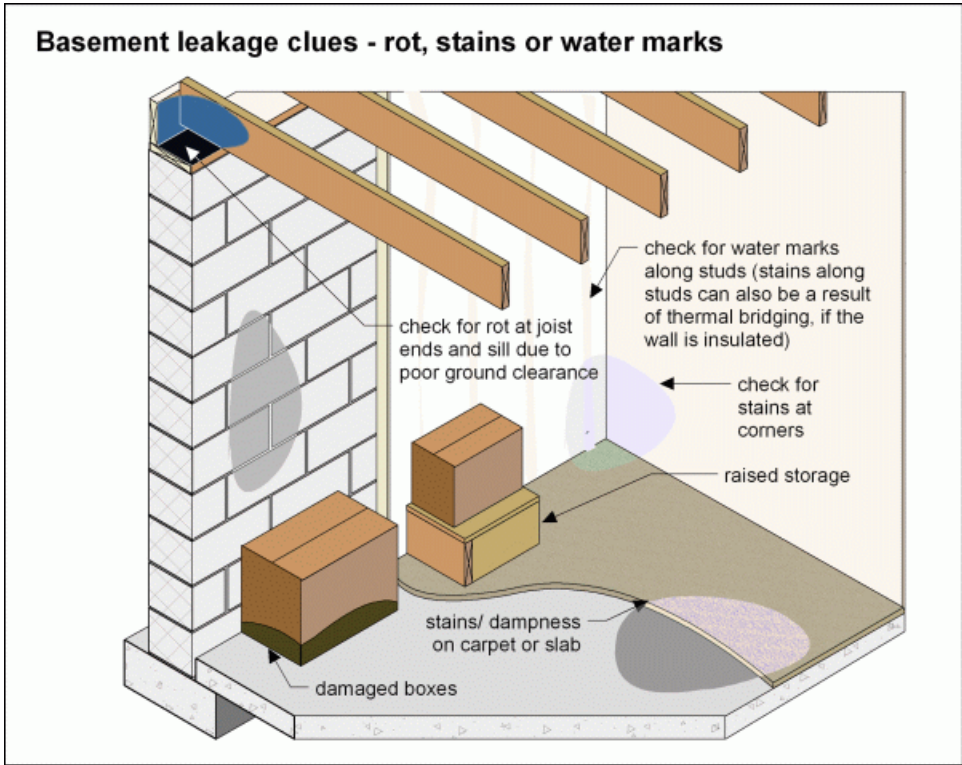
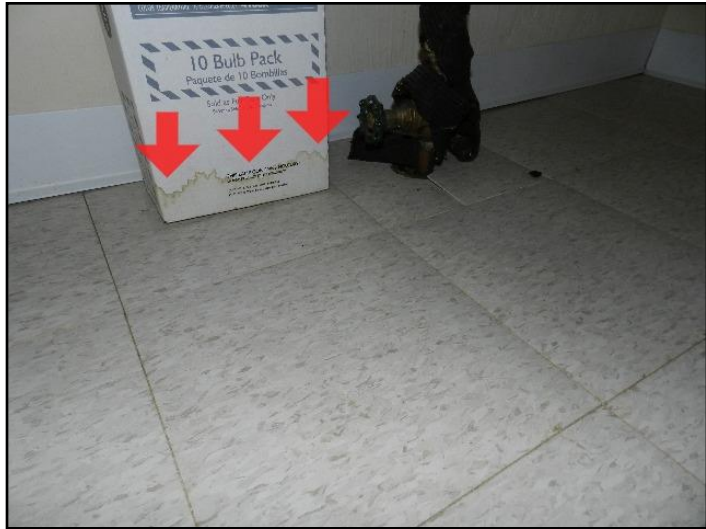
113. Condition: • [Stains](#)

123. Water stains

Time: Immediate

Cost: Major

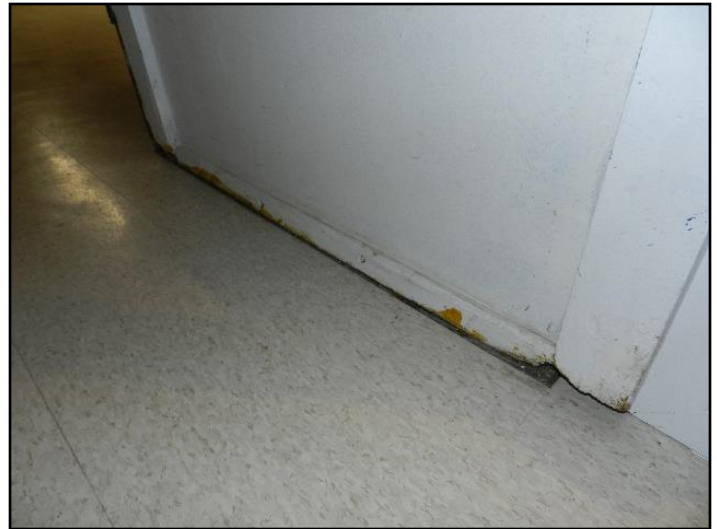
114. Condition: • [Wall cracks with water stains](#)

125. Wall cracks with water stains

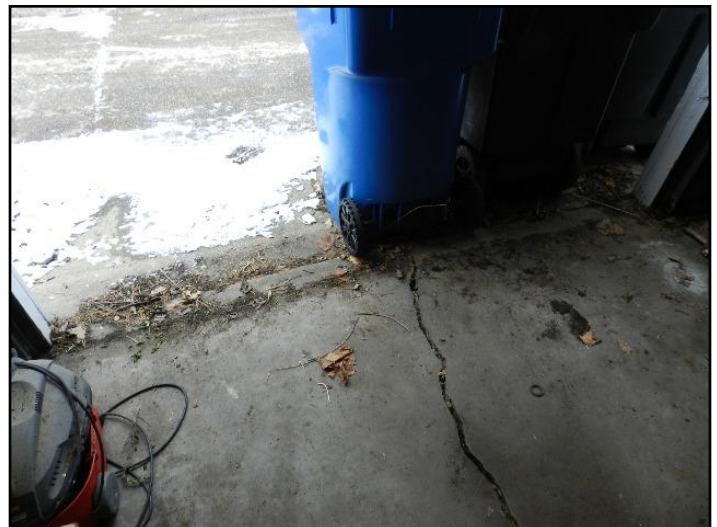
127. Cracked

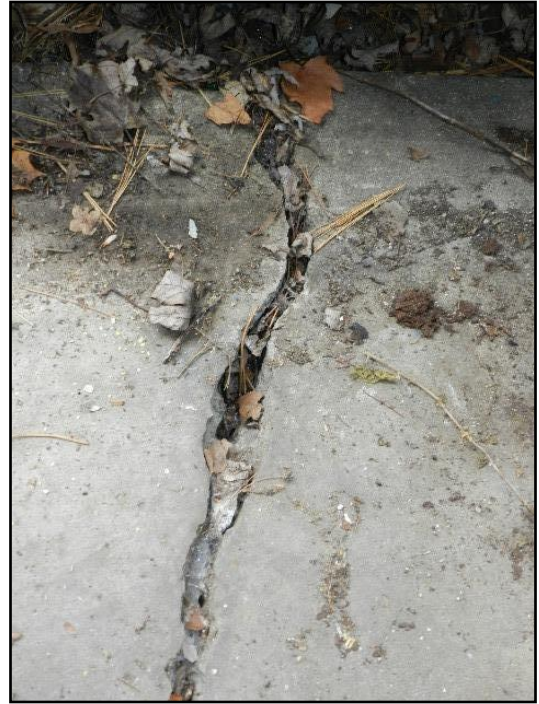
129. Cracked
