# Your Inspection Report

3256 West Sample St, Suite 2  
Chicago, IL

**INSPECTION DATE:**  
Saturday, February 3, 2018

RE: Report No. 1079, v.2  
3256 West Sample St, 2  
Chicago, IL

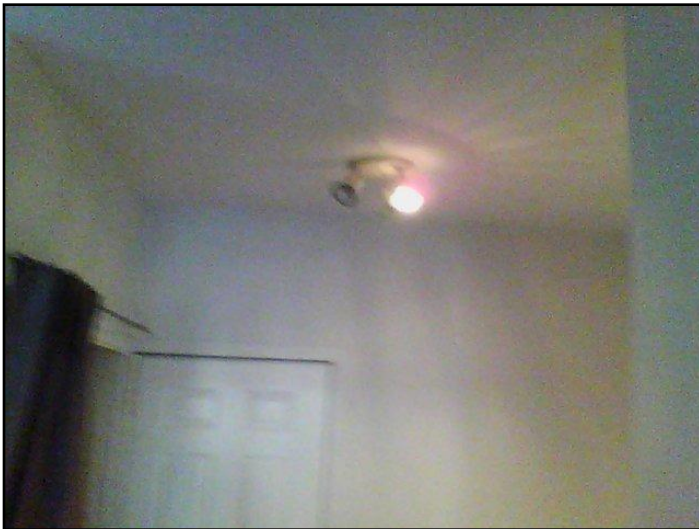
4. Moisture in wall, possible leak

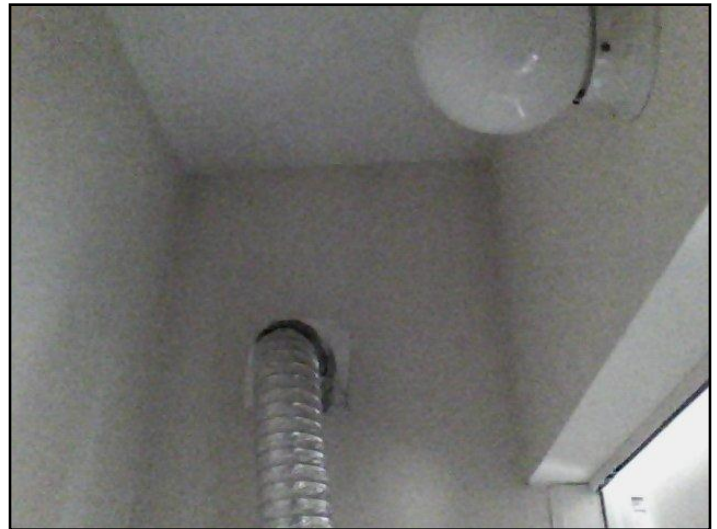
5. Moisture in wall, possible leak

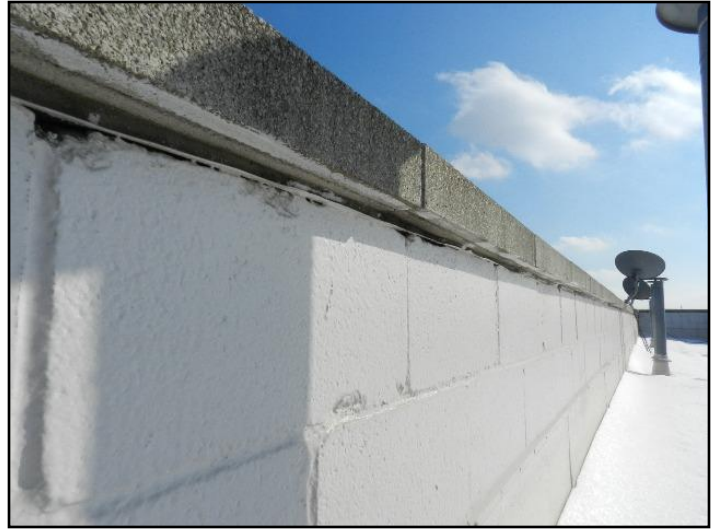
12. *Inspect during annual tune-up*

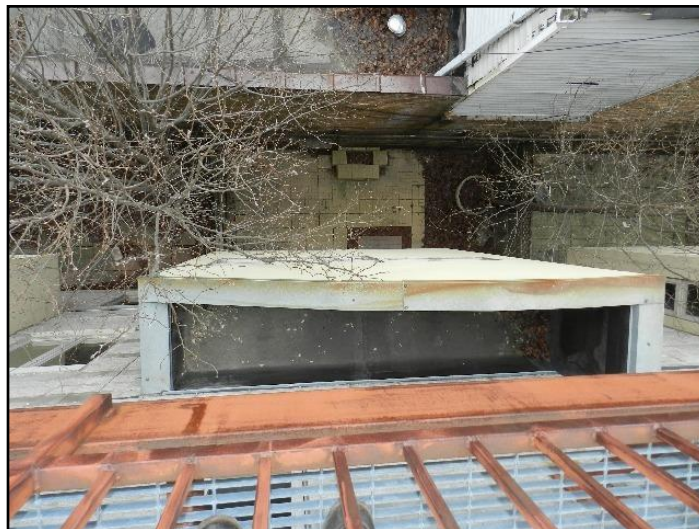
4. Condition: • [Old, worn out](#)

Location: Second Floor

13. *Old, worn out*

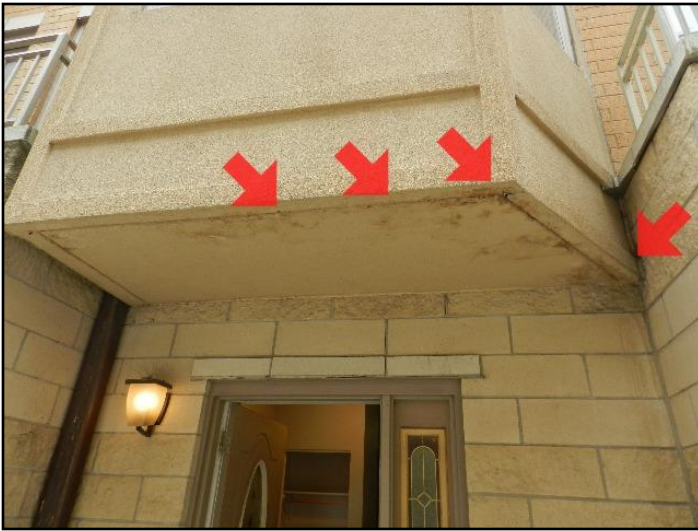
15. No drip edge, water damage

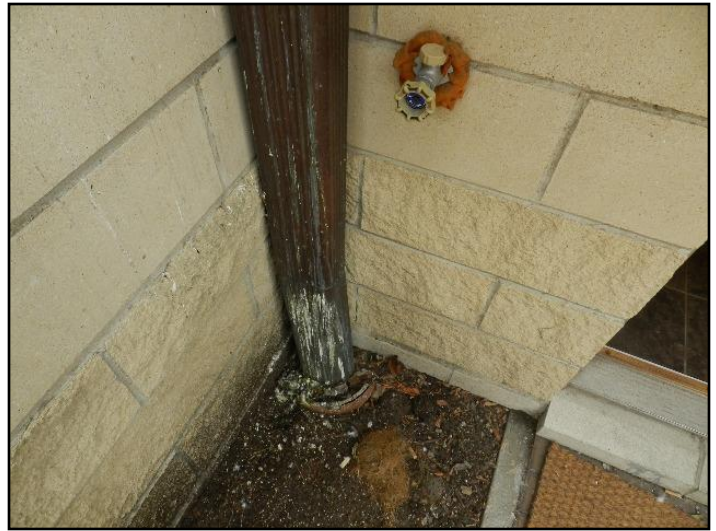
**5. Condition:** • [Loose or damaged](#)

16. Loose or damaged

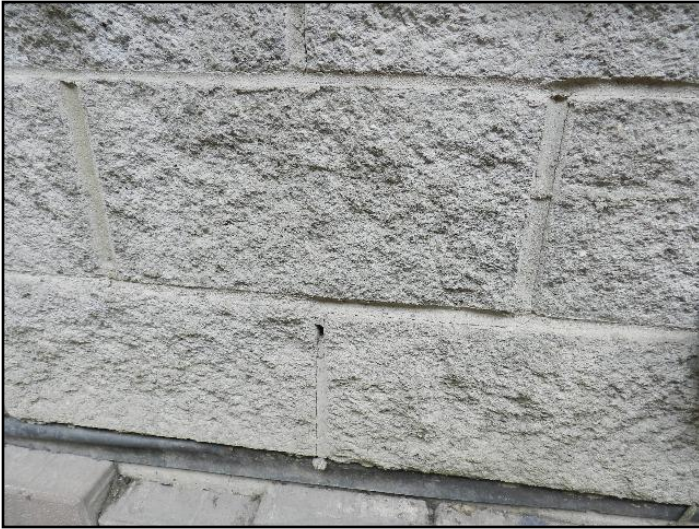
## 7. Condition: • [Mortar deterioration](#)

20. Mortar deterioration

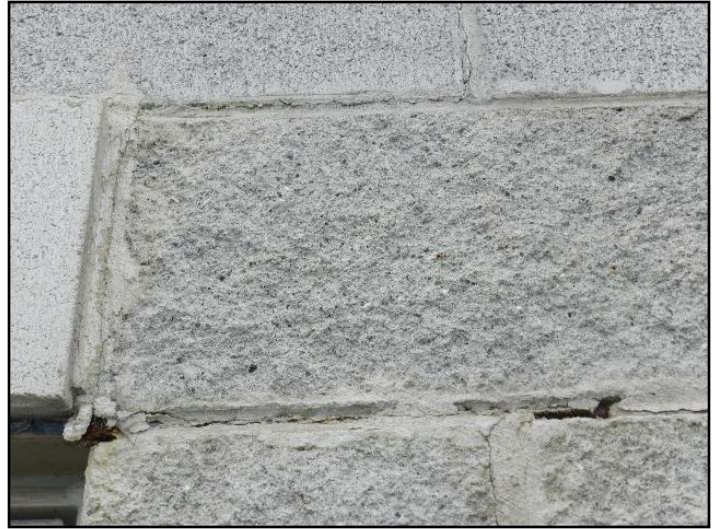
21. Mortar deterioration

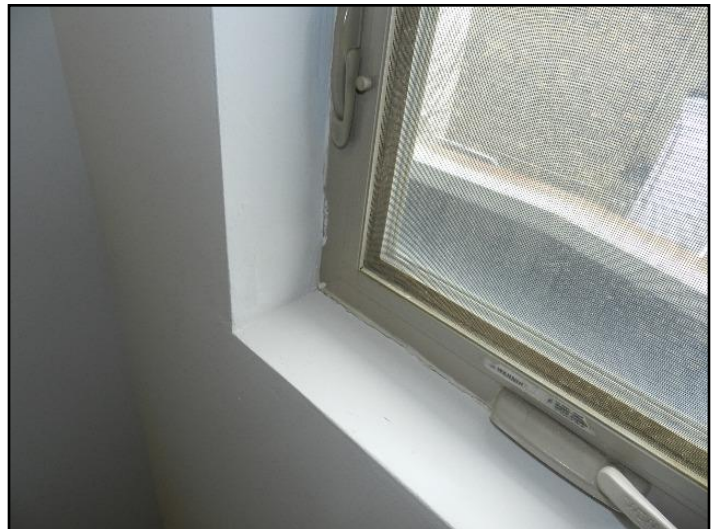
9. Condition: • [Lost seal on double or triple glazing](#)

27. Lost seal on double or triple glazing

Task: Replace

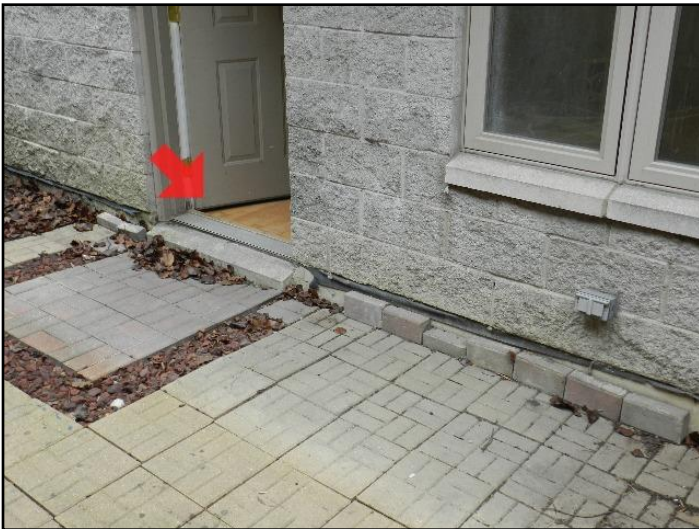
11. Condition: • [Water leaks](#)

29. Water leaks

Task: Repair

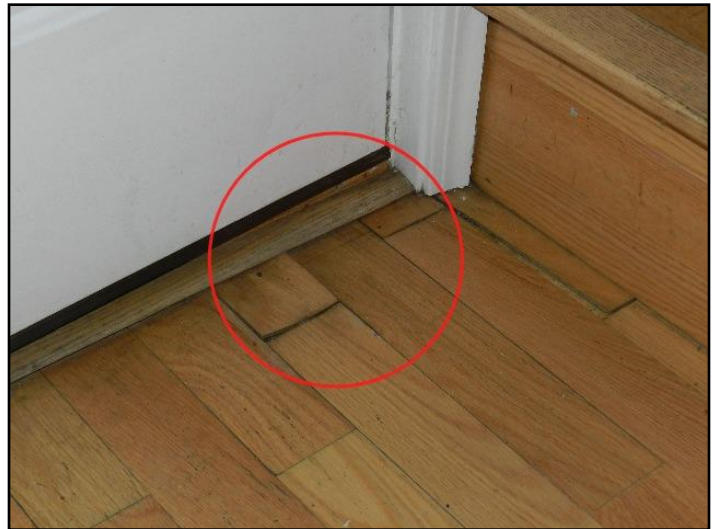
30. Water leaks

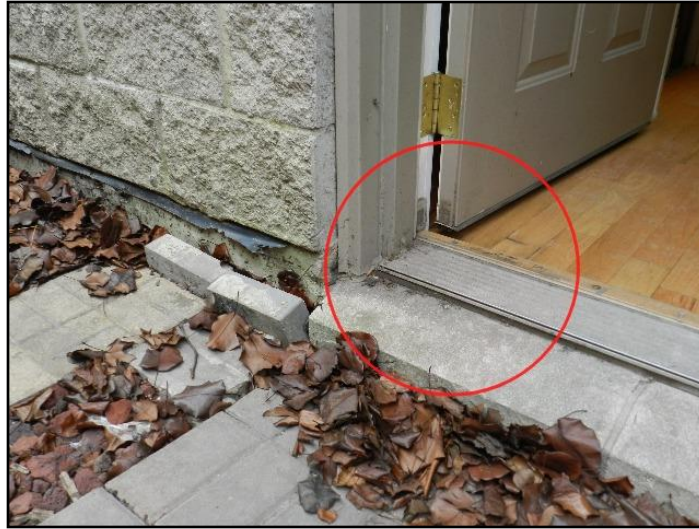
31. Water leaks

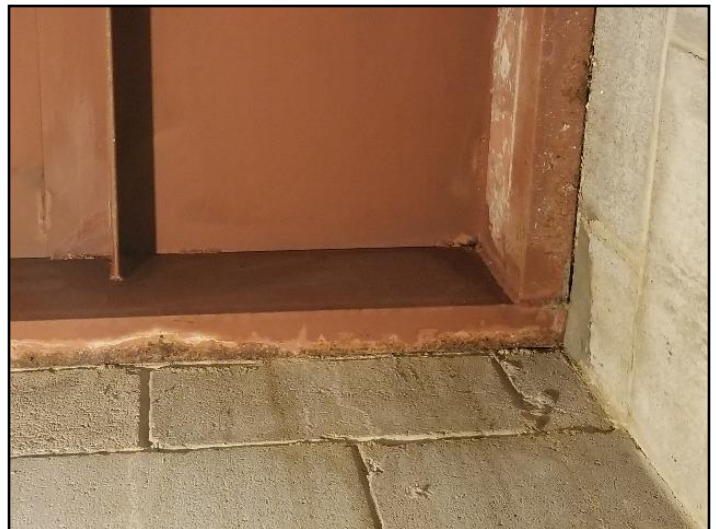
12. Condition: • [Rust](#)

33. Rust at fire escape landing

Task: Repair or replace Clean Correct Protect

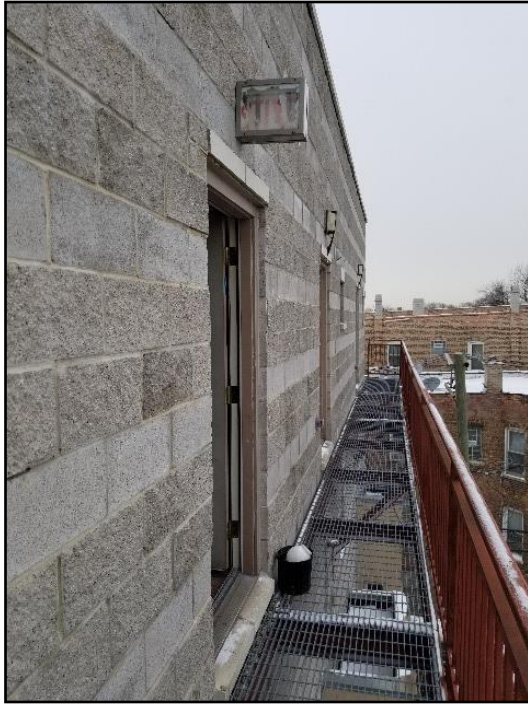
34. Rust at fire escape guard

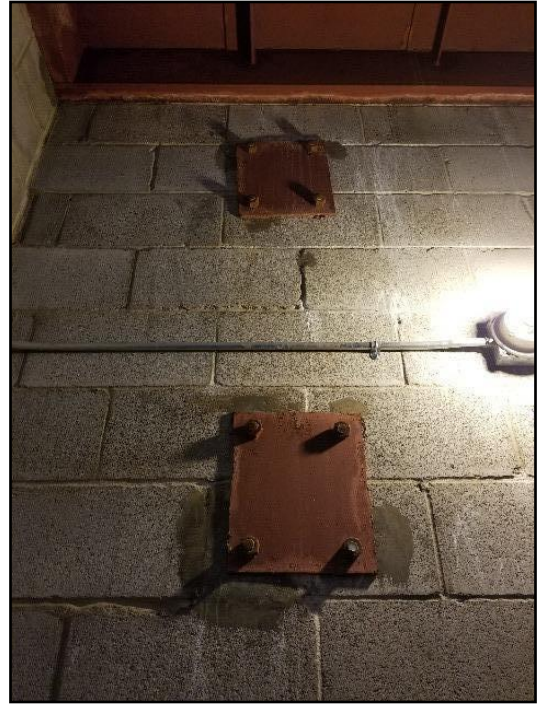
35. Rust at structural support of ledge

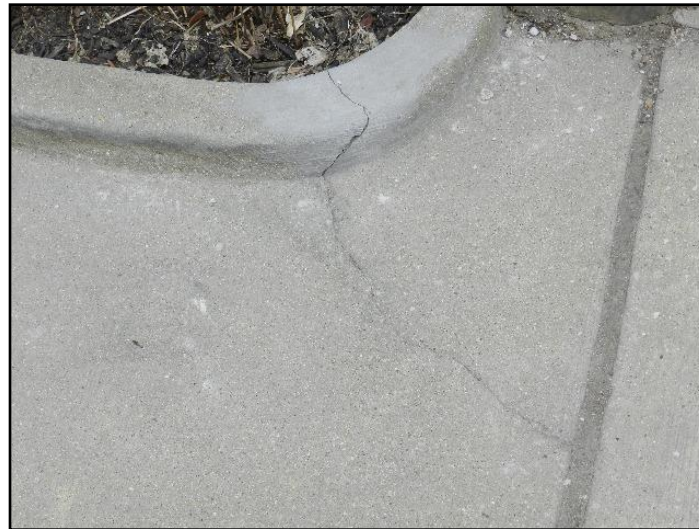
13. Condition: • [Cracked or damaged surfaces](#)

36. Cracked or damaged surfaces

Task: Repair

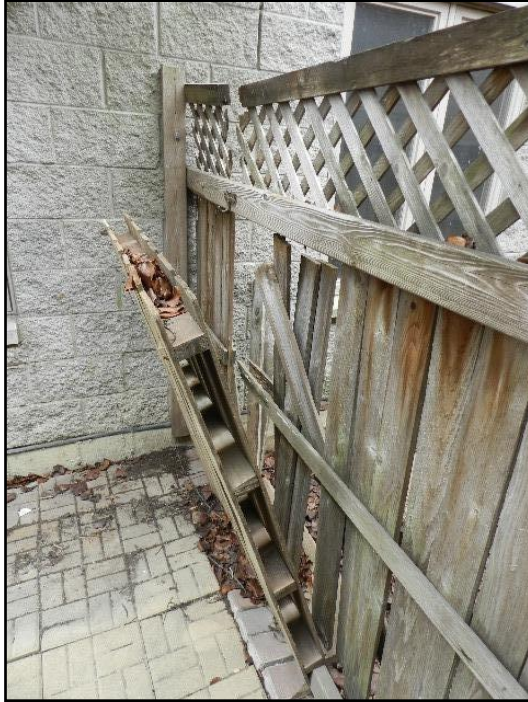
14. Condition: • Boards damaged

37. Boards damaged

**Task:** Replace

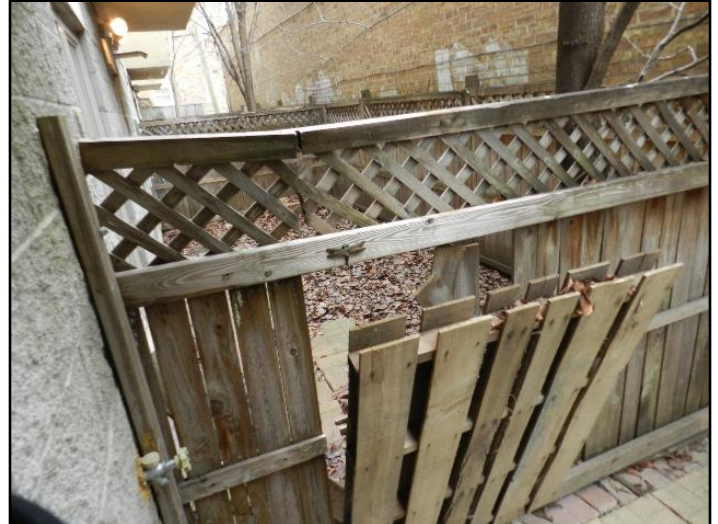
38. Boards damaged

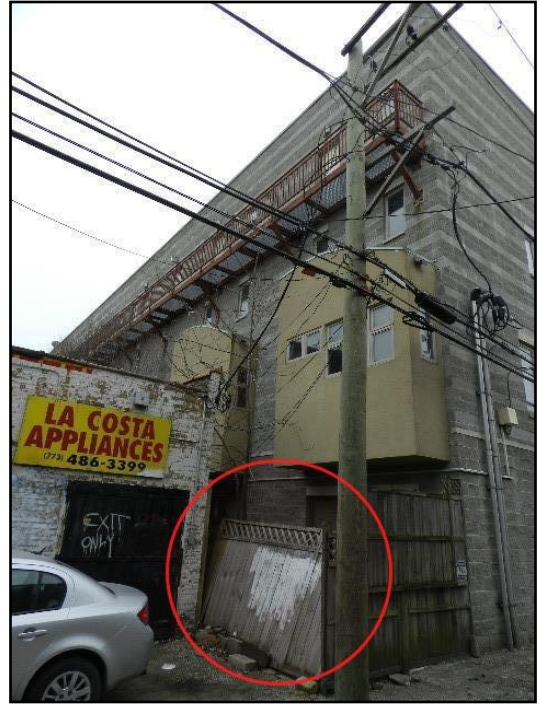
**15. Condition:** • Damage

40. Fence damage throughout property

**Task:** Replace Request disclosure

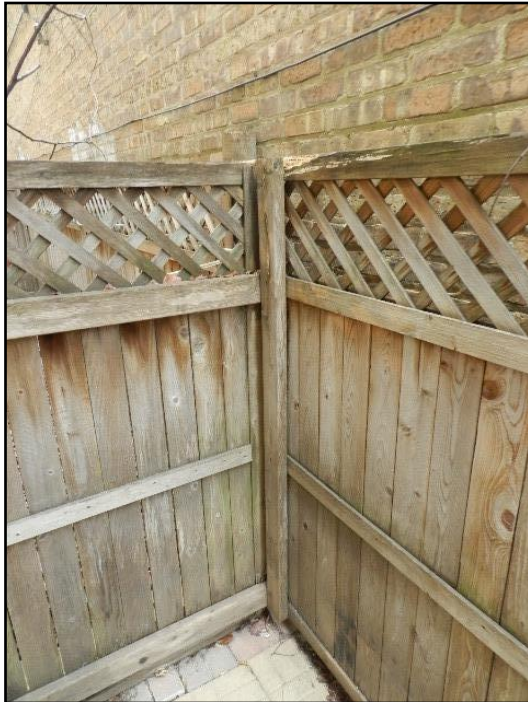
16. Condition: • Rot

41. Rot

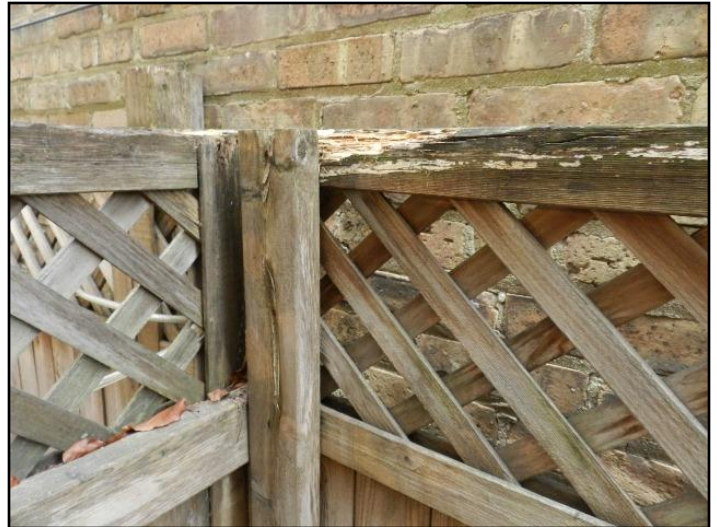
42. Rot

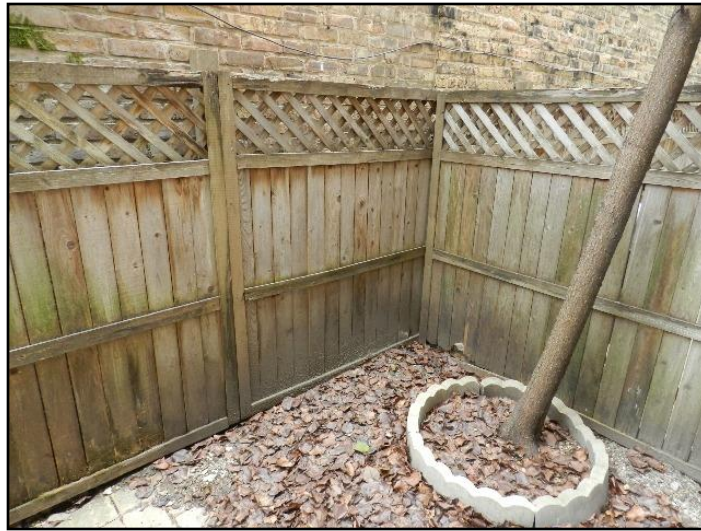
43. Rot

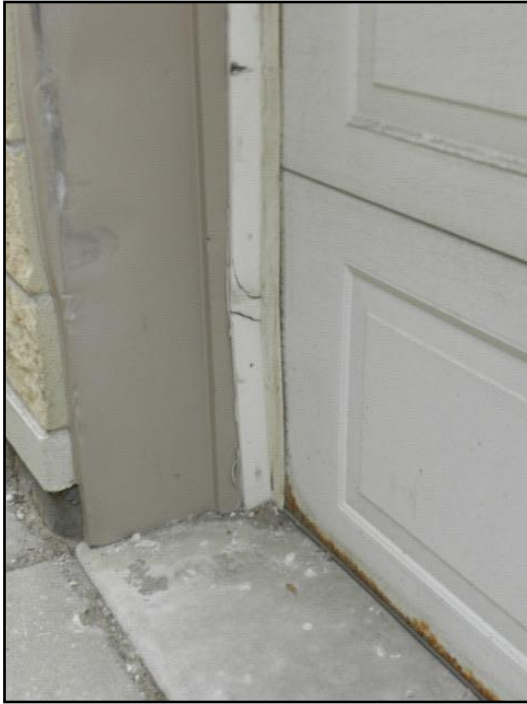
20. Condition: • Damage

48. Damage

Task: Repair or replace

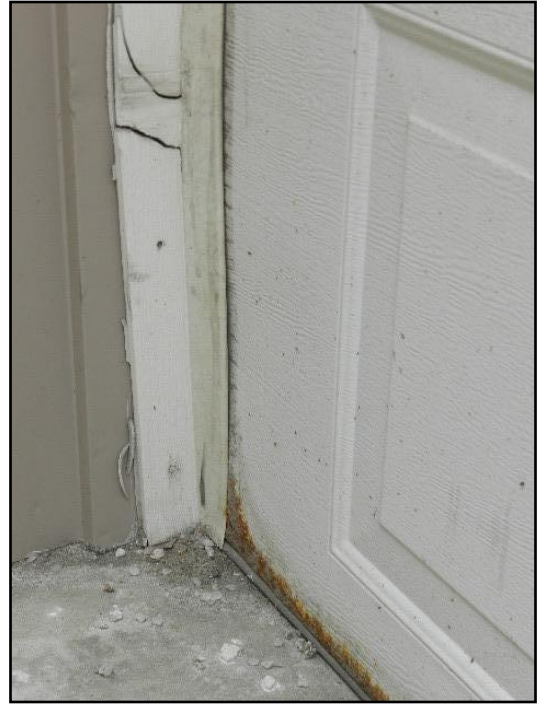
49. Damage

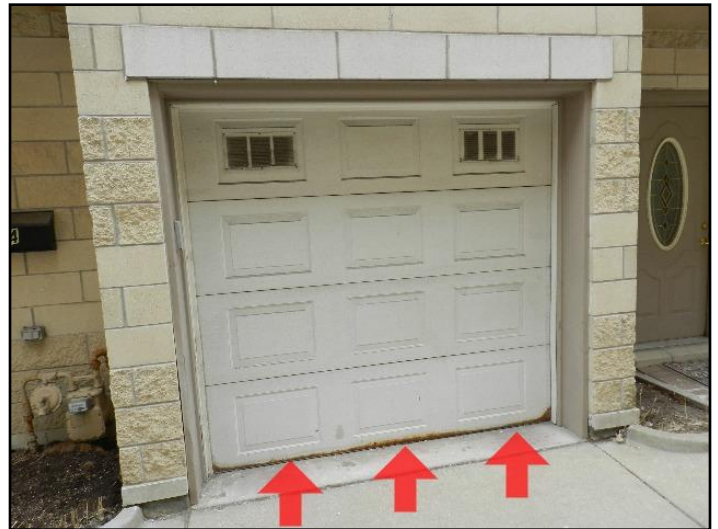
**21. Condition:** • Rust

51. Rust

**Task:** Repair Clean Protect

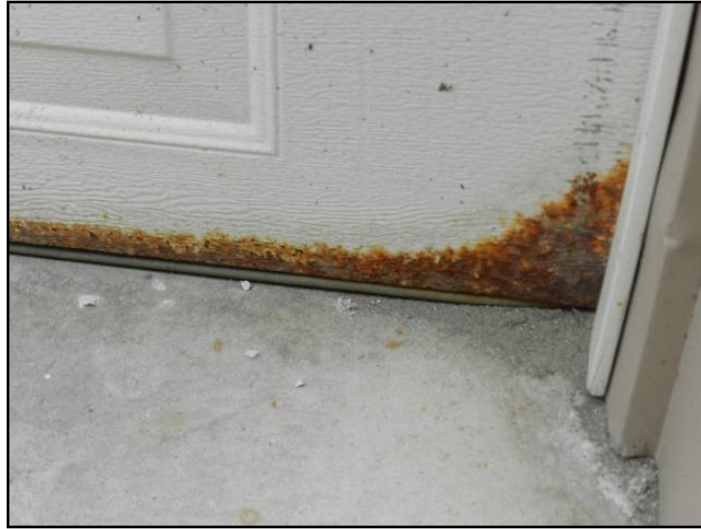
**52.** *Rust*

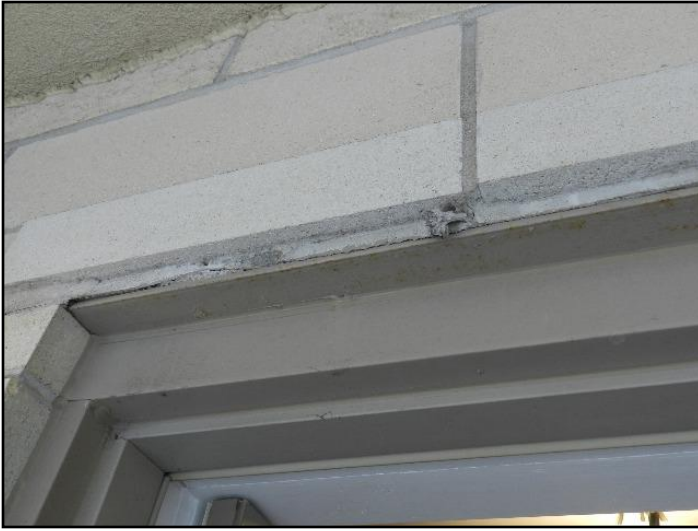
**22. Condition:** • [Lintels rusting](#)

53. *Lintels rusting*

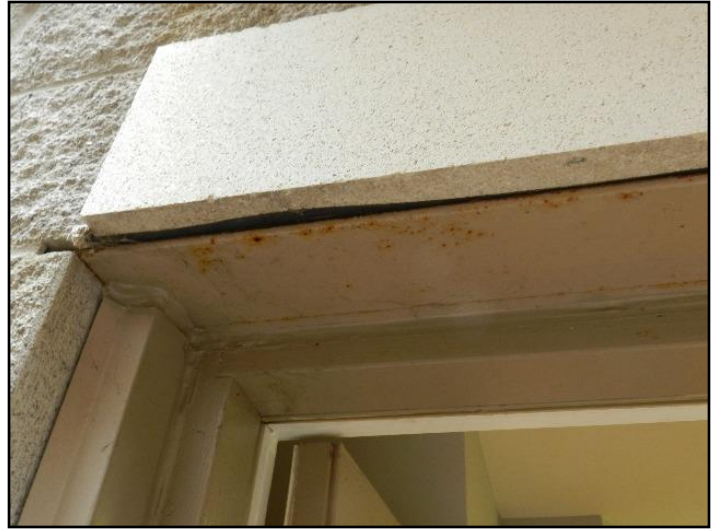
54. *Lintels rusting*

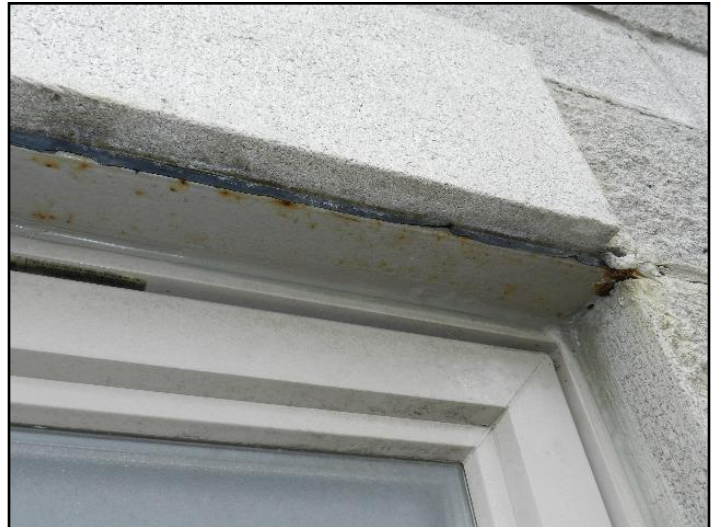
56. *Lintels rusting*

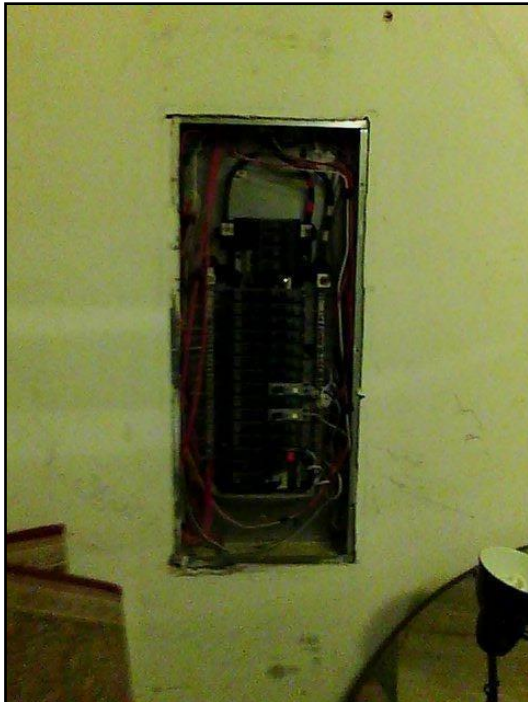
23. **Condition:** • [Overheating](#)

59. Overheating at service feeder

**Task:** Further evaluation Monitor

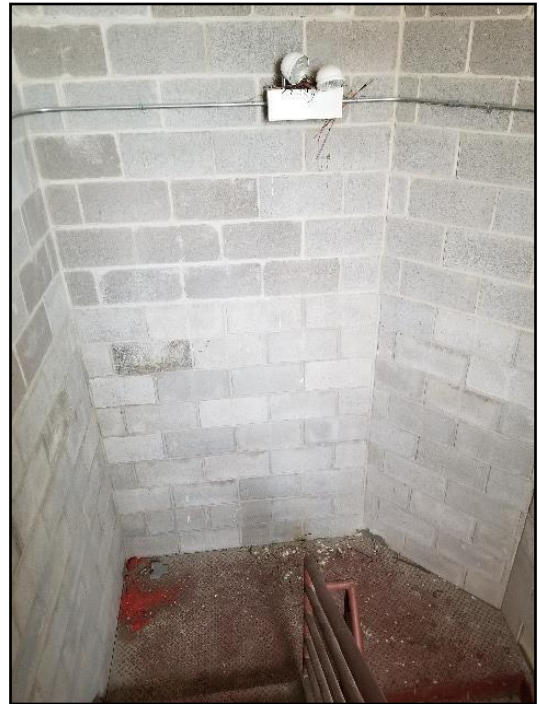
62. Damage to emergency lighting

**Task:** Repair or replace Further evaluation

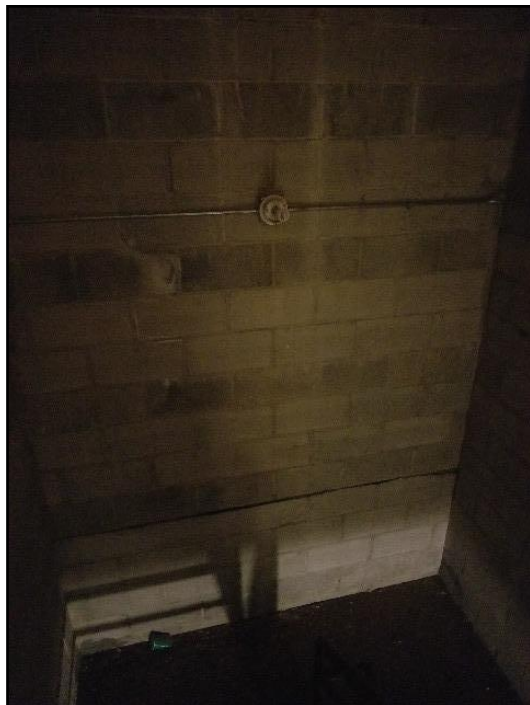
63. Damage, no light at stair

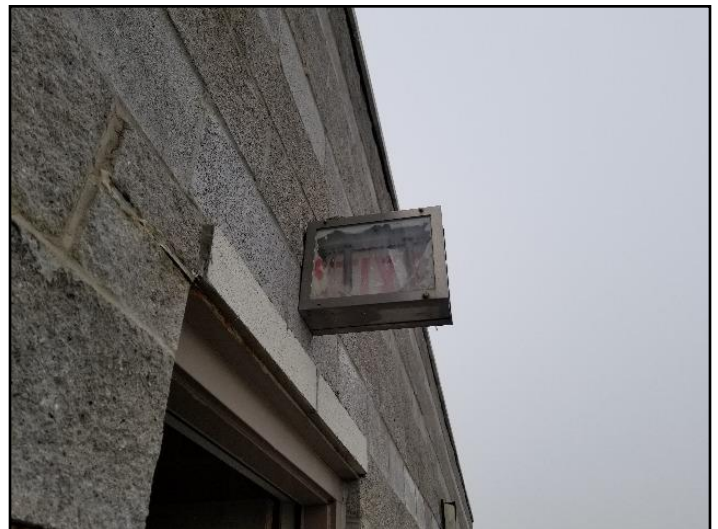
64. Damage to Exit Light

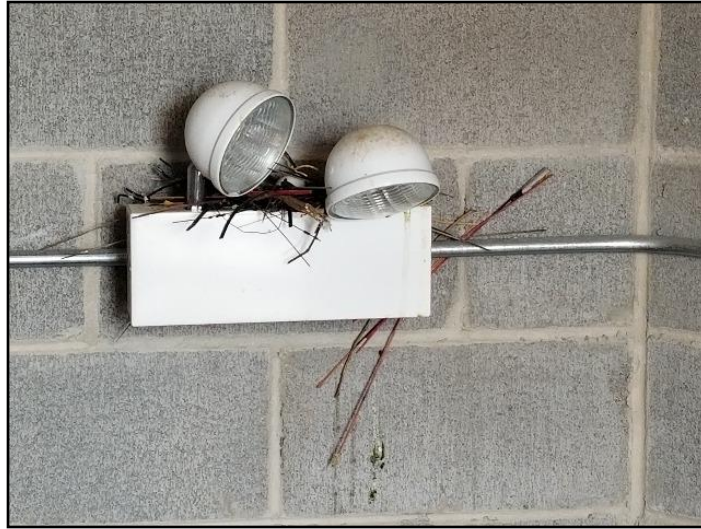
65. Birds nest at bug-eye emergency lighting

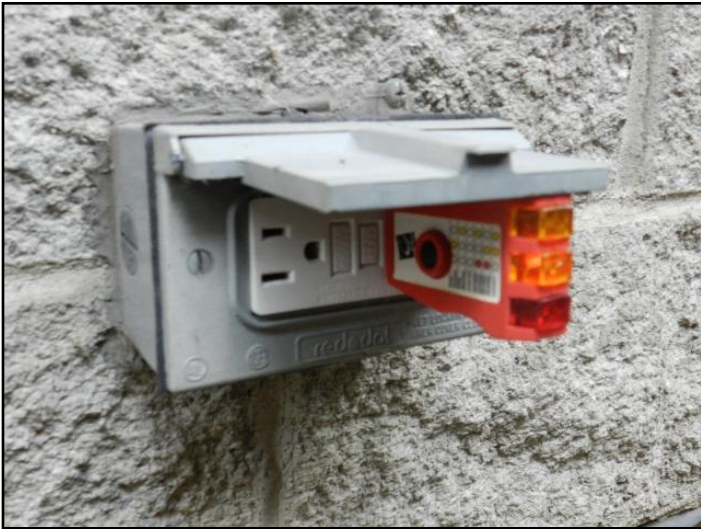
25. Condition: • [Reversed polarity](#)

66. Reversed polarity

Task: Repair

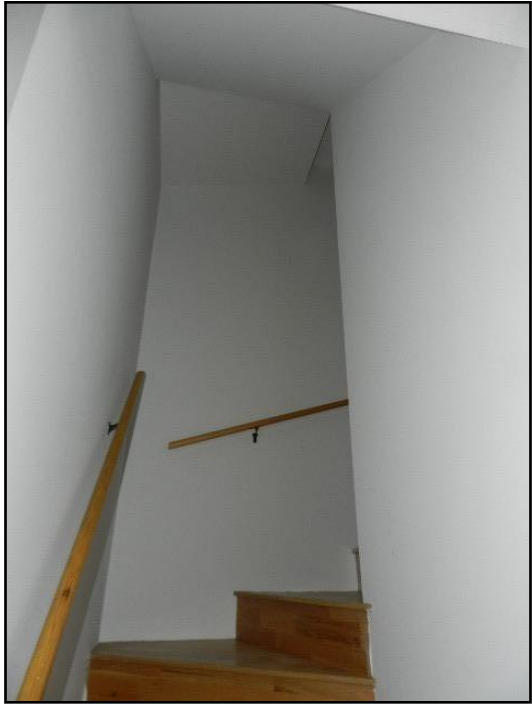
**26. Condition:** • [Poor stairway lighting](#)

68. Poor stairway lighting

**Task:** Repair or replace

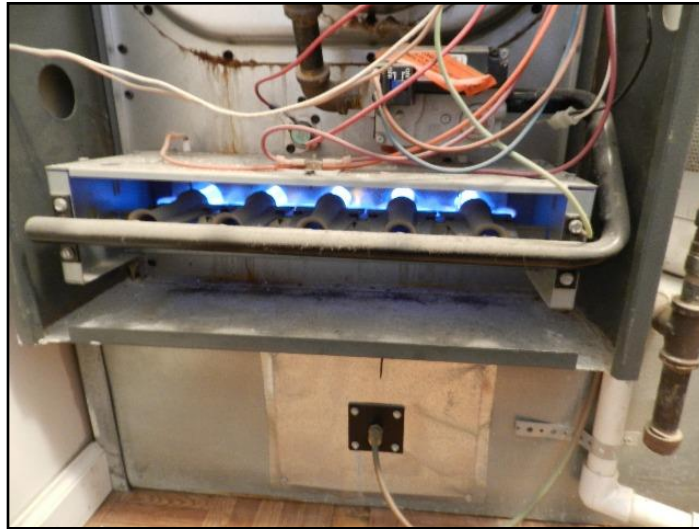
**28. Condition:** • [Poor flame color or pattern](#)

71. Poor flame color or pattern

**Task:** Further evaluation

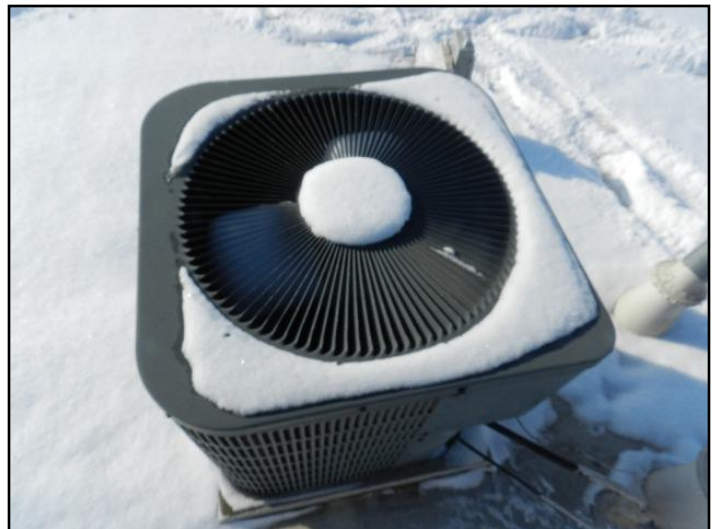
**31. Condition:** • [Near end of life expectancy](#)

74. Near end of life expectancy

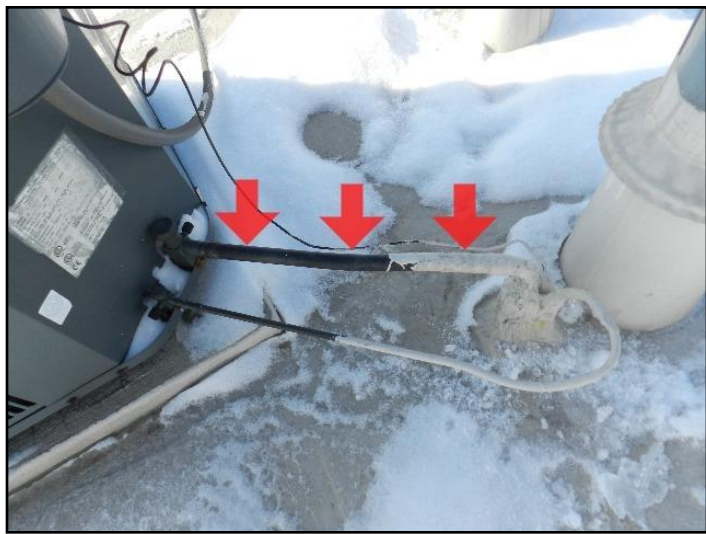
**32. Condition:** • [Insulation - missing](#)

75. Insulation - missing

**Task:** Repair or replace Protect

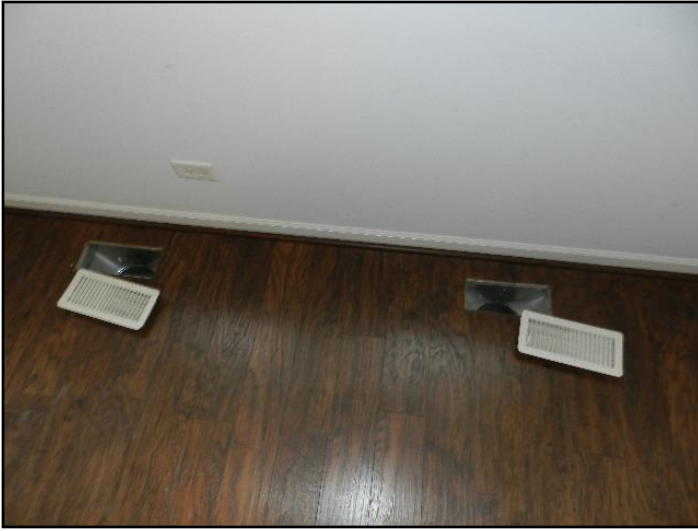
76. Loose, not attached registers

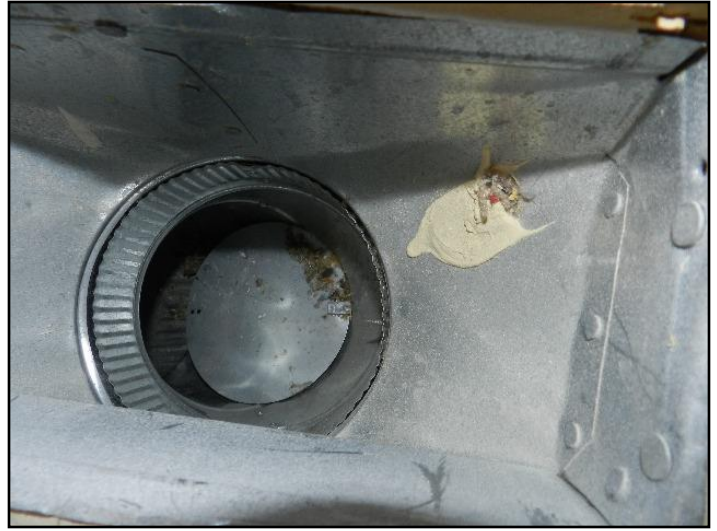
33. Condition: • [Obstructed registers](#)

77. Obstructed registers

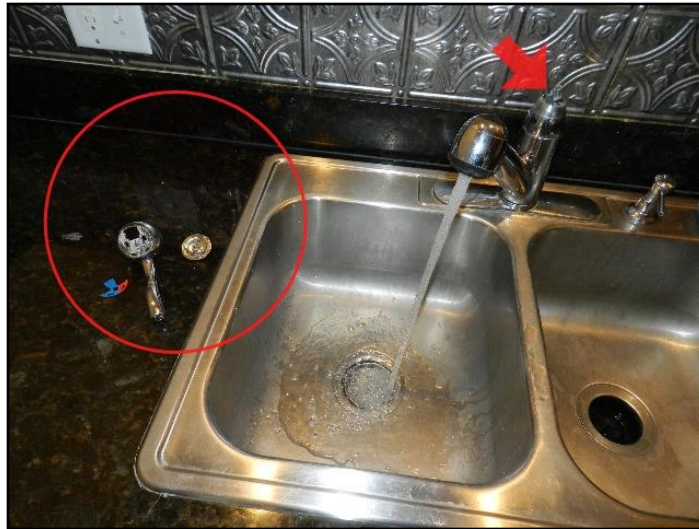
37. Condition: • [Loose](#)

82. Loose/damaged

Task: Replace

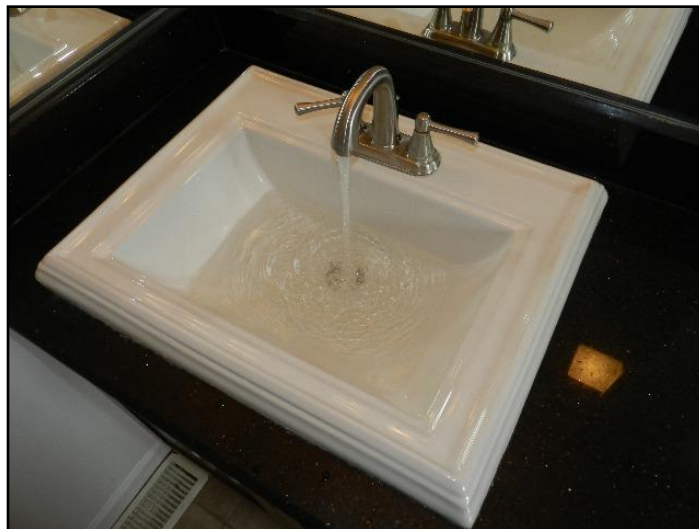
38. Condition: • [Slow drains](#)

83. Slow drains

Task: Clean Correct

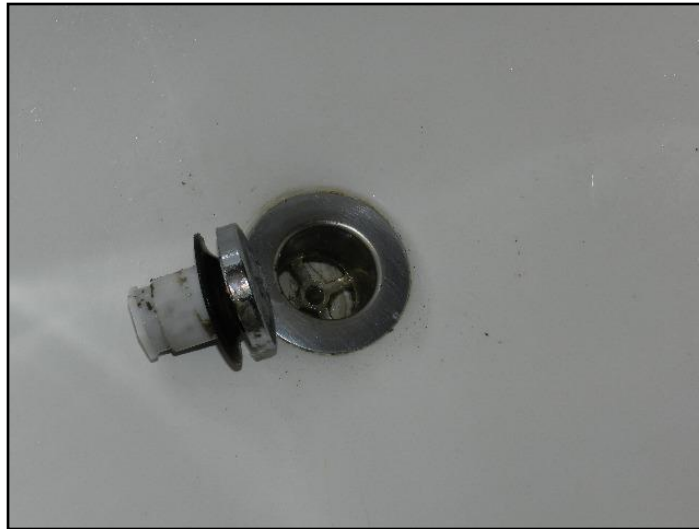
39. Condition: • Drain stop ineffective

84. Drain stop ineffective

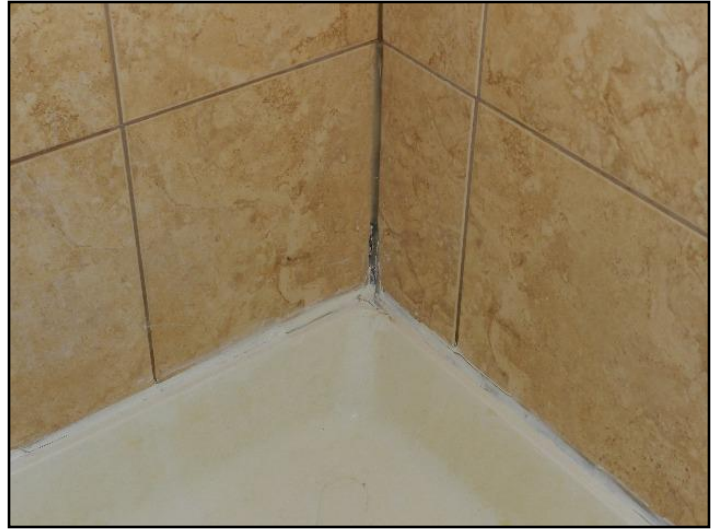
41. Condition: • [Grout loose, missing or deteriorated](#)

**87.** Grout loose, missing or deteriorated

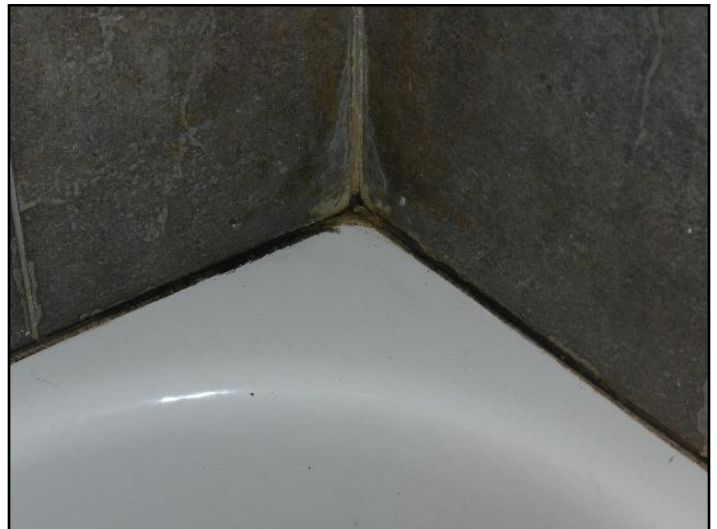
**89.** Grout loose, missing or deteriorated

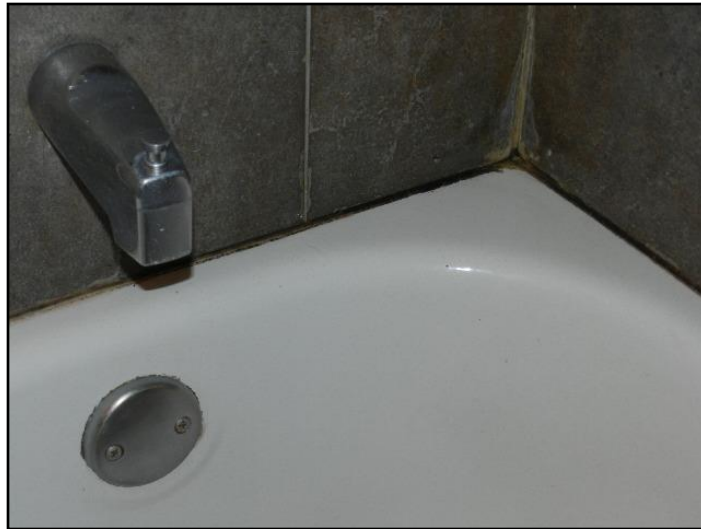
90. Grout loose, missing or deteriorated

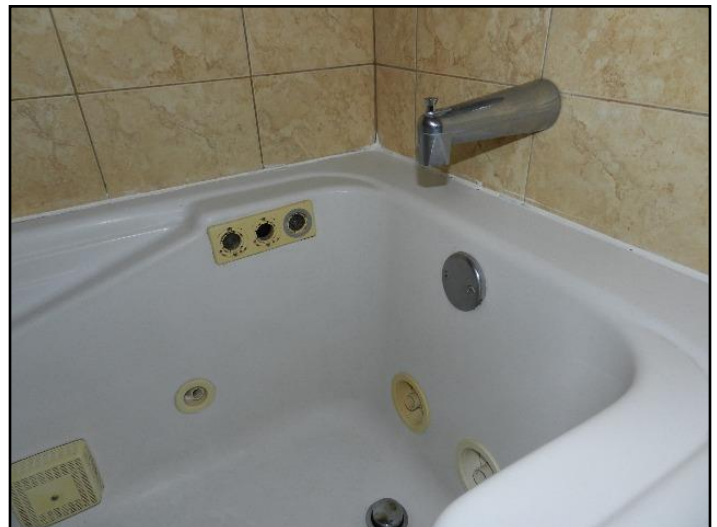
42. Condition: • [Odor](#)

92. Odor

Task: Replace

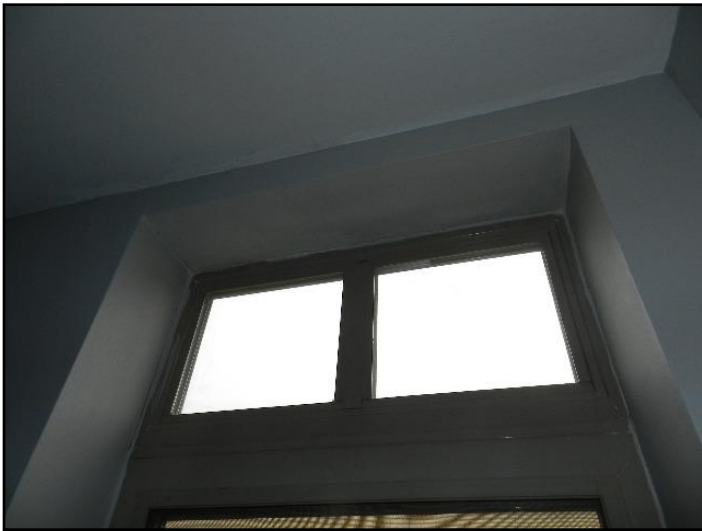
**43. Condition:** • [Water leaks](#)

93. Leak at window opening

**Task:** Repair or replace Correct Upgrade Protect

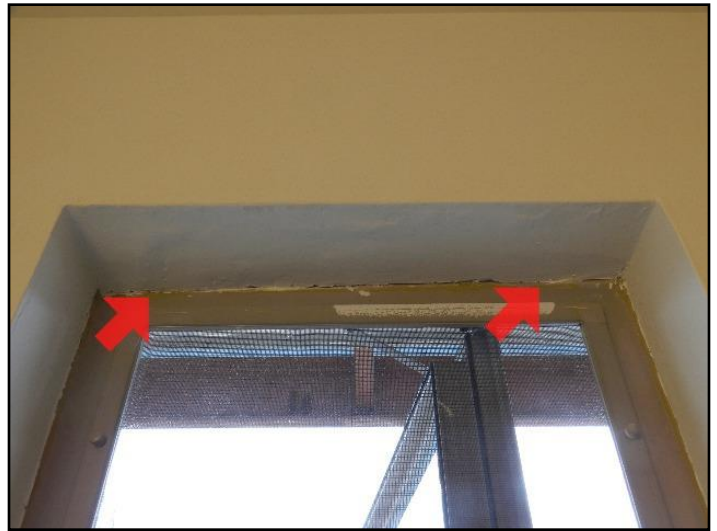
94. Leak at window opening

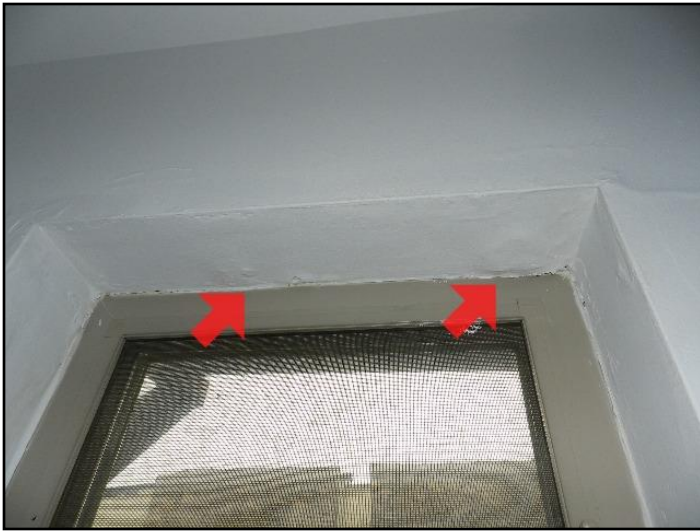
95. Leak at window opening

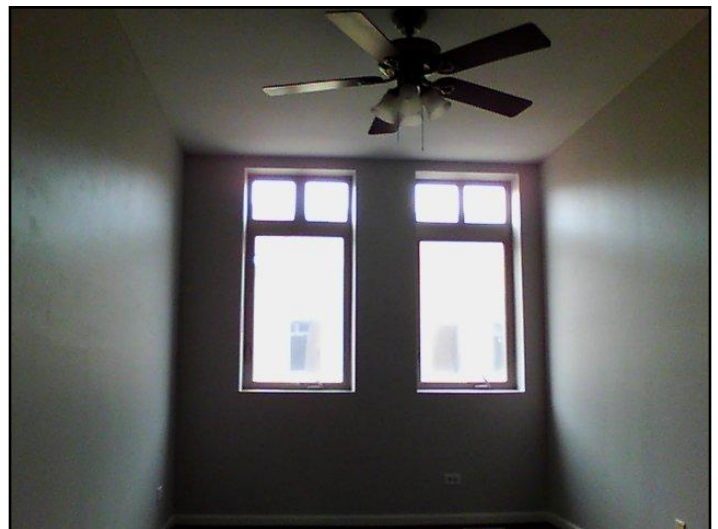
98. Possible water leaks

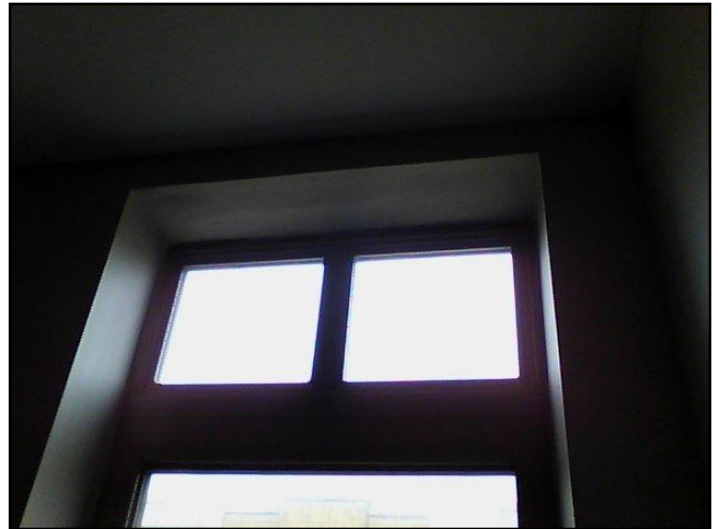
100. Leak at window opening

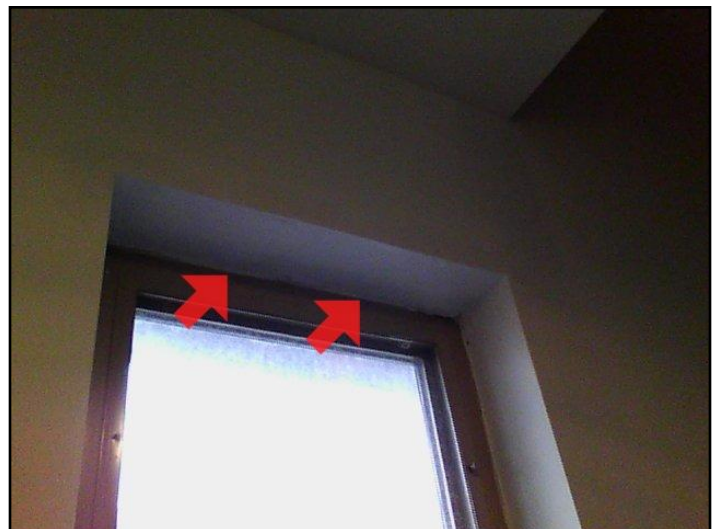
102. Leak at window opening

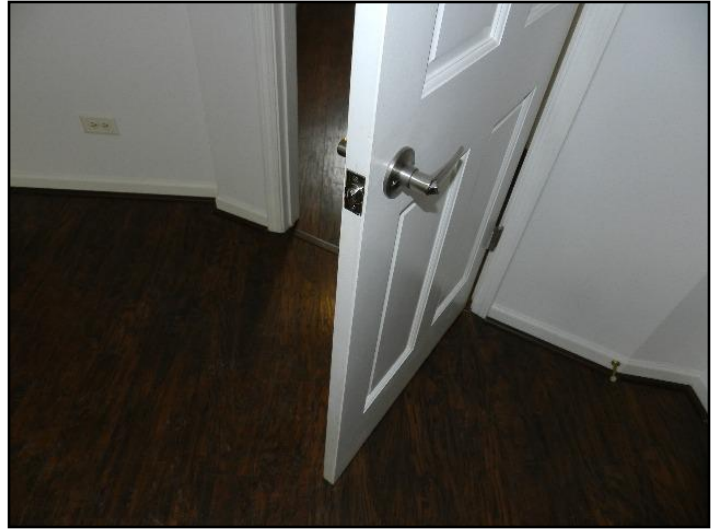
44. Condition: • [Broken](#)

104. Privacy lock broken

Task: Replace

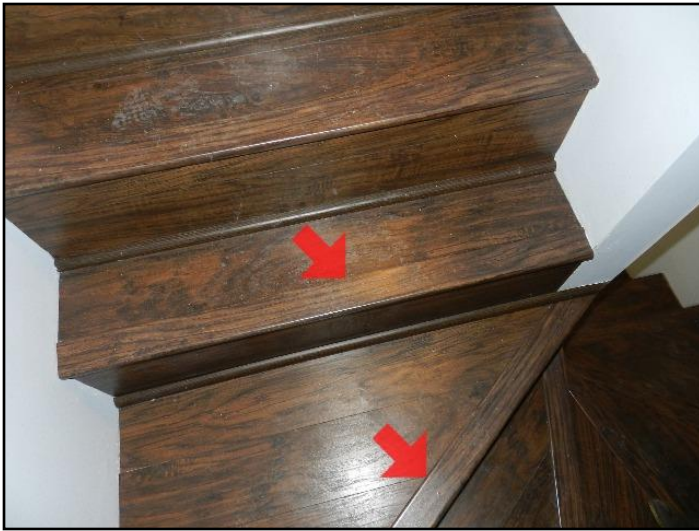
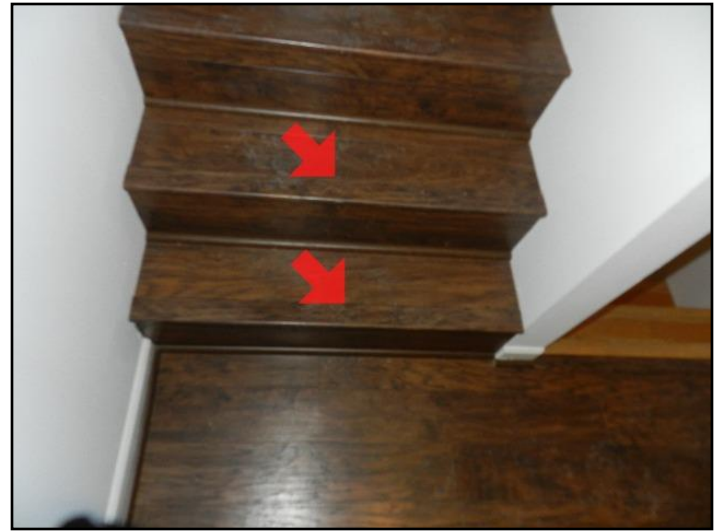
45. Condition: • [Loose](#)

Tripping hazard

106. Loose nosing

107. Loose nosing

Task: Replace

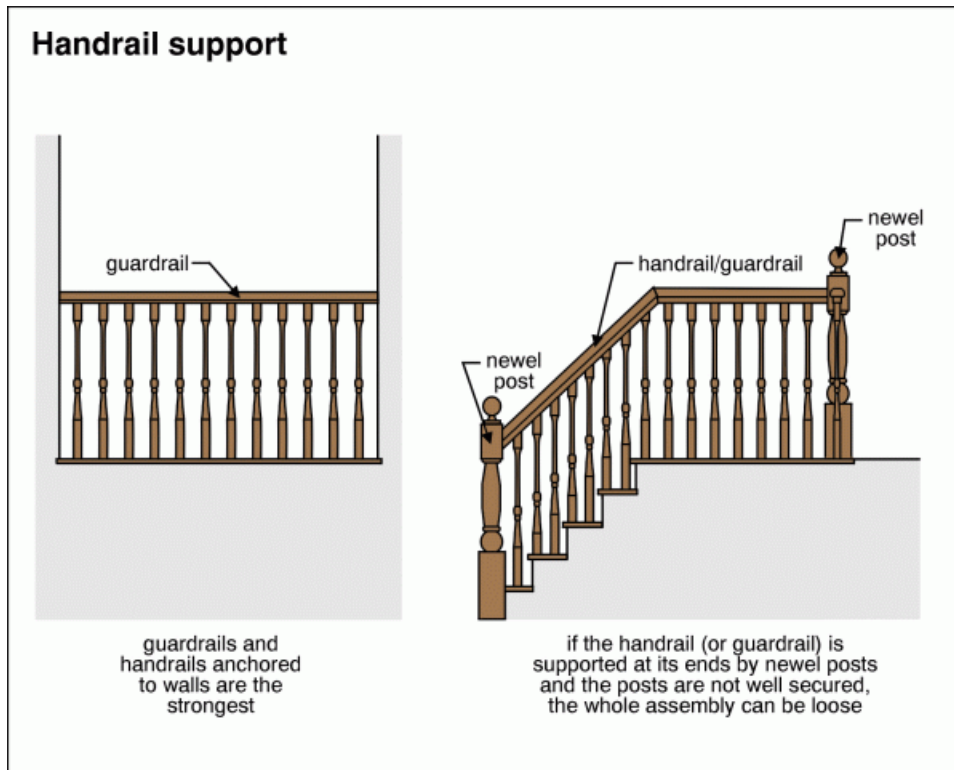
46. Condition: • [Loose](#)

108. Loose

Task: Repair or replace
