# Your Inspection Report

3256 West Sample St, Suite 2  
Chicago, IL

**INSPECTION DATE:**  
Saturday, February 3, 2018

RE: Report No. 1079, v.2  
3256 West Sample St, 2  
Chicago, IL

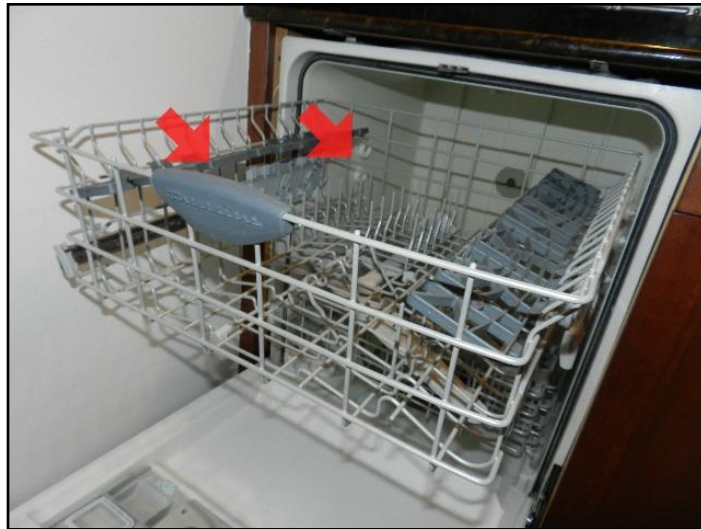
49. Condition: • Rollers damaged

110. *Rollers damaged*

**Task:** Repair or replace

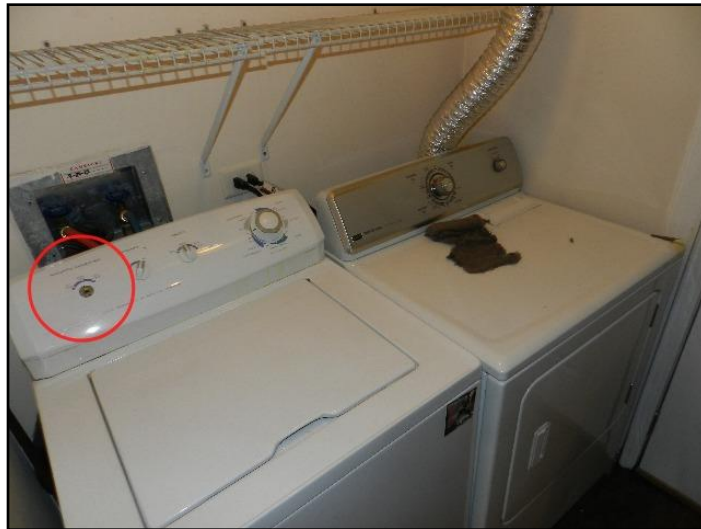
**50. Condition:** • Old

111. *Old, missing items*

**Task:** Repair or replace

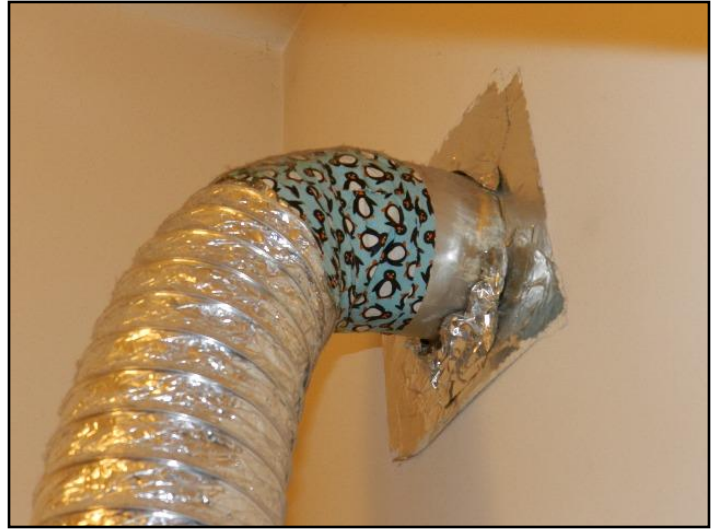
113. Loose, no clamp
