Your Inspection Report

5246 North Sample St
Chicago, IL

INSPECTION DATE:
Wednesday, January 24, 2018

RE: Report No. 1078
5246 North Sample St
Chicago, IL

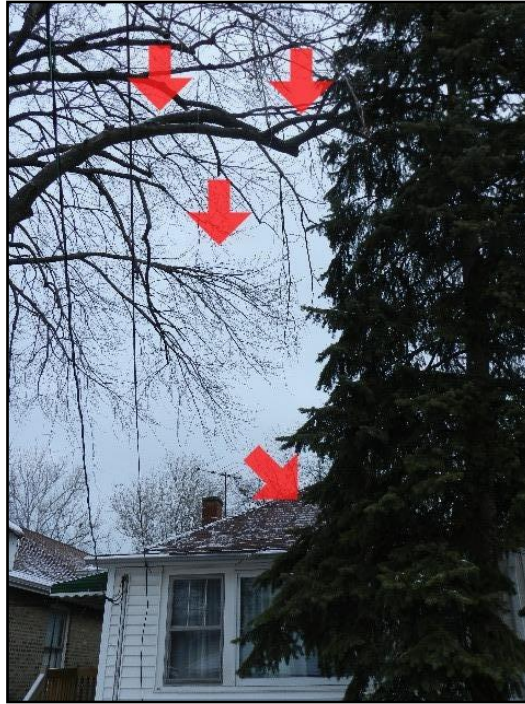
Condition: • Tree branches touching roof

1. Tree branches above roof structure

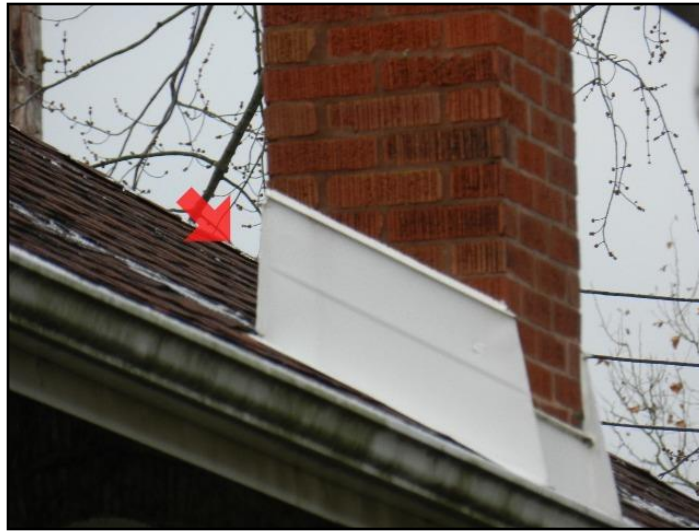
Condition: • [Cricket missing, loose, damaged](#)

Implication(s): Chance of water damage to contents, finishes and/or structure

2. Cricket missing, loose, damaged

Task: Repair or replace Provide Protect

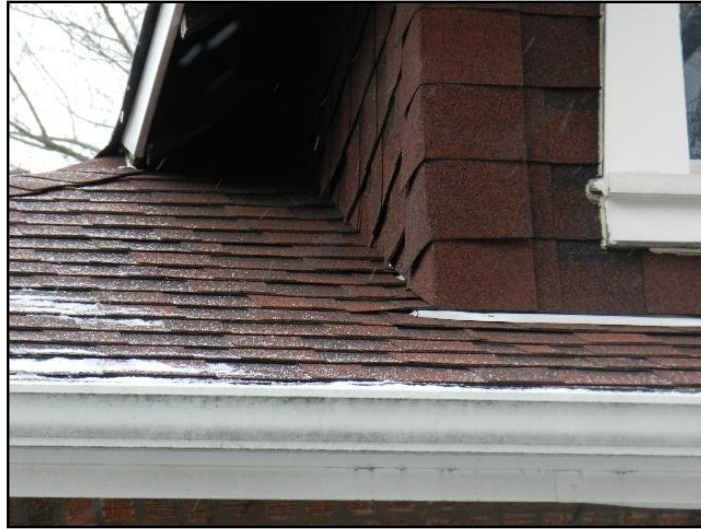
3. Condition: • [Side flashings not set into shingles properly](#)

Implication(s): Chance of water damage to contents, finishes and/or structure

3. Side flashings not set into shingles properly

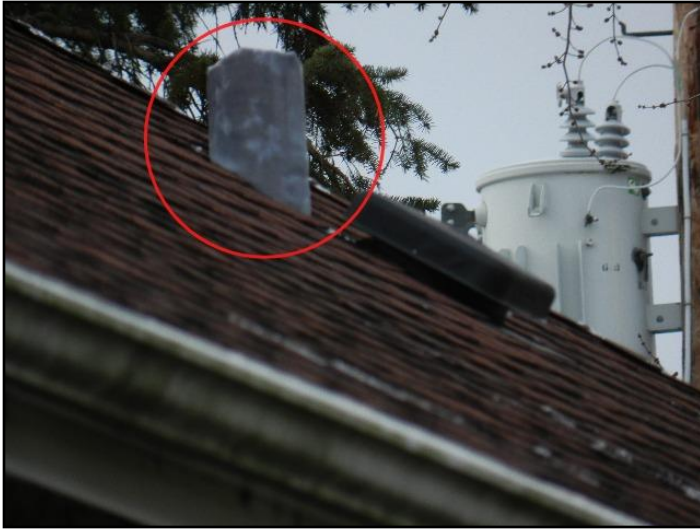
4. Missing flashing and cap

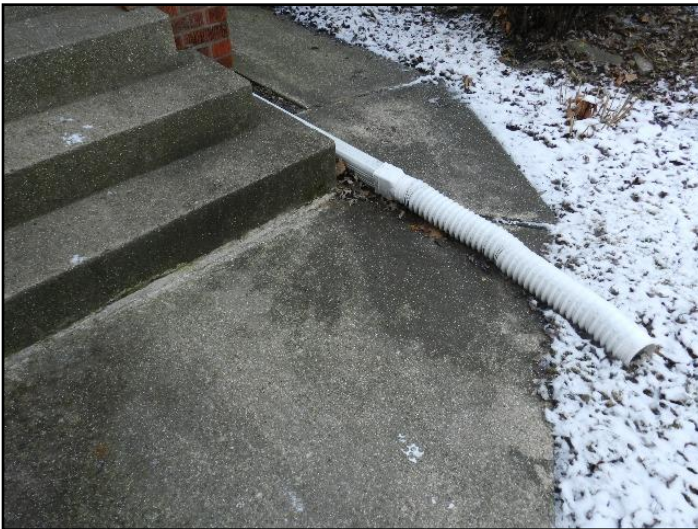
6. Tripping hazard, loose or damaged

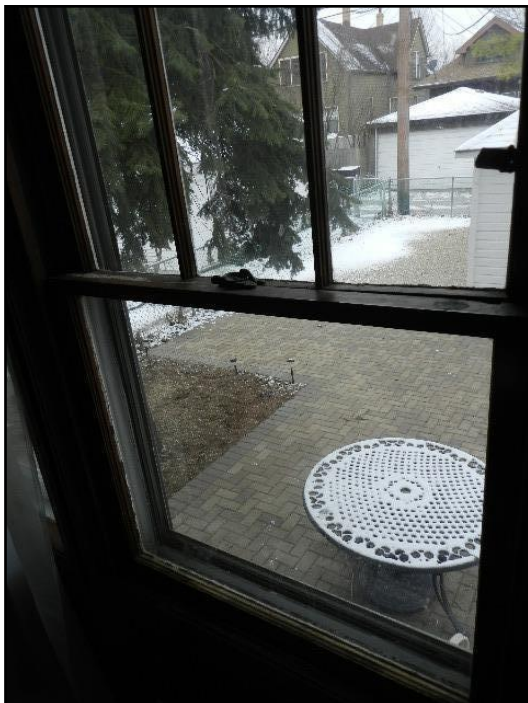
18. Air leaks, does not lock

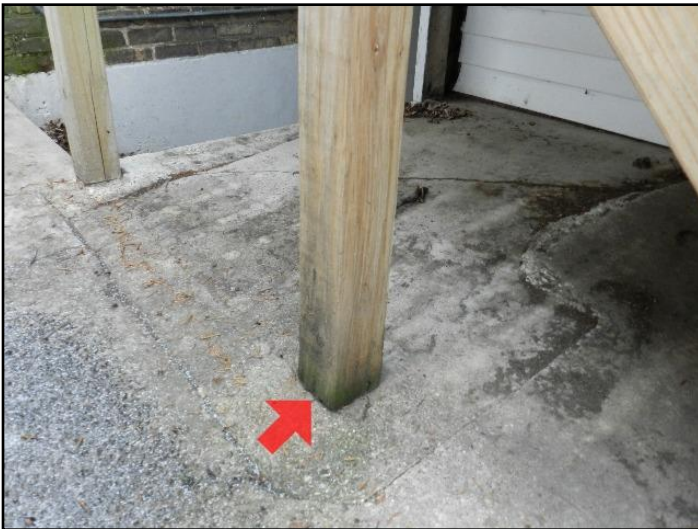
22. Rot, no footing

Task: Correct

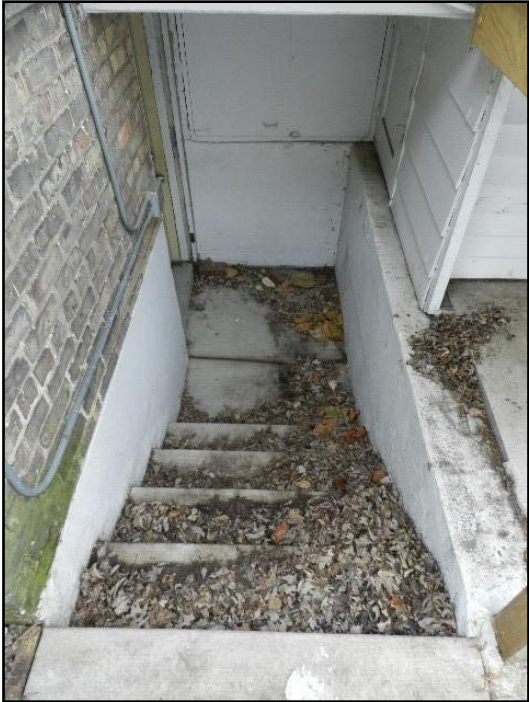
24. Guard and handrail problems

Task: Provide

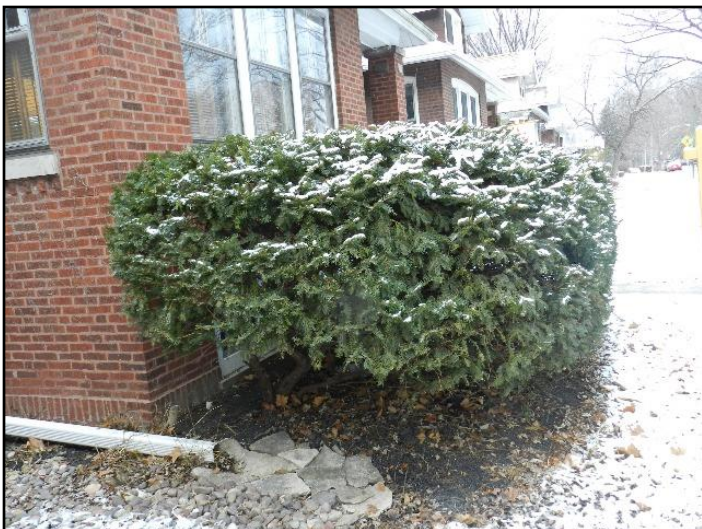
25. *Overgrown shrubs too close to building*

Task: Clean Correct Service annually

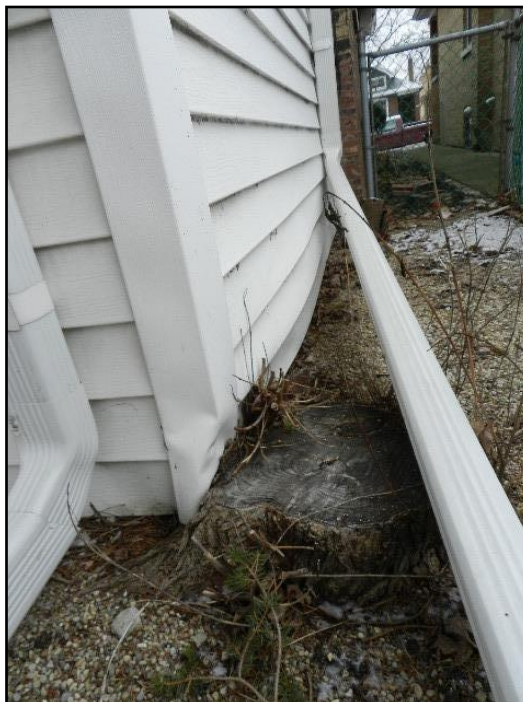
26. *Trees trunk too close to building*

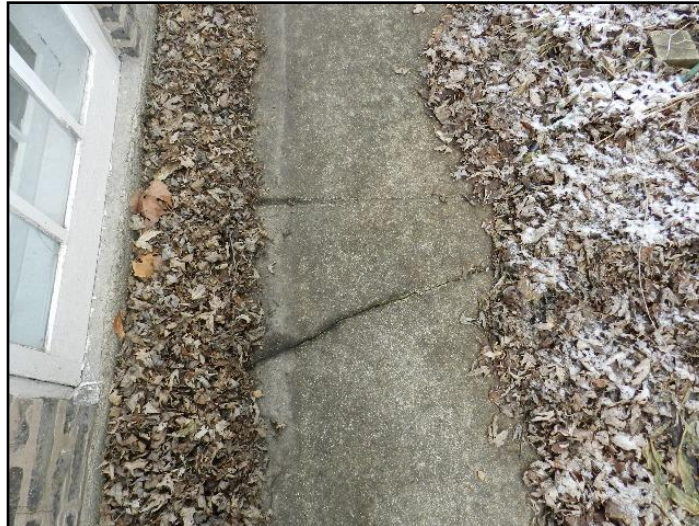
28. Cracked or damaged surfaces

Task: Repair

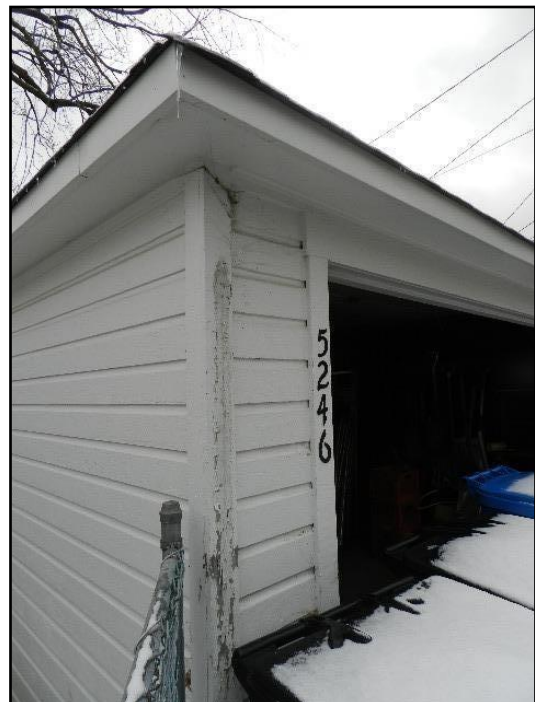
30. Gate does not open, paint needed at garage

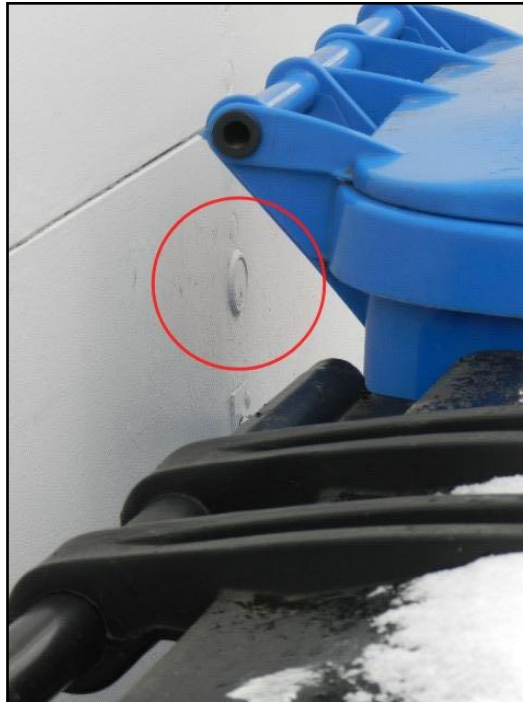
Condition: • Lock not effective on exterior door

35. Lock not effective

Task: Repair or replace Further evaluation

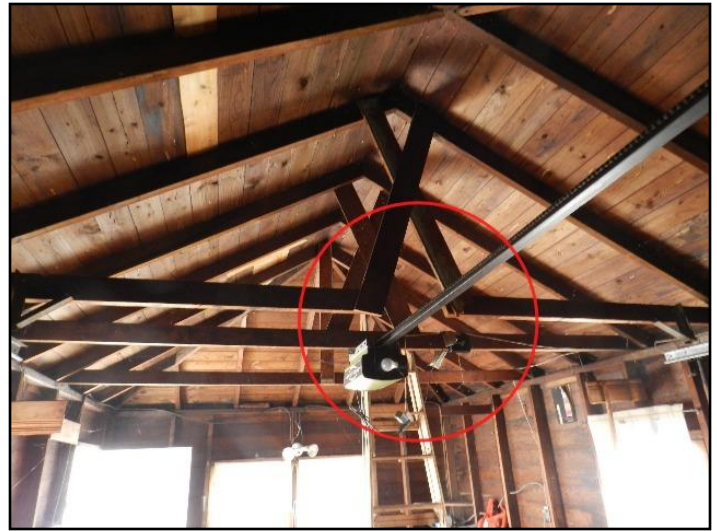
37. Cut roof framing joists

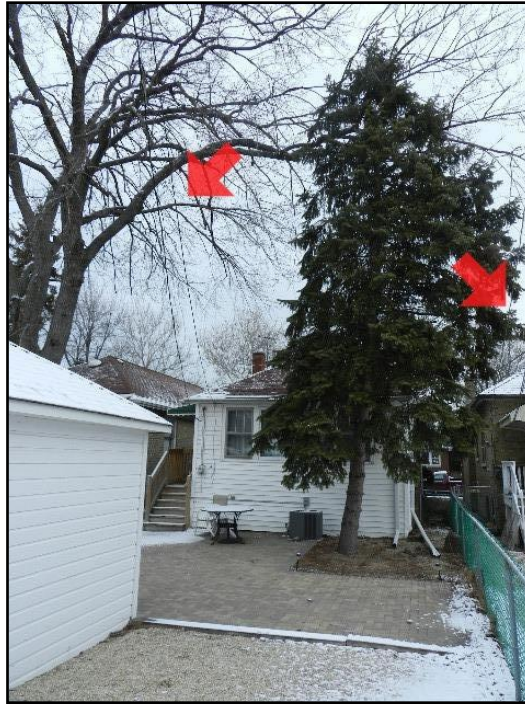
27. Condition: • [Branches / vines interfering with wires](#)

Implication(s): Damage to wire | Electric shock | Interruption of electrical service

39. Branches / vines interfering with wires

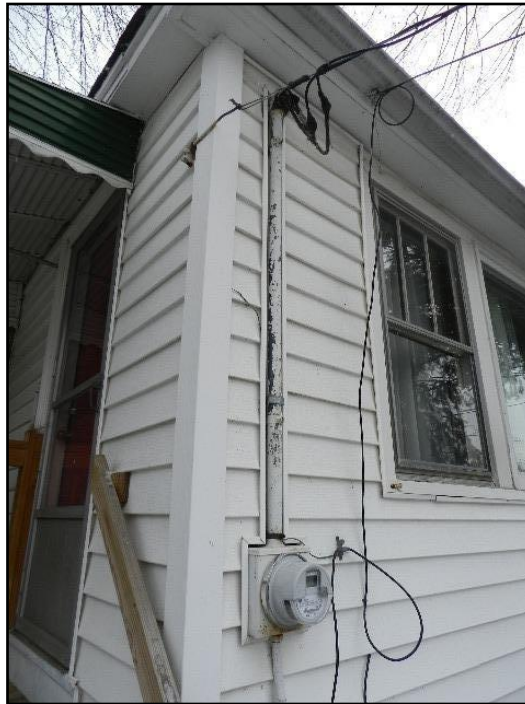
Condition: • [Inadequate service size](#)

40. Old, inadequate electrical service size

Task: Upgrade

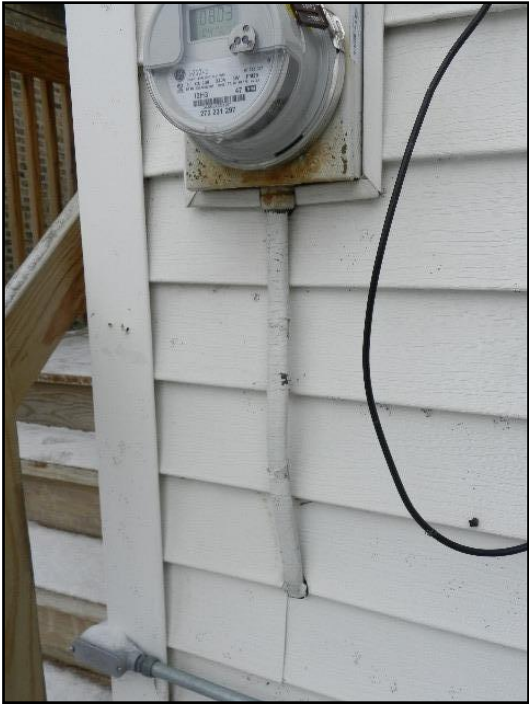
Condition: • [Conduit or cable not weather-tight](#)

Implication(s): Shock hazard or interruption of electrical service | Electric shock

41. Conduit or cable not weather-tight

Task: Replace

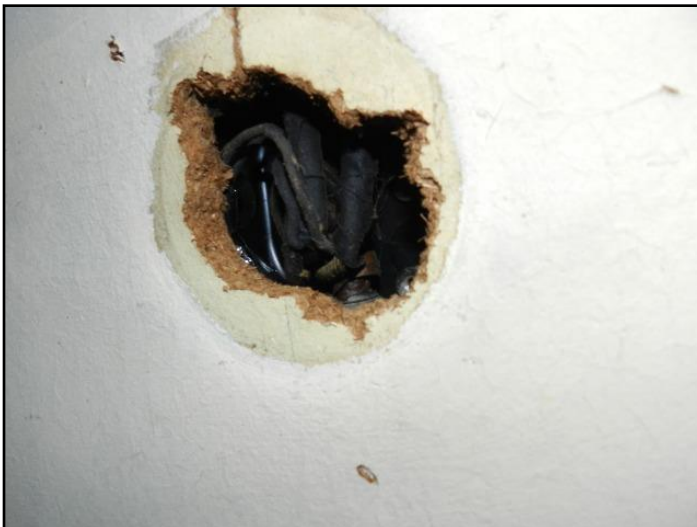
Condition: • [Wrong type](#)

Implication(s): Electric shock | Fire hazard

43. Wrong type, old tape wiring

Task: Replace

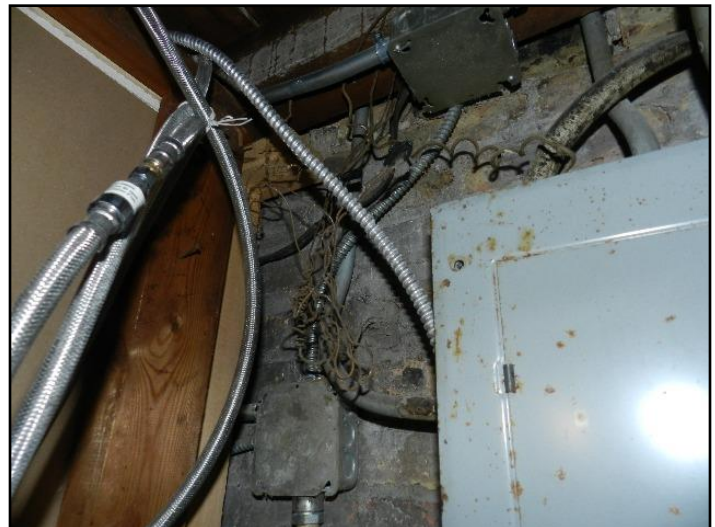
44. Wrong type, tape wiring, Romex

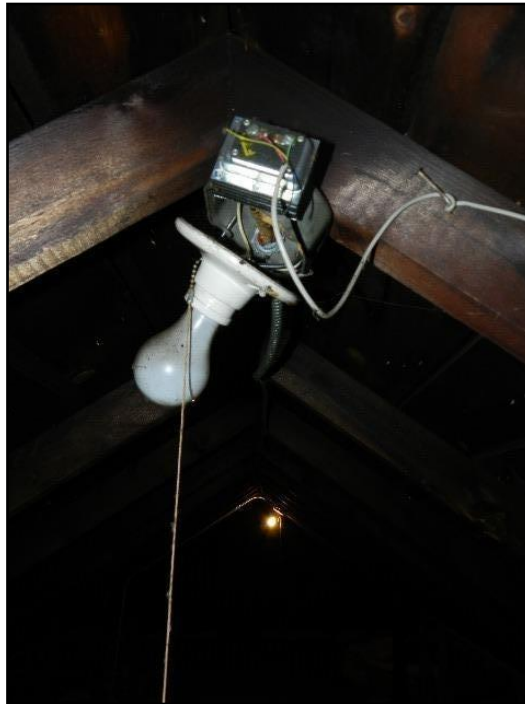
45. Condition: • For junction box is loose

48. For junction box is loose

Task: Correct

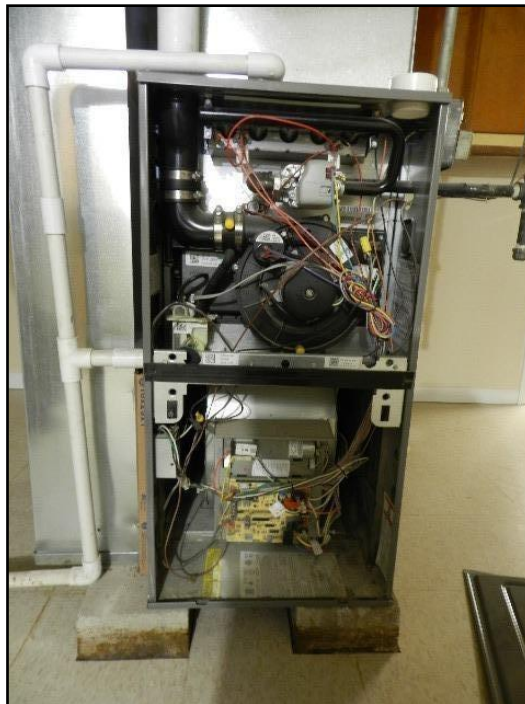
48. Condition: • [Inadequate combustion air](#)

Implication(s): Equipment not operating properly | Hazardous combustion products entering home | Increased heating costs | Reduced comfort | Increased operating costs

49. Inadequate combustion air

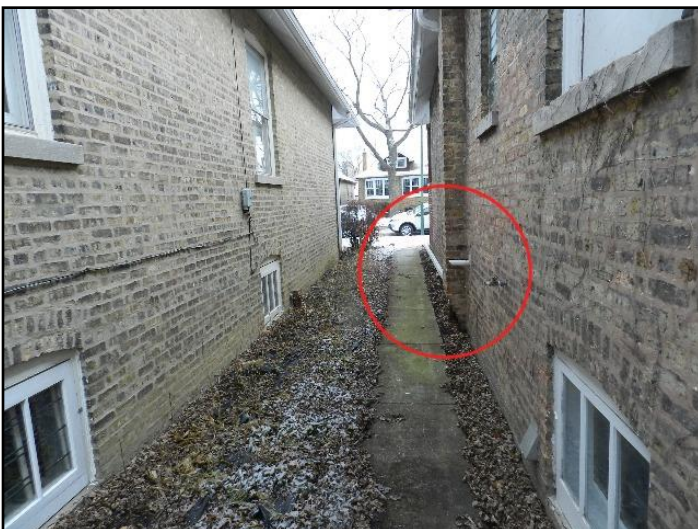
49. Condition: • [Poor vent location, arrangement](#)

Implication(s): Equipment not operating properly | Equipment inoperative | Hazardous combustion products entering home

50. Poor vent location, arrangement

Task: Correct Remove

Time: Immediate

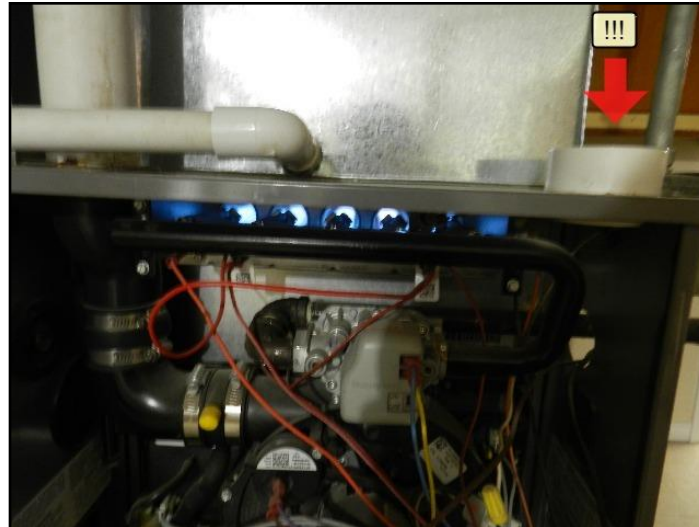
50. Condition: • [Poor combustion air intake location](#)

Implication(s): Equipment not operating properly | Equipment inoperative | Hazardous combustion products entering home

52. Poor combustion air intake location

Task: Provide Correct

Time: Immediate

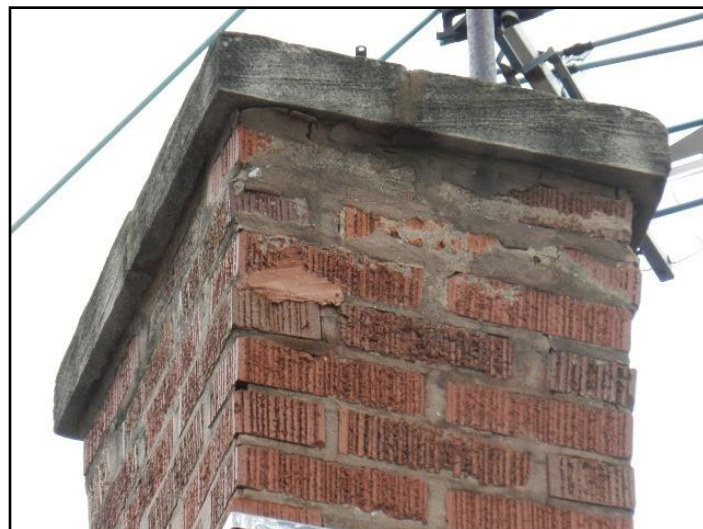
53. Condition: • [Loose, missing or deteriorated mortar](#)

Implication(s): Material deterioration

53. Loose, missing or deteriorated mortar

Task: Repair

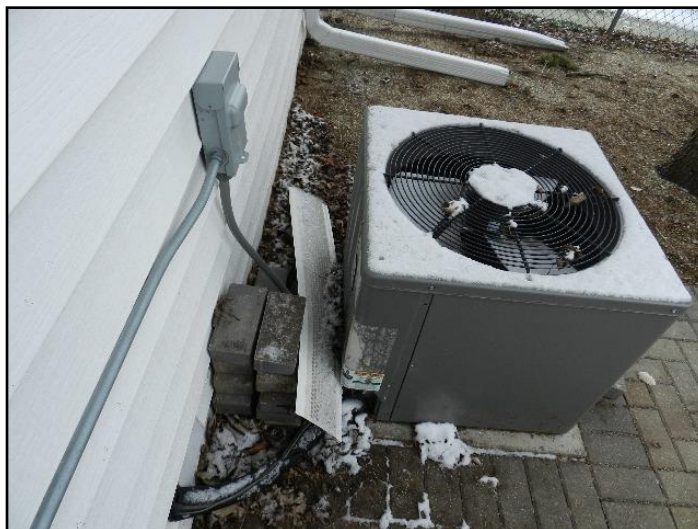
55. Condition: • Aging

54. Condenser not covered/protected from snow/ice

Task: Service Clean Protect

Time: Immediate

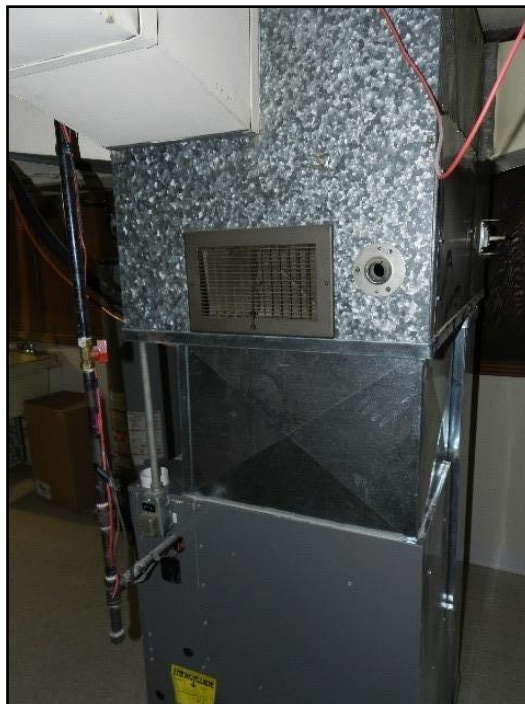
58. Condition: • [Disconnected or leaking](#)

58. Opening and grille in supply duct by furnace

Task: Repair Correct

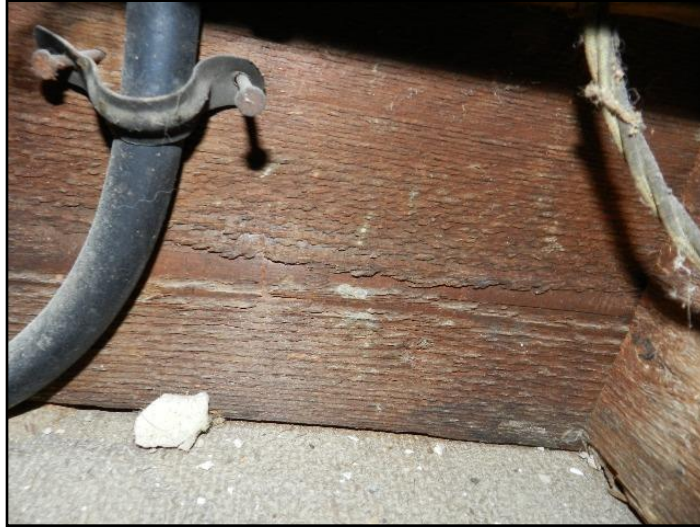
60. Condition: • [Return chase or plenum contain pipes, wires or vents](#)

Implication(s): Material deterioration | Damage to wire

59. *Return chase or plenum contain pipes, wires...*

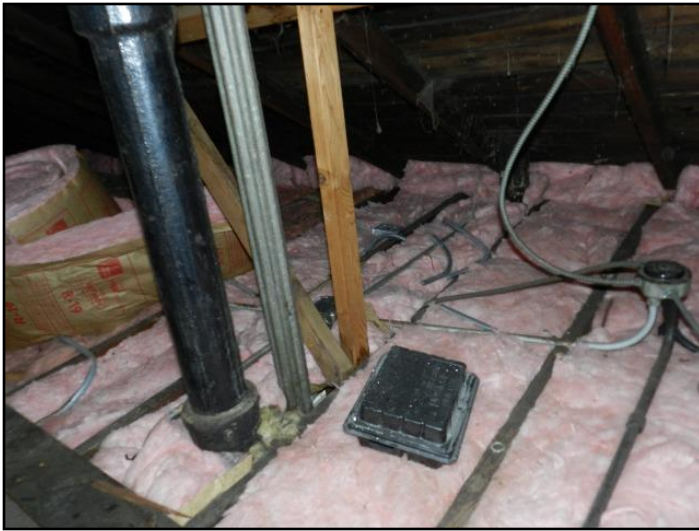
62. Condition: • [Exposed combustible insulation](#)

Implication(s): Increased fire hazard

60. Pest droppings,exposed combustible insulation

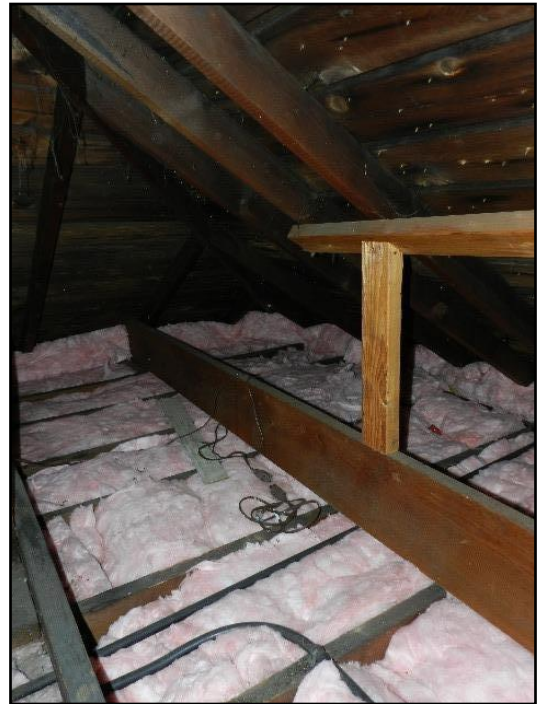
61. Exposed combustible insulation

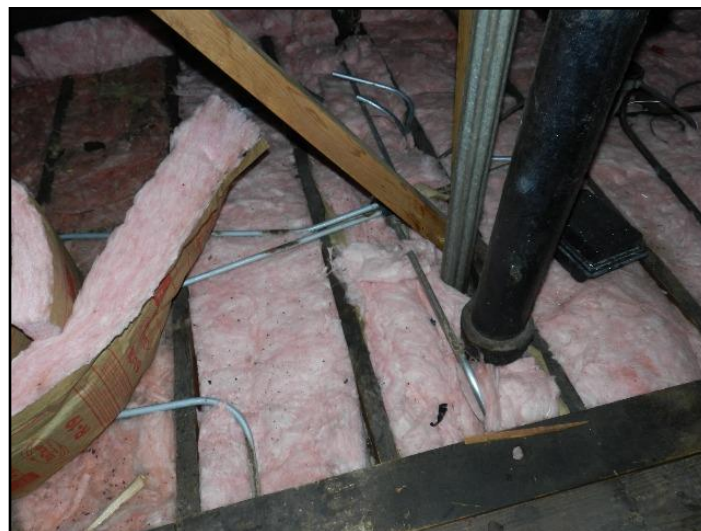
62. Pest droppings,exposed combustible insulation

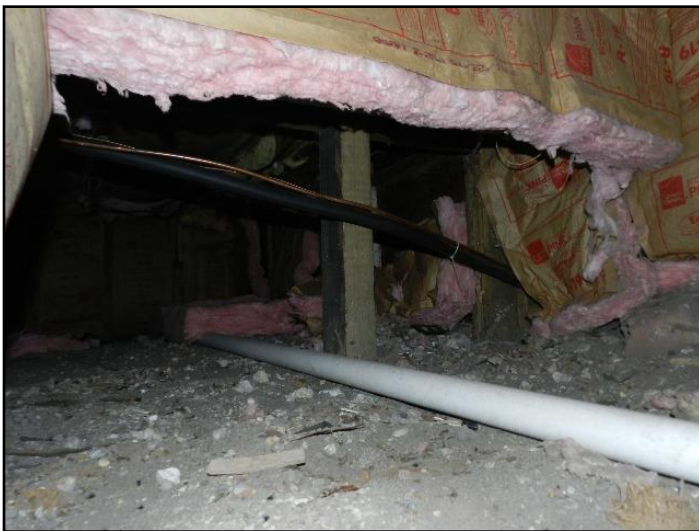
65. Condition: • [Exposed combustible insulation](#)

Implication(s): Increased fire hazard

64. Exposed combustible insulation

Task: Repair or replace

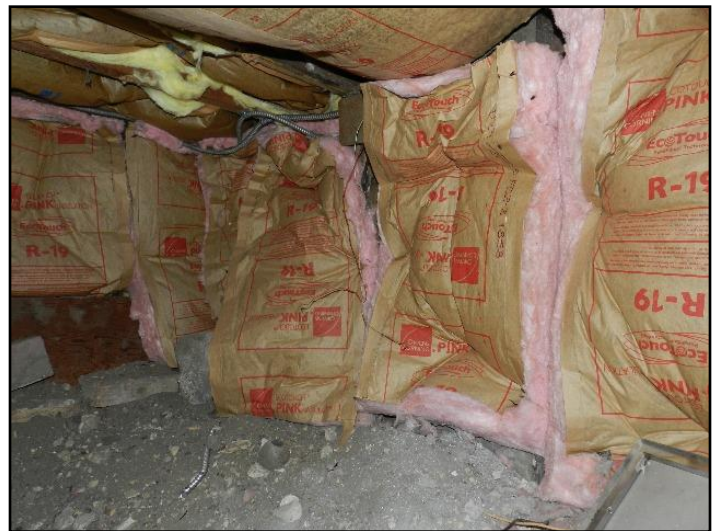
65. Wet, exposed combustible insulation

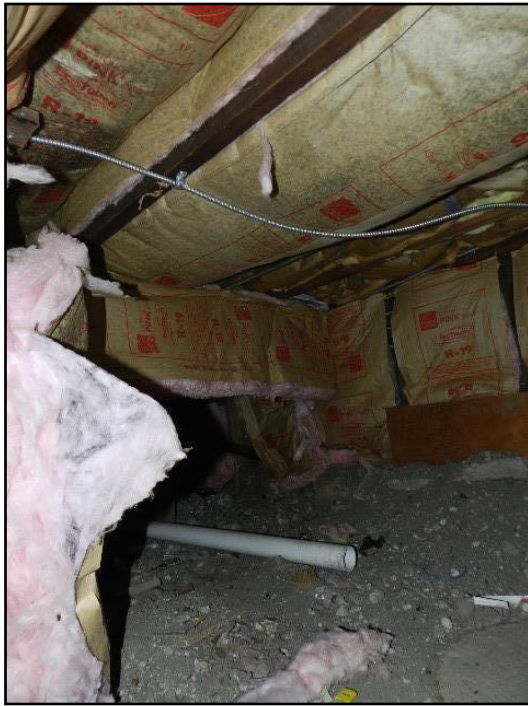
66. Exposed combustible insulation

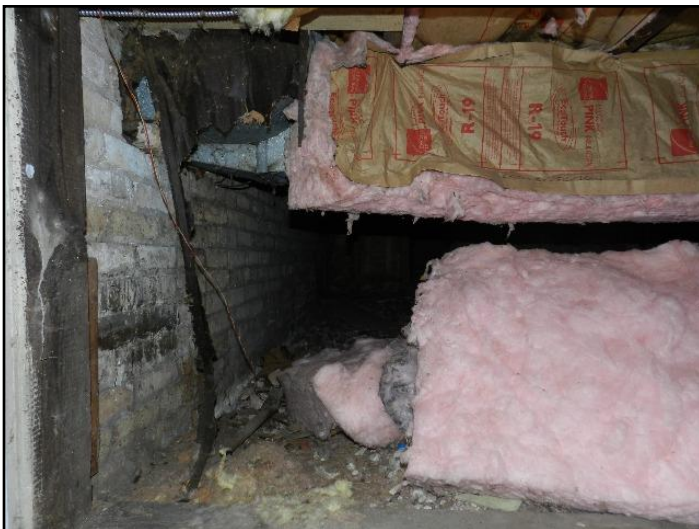
68. Wet, exposed combustible insulation

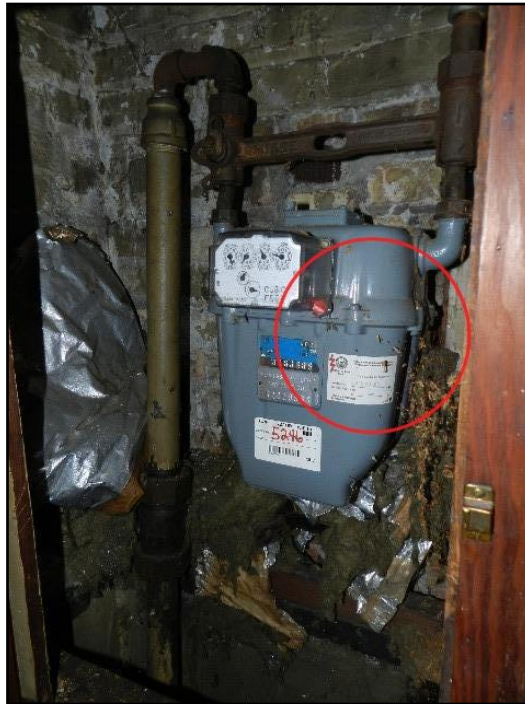
71. Condition: • [Gas odor around meter: verify with gas provider \(Peoples Gas @ 866-556-6001\)](#)

74. Gas odor around meter

Task: Further evaluation

Time: Immediate

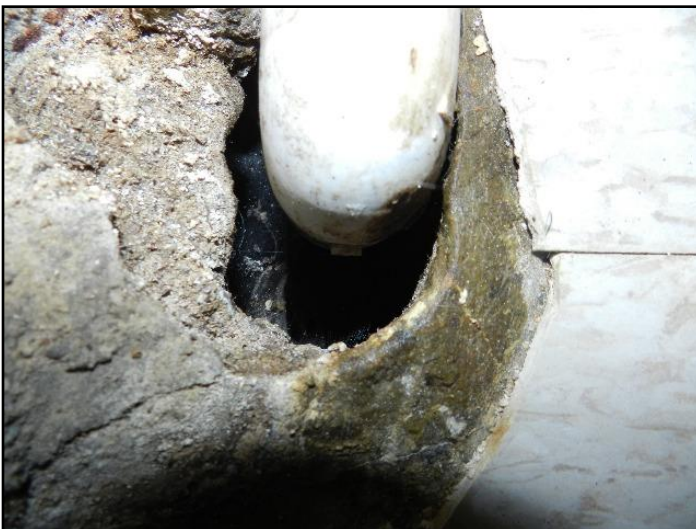
77. Condition: • [Missing](#)

Implication(s): Chance of water damage to contents, finishes and/or structure

80. Missing - incorrect condensate draining

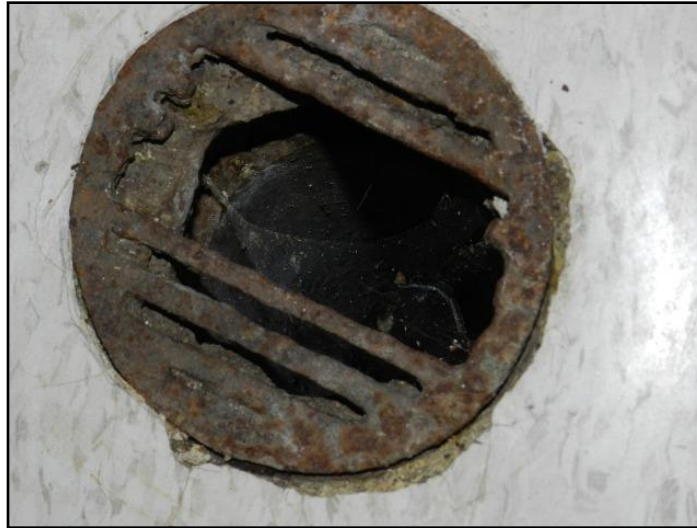
79. Condition: • [Grate missing, rusted or obstructed](#)

Implication(s): Chance of water damage to contents, finishes and/or structure | Trip or fall hazard

82. *Grate missing, rusted or obstructed*

Task: Replace

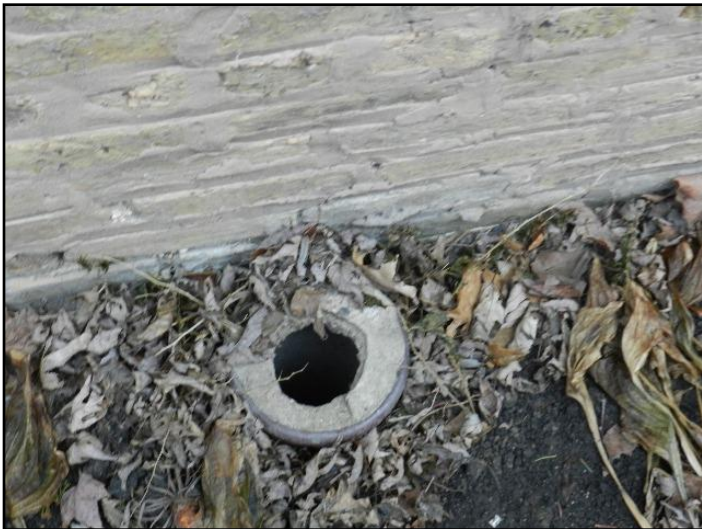
80. Condition: • [Backup](#)

Implication(s): Chance of water damage to contents, finishes and/or structure

83. Uncapped drain to sewer, possible backup

Task: Repair or replace Monitor Clean Protect

Time: Immediate

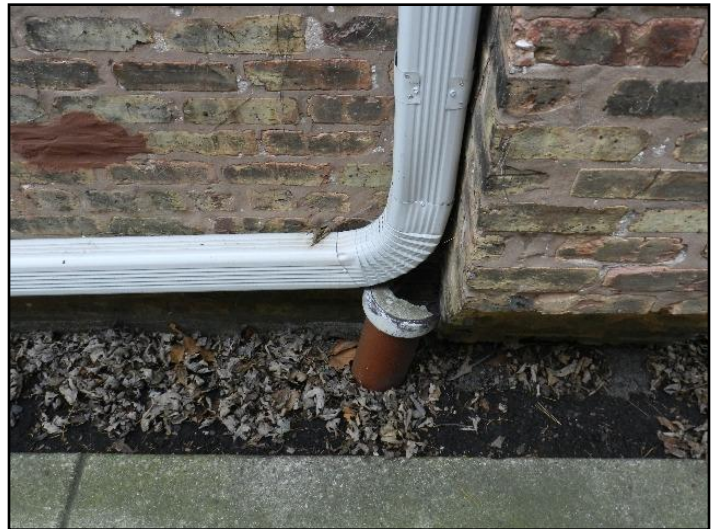
84. Uncapped drain to sewer, possible backup

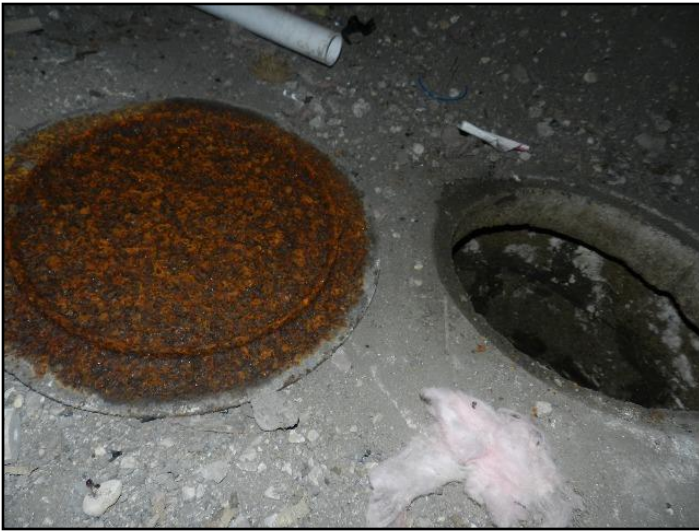
85. Rusted cover at catch basin

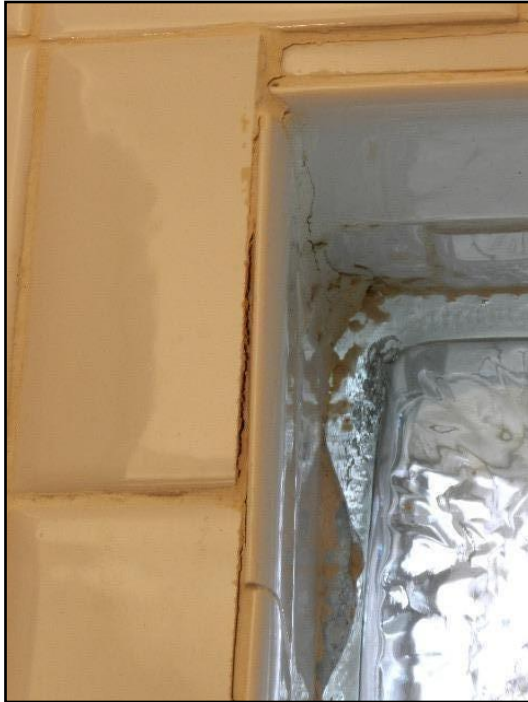
85. Condition: • [Grout loose, missing or deteriorated](#)

Implication(s): Chance of water damage to contents, finishes and/or structure

88. Grout loose, missing or deteriorated

Task: Repair or replace

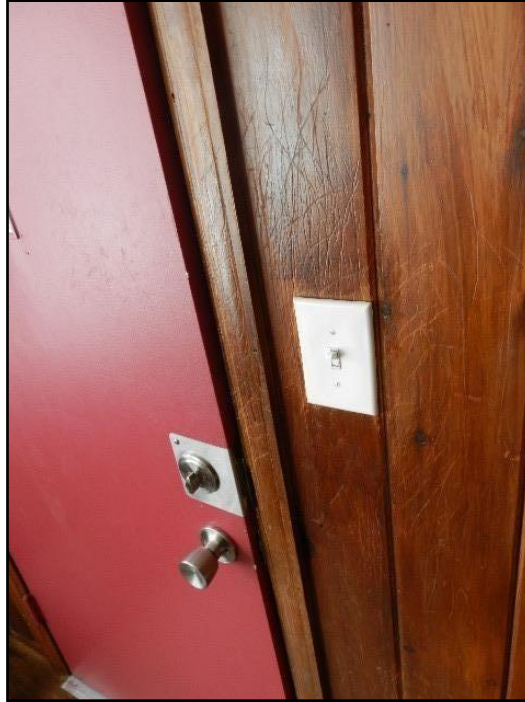
89. Condition: • Damaged

Implication(s): Material deterioration | Damage or physical injury due to falling materials

94. *Damaged, dog scratches at wall*

Task: Repair or replace

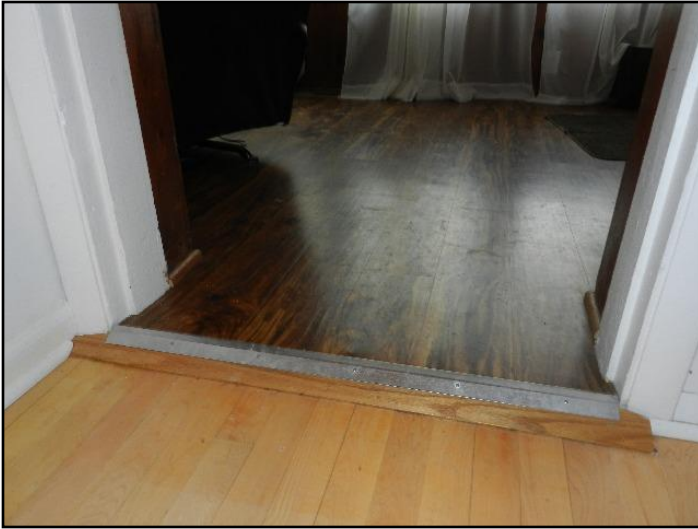
91. Condition: • [Trip hazard](#)

95. Trip hazard, uneven floor levels

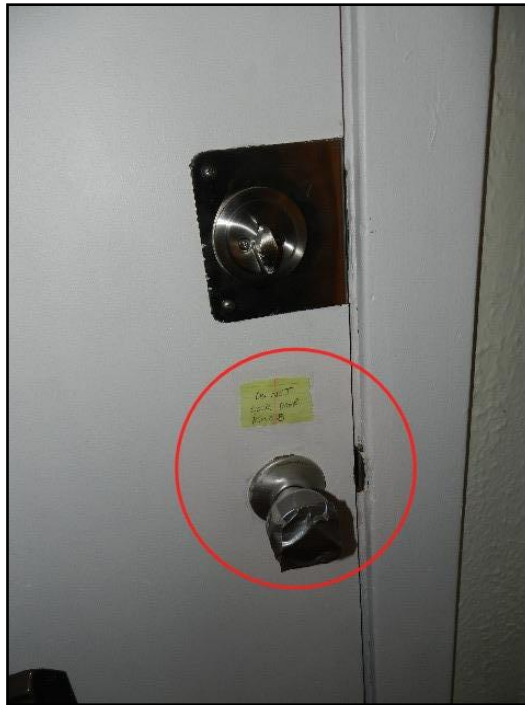
95. Condition: • Lock not effective on exterior door

106. Lock not effective on exterior door

Task: Further evaluation Request disclosure

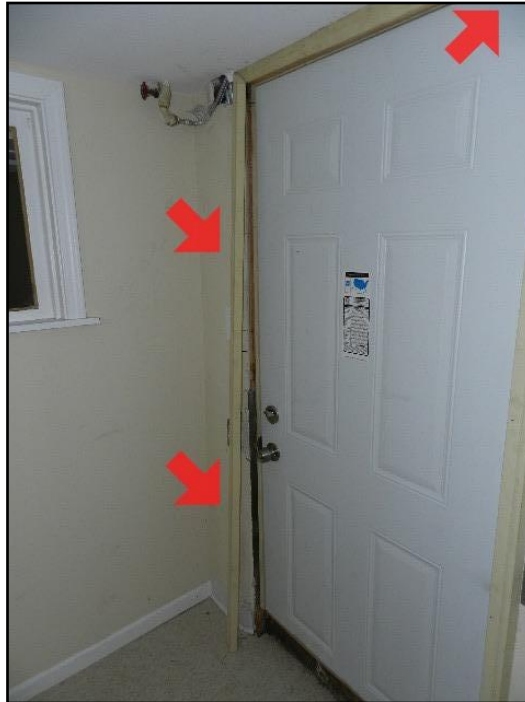
97. Condition: • [Poorly fit](#)

Implication(s): Material deterioration

107. *Poorly fit, loose*

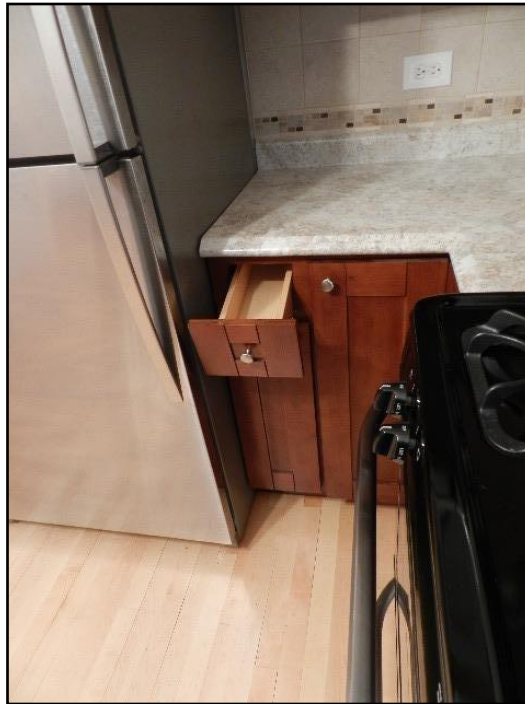
98. Condition: • [Doors or drawers missing or loose](#)

Implication(s): Nuisance | Damage or physical injury due to falling materials

108. *Doors or drawers missing or loose*

Task: Repair

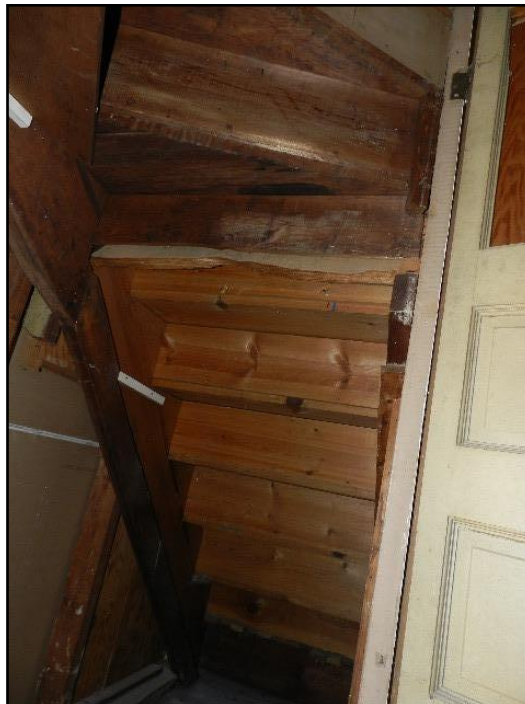
99. **Condition:** • [Drywall missing or incomplete on underside of stairs](#)

Implication(s): Increased fire hazard

109. Drywall missing or incomplete on underside...

Task: Repair or replace Upgrade Protect

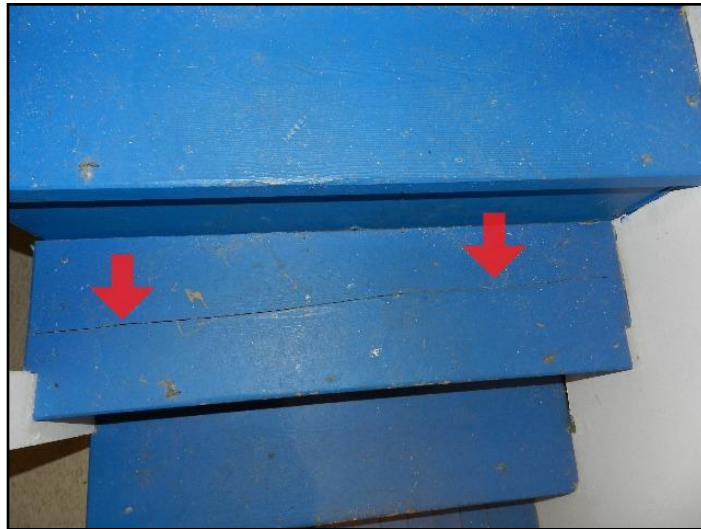
102. Condition: • [Worn or damaged](#)
Implication(s): Weakened structure | Trip or fall hazard

114. Worn or damaged

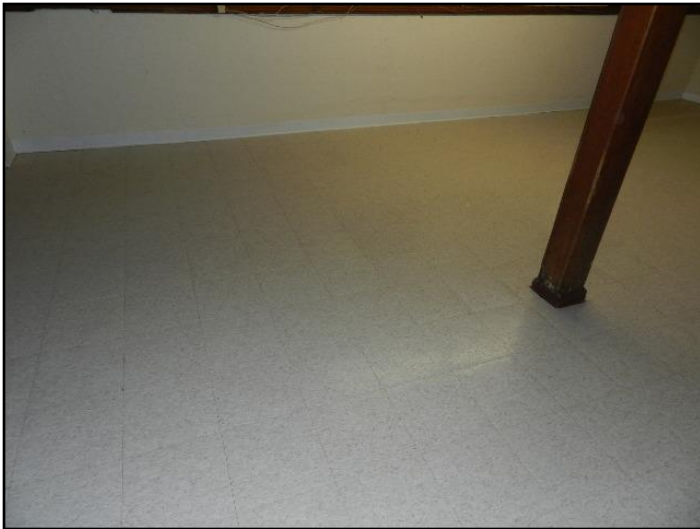
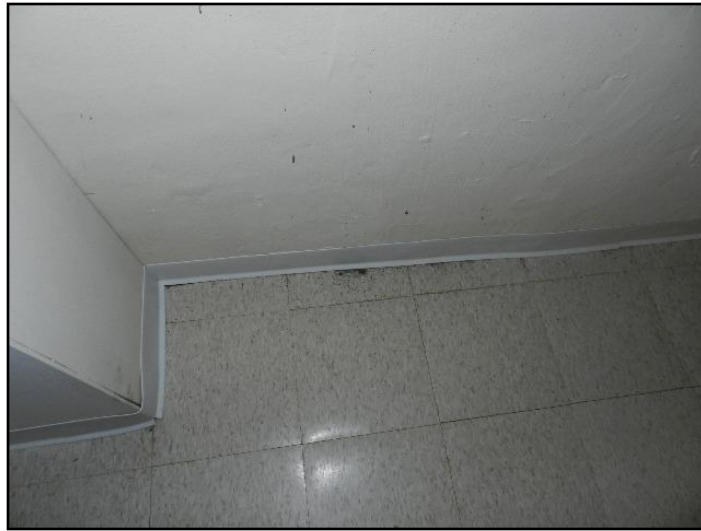
110. Condition: • [Loose floor tiles](#)

Implication(s): Chance of water damage to contents, finishes and/or structure | Trip or fall hazard

116. Loose floor tiles

118. Loose floor tiles

Task: Further evaluation Request disclosure

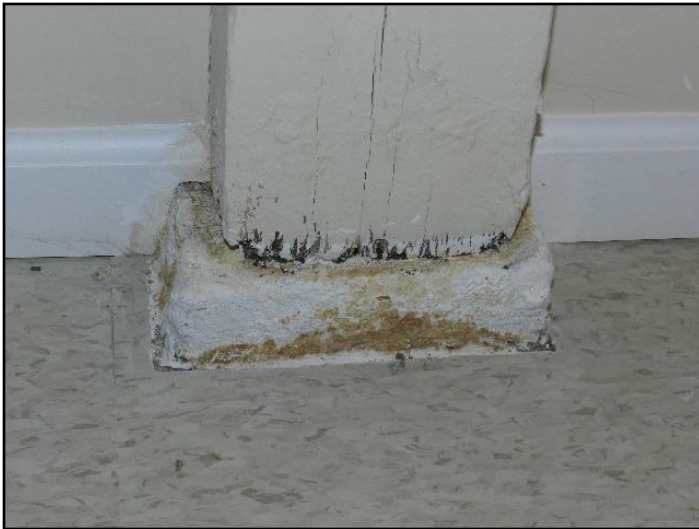
114. Condition: • [Wall cracks with water stains](#)

Implication(s): Chance of water damage to contents, finishes and/or structure

124. Wall cracks with water stains

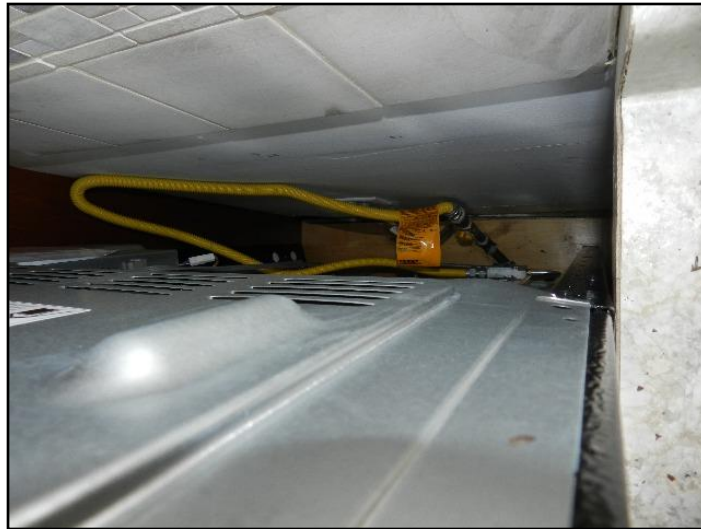
118. Condition: • Anti-tip device missing

130. Anti-tip device missing

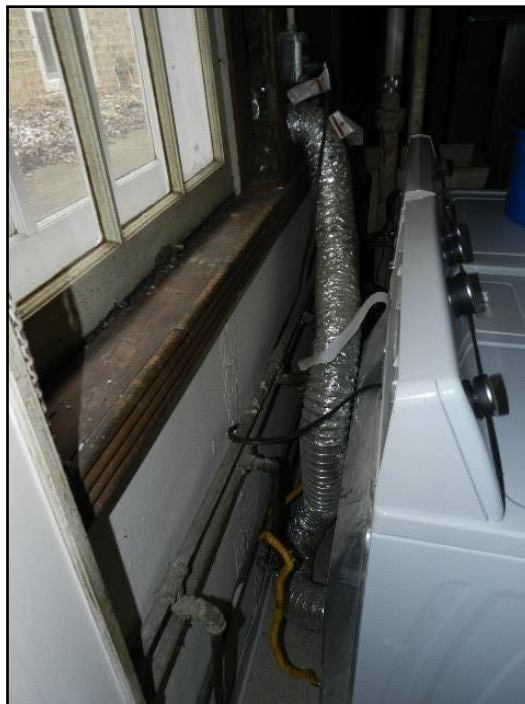
119. Condition: • Dryer vent material not smooth wall

Implication(s): Equipment ineffective | Fire hazard

131. Dryer vent material not smooth wall

Task: Replace Clean

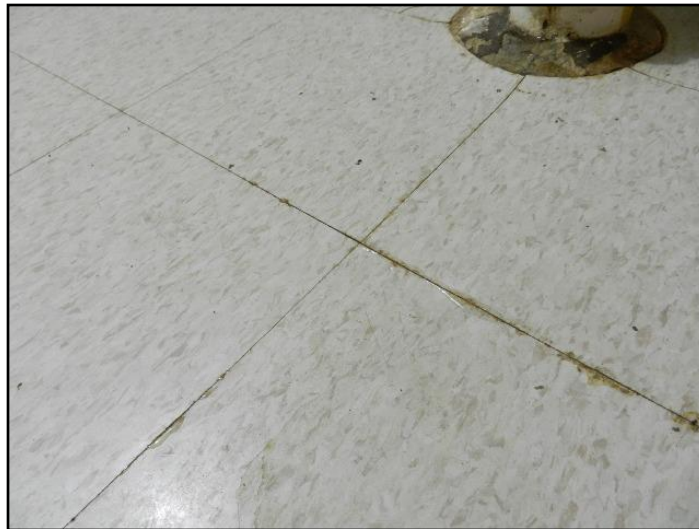
120. Condition: • Possible asbestos containing materials

Implication(s): Health hazard

132. *Possible vinyl-asbestos floor tiles*

Task: Further evaluation Request disclosure
