# Your Inspection Report

3256 West Sample St, Suite 2  
Chicago, IL

**INSPECTION DATE:**  
Saturday, February 3, 2018

RE: Report No. 1079, v.2  
3256 West Sample St, 2  
Chicago, IL

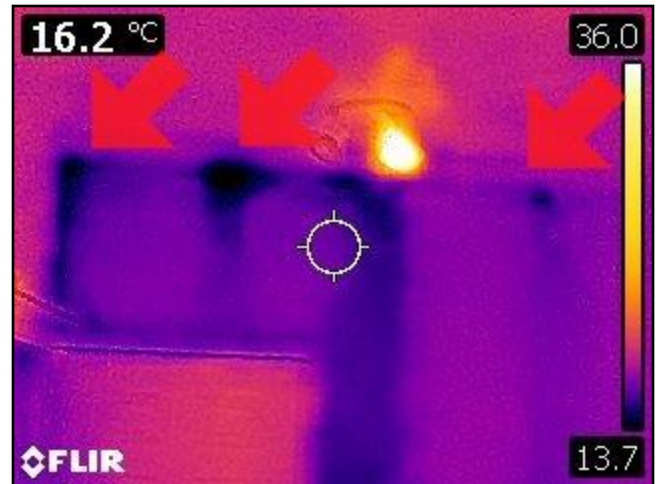
3. Moisture in wall, possible leak

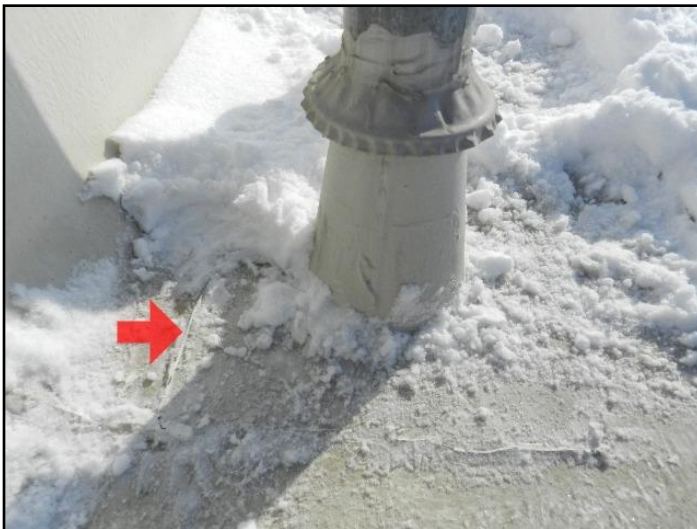
6. Openings at seams or flashings

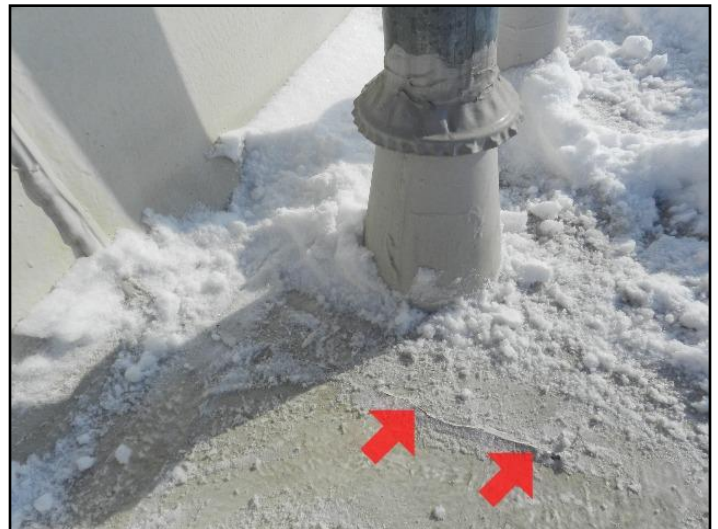
7. Openings at seams or flashings

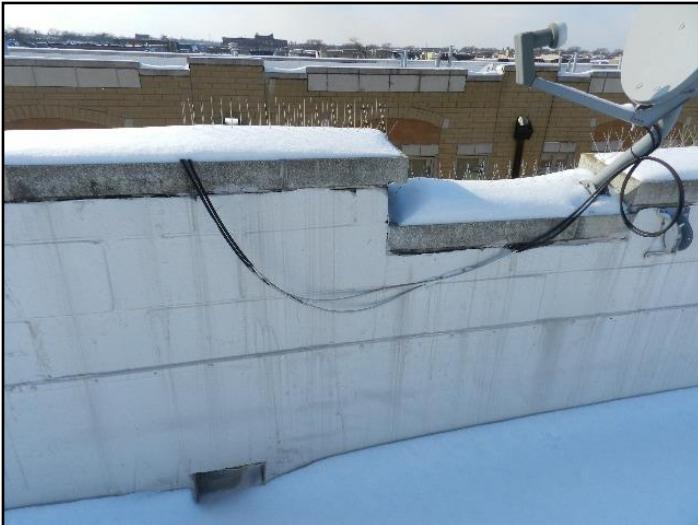
9. Inspect during annual tune-up

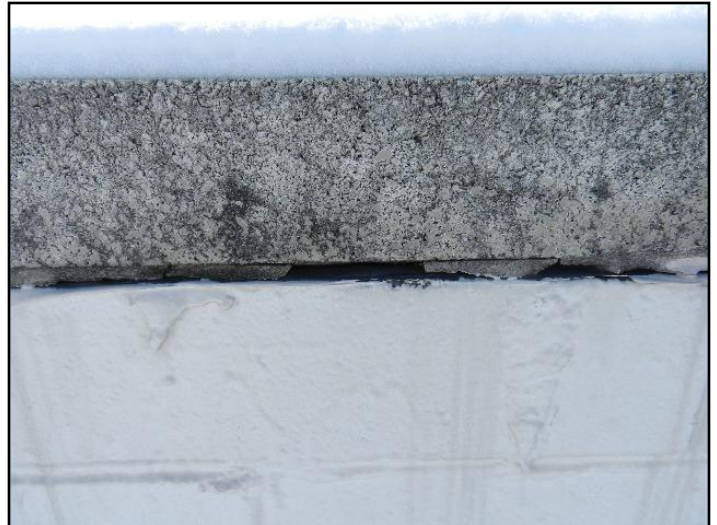
10. Inspect during annual tune-up

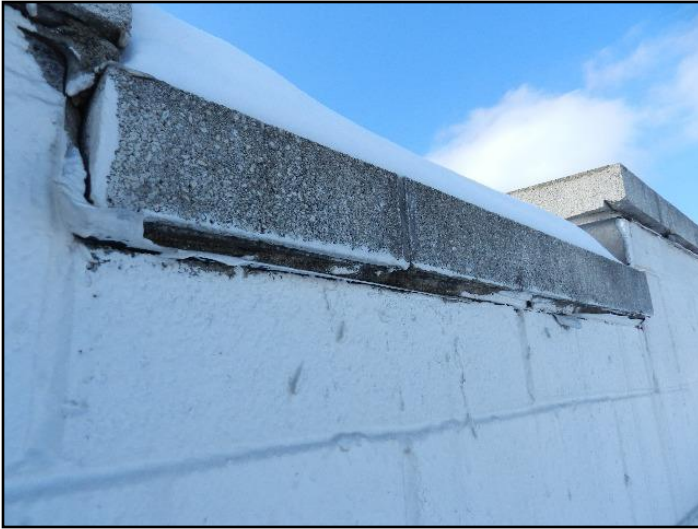
11. *Inspect during annual tune-up*

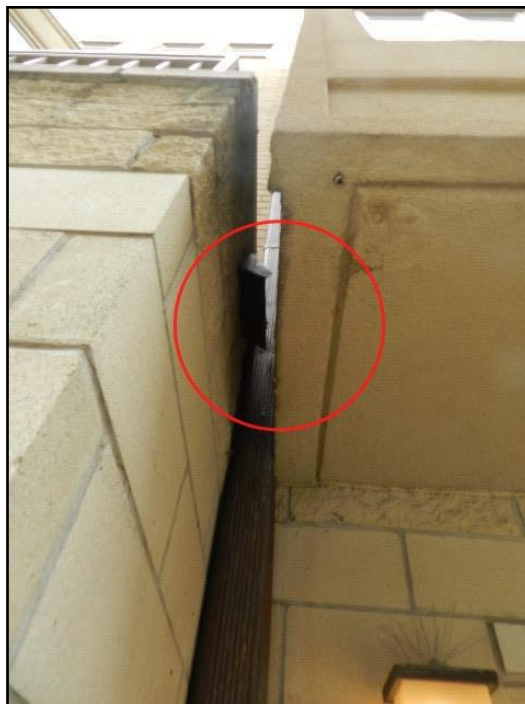
17. Discharging on a wall

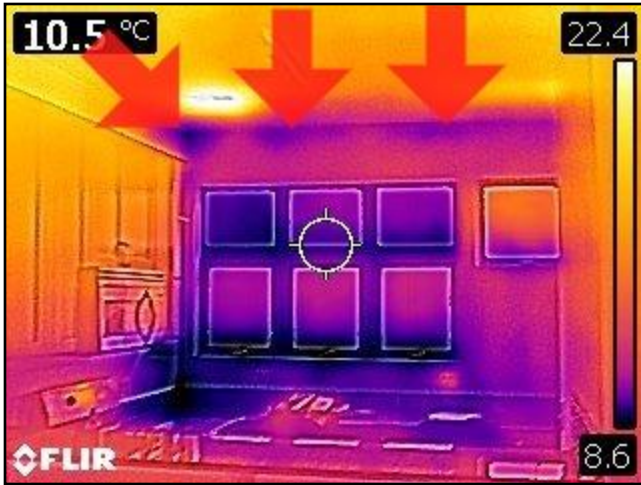
18. Moisture in wall

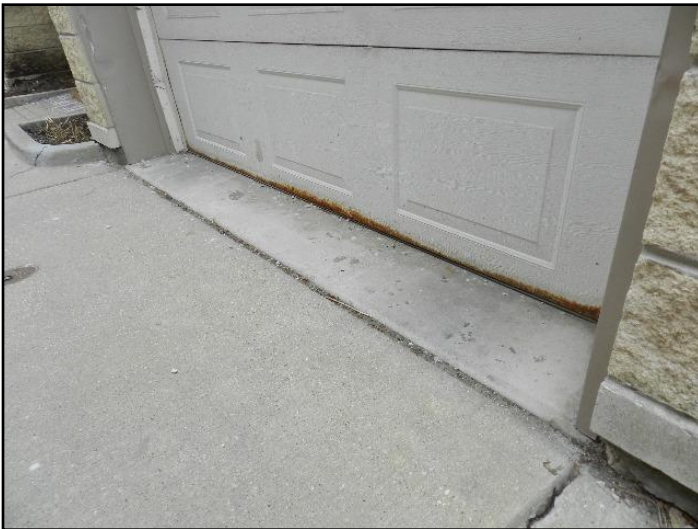
50. Rust, damage to frame

**Task:** Repair Clean Protect

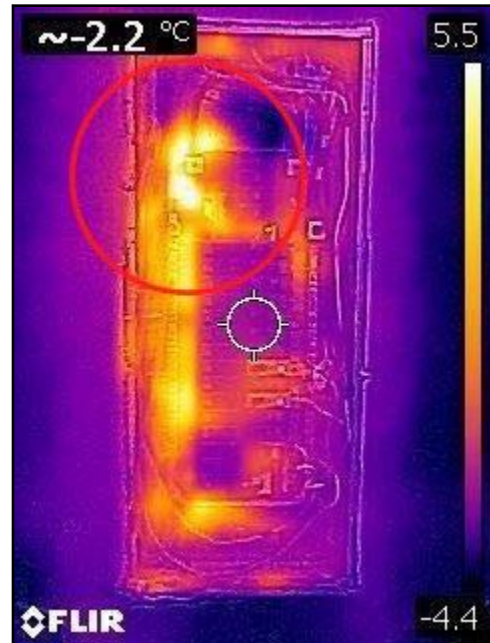
60. Overheating at service feeder

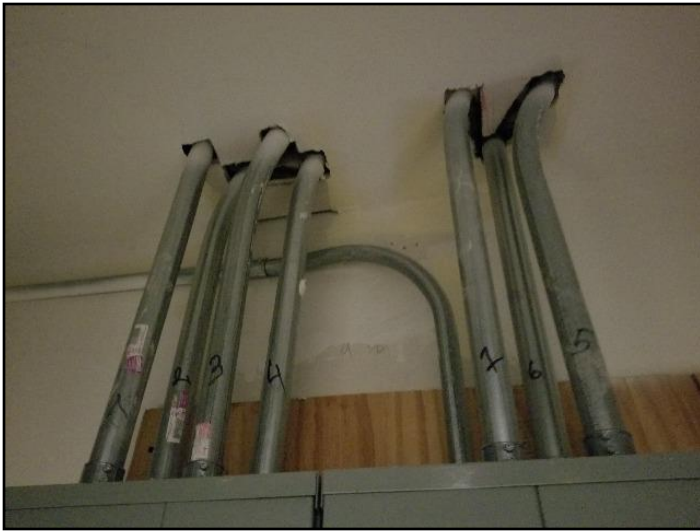
61. No fire caulking/sealant

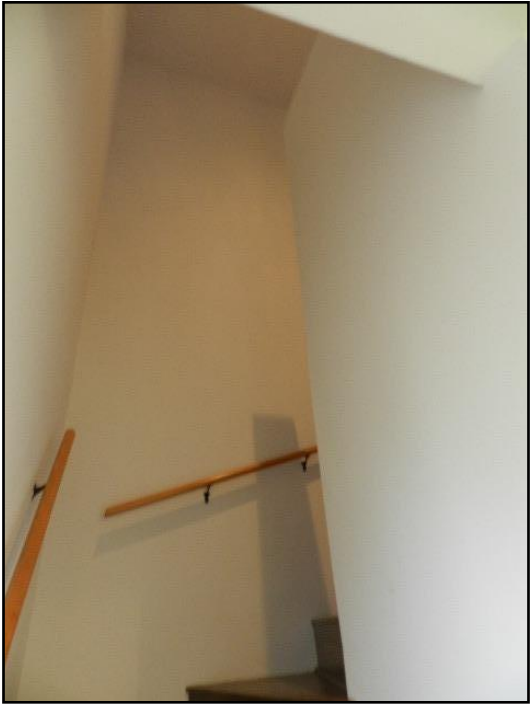
69. Poor stairway lighting

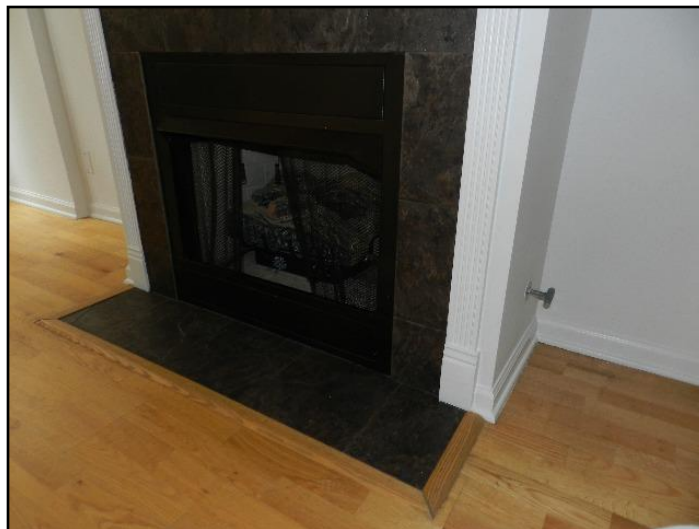
**Implication(s):** System inoperative

72. Unable to start the igniter

**Task:** Further evaluation

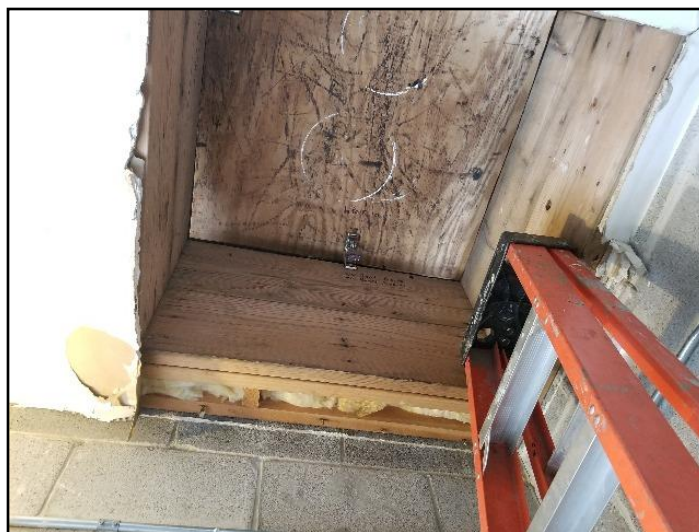
**34. Condition:** • [Not insulated and not weatherstripped](#)

**Implication(s):** Chance of condensation damage to finishes and/or structure | Increased heating and cooling costs | Reduced comfort

*79. Not insulated and not weatherstripped*

**Task:** Repair or replace

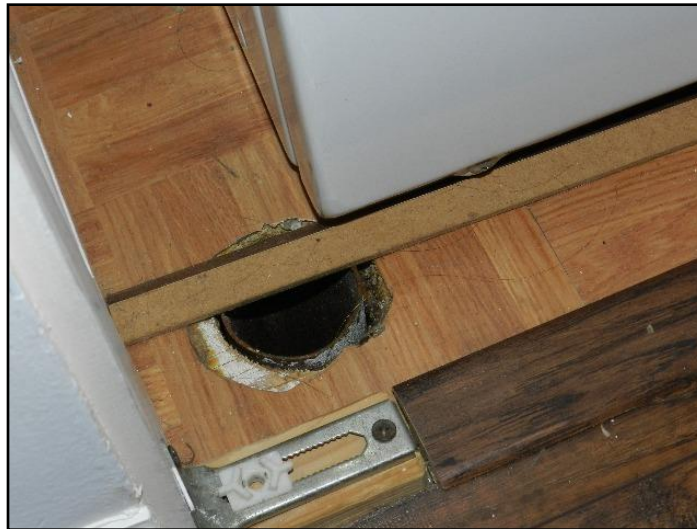
36. Condition: • [Grate missing, rusted or obstructed](#)

Implication(s): Chance of water damage to contents, finishes and/or structure | Trip or fall hazard

81. *Grate missing, rusted or obstructed*

Task: Provide

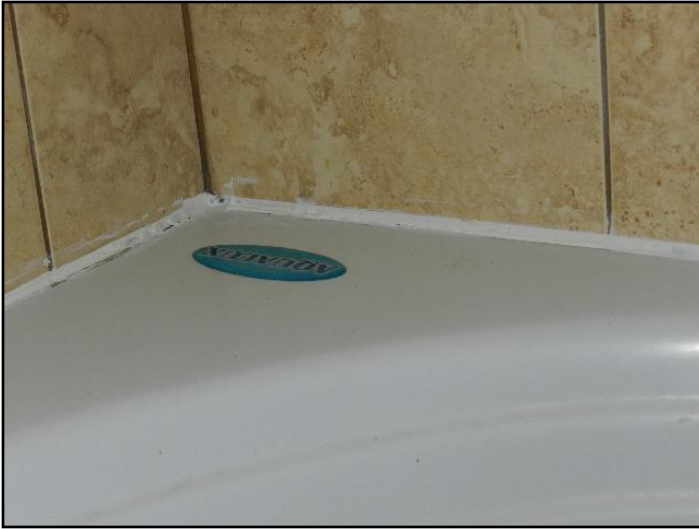
41. Condition: • [Grout loose, missing or deteriorated](#)

**86.** Grout loose, missing or deteriorated

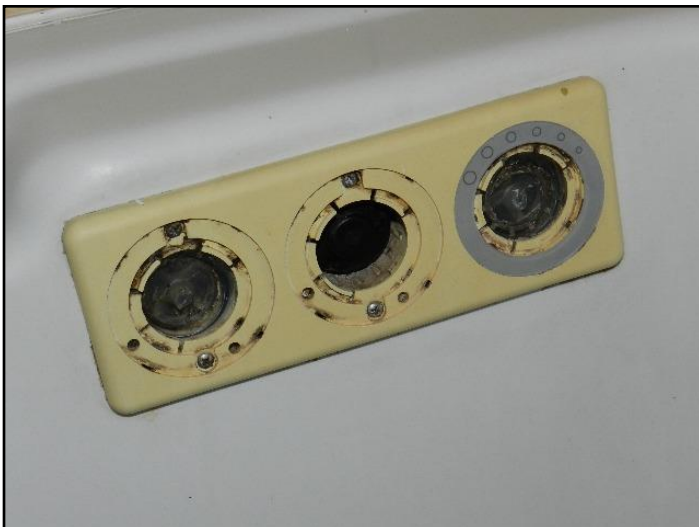
42. Condition: • [Odor](#)

Implication(s): Sewer gases entering the building

91. Odor, covers missing

Task: Replace

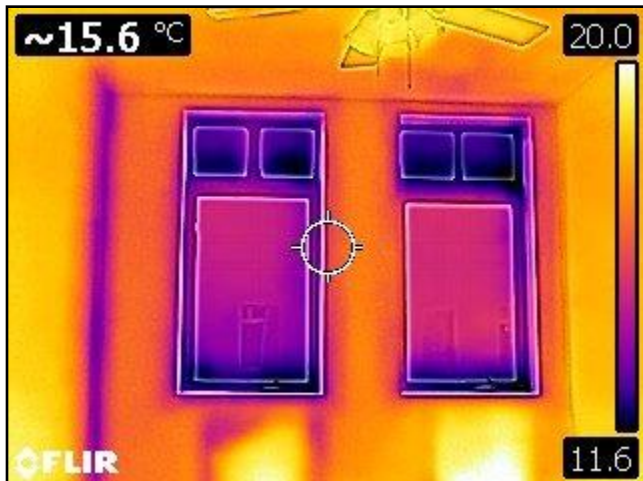
**43. Condition:** • [Water leaks](#)

99. Possible water leaks

**Task:** Repair or replace Correct Upgrade Protect

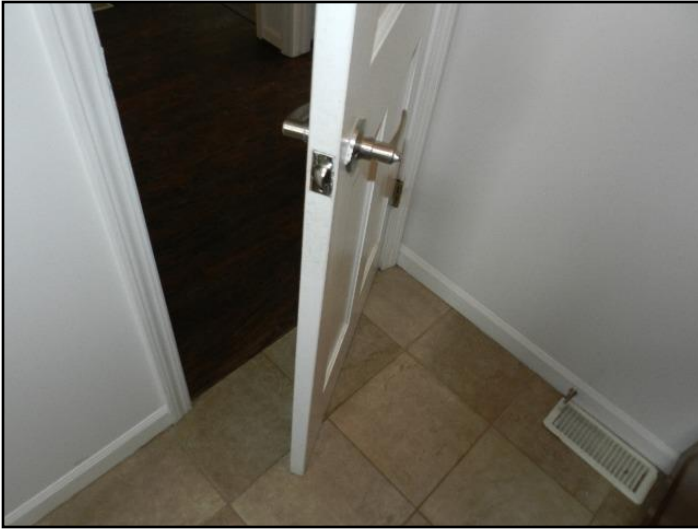
44. Condition: • [Broken](#)

103. Privacy lock broken

Task: Replace

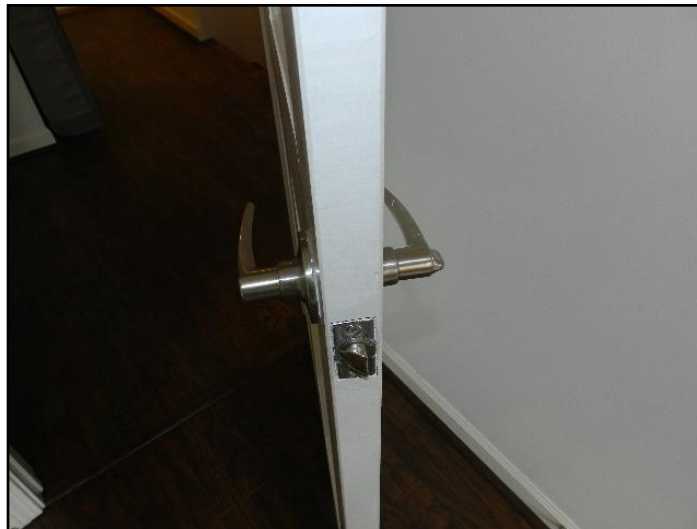
105. Privacy lock broken

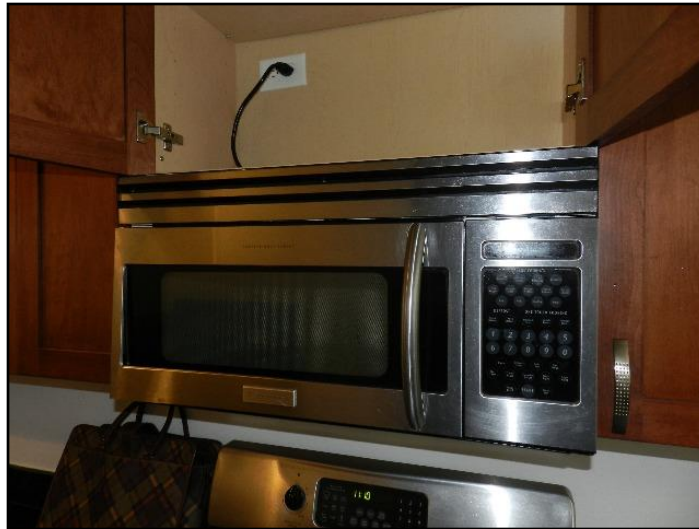
47. Condition: • Not vented to exterior

Implication(s): Chance of condensation damage to finishes and/or structure

109. Not vented to exterior

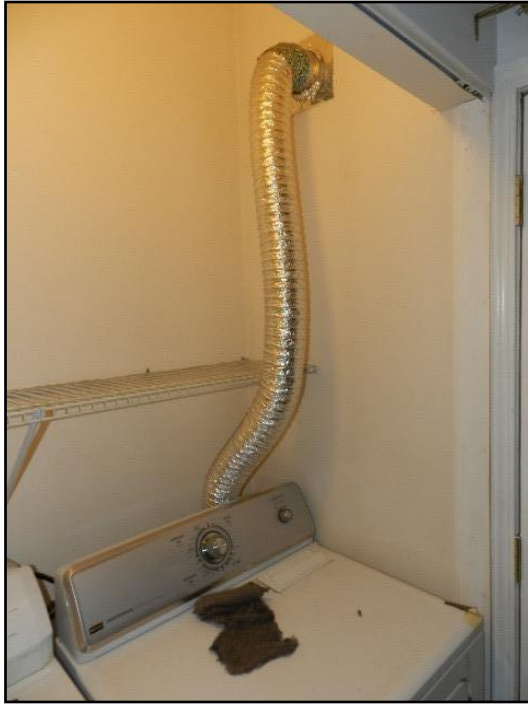
**51. Condition:** • Dryer vent material not smooth wall

**Implication(s):** Equipment ineffective | Fire hazard

112. Dryer vent material not smooth wall

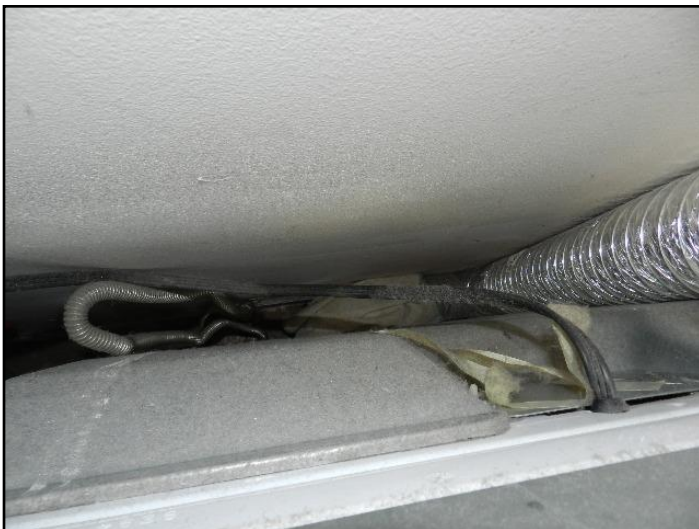
114. Dryer vent material not smooth wall

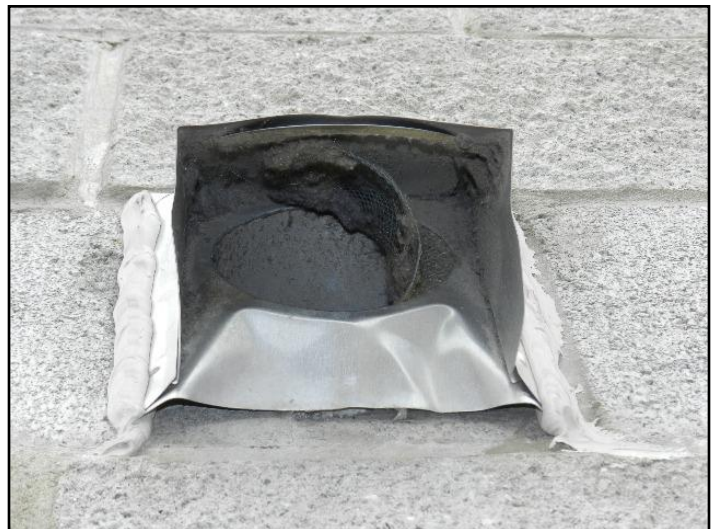
115. Dryer vent material not smooth wall
