Your Inspection Report

5246 North Sample St
Chicago, IL

INSPECTION DATE:
Wednesday, January 24, 2018

RE: Report No. 1078
5246 North Sample St
Chicago, IL

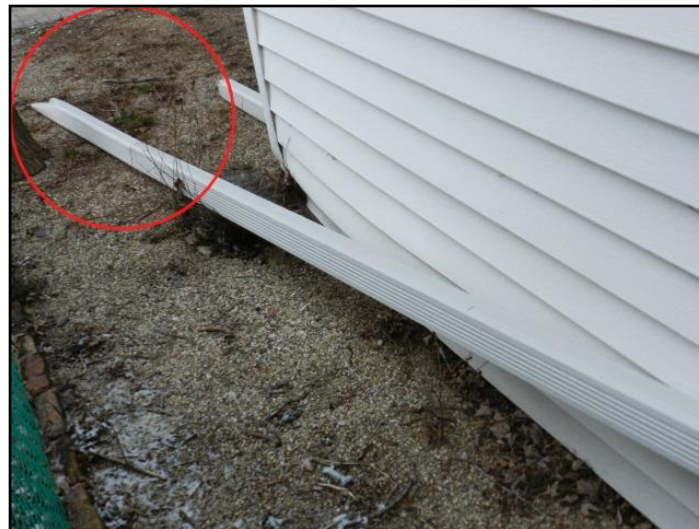
8. Damage

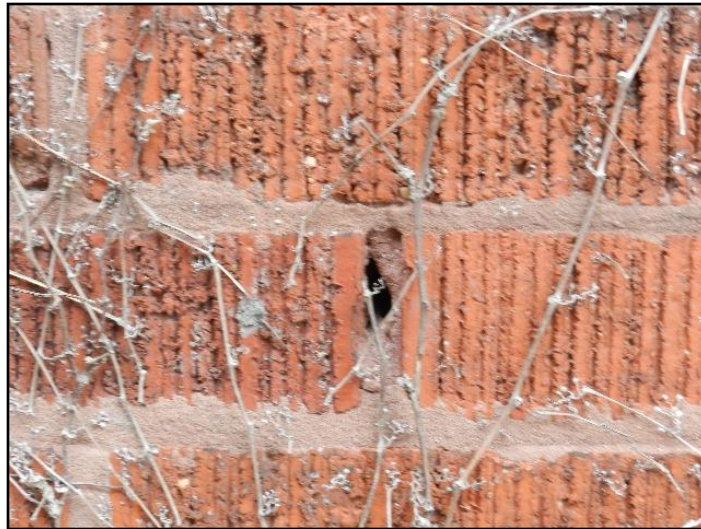
13. Mortar deterioration

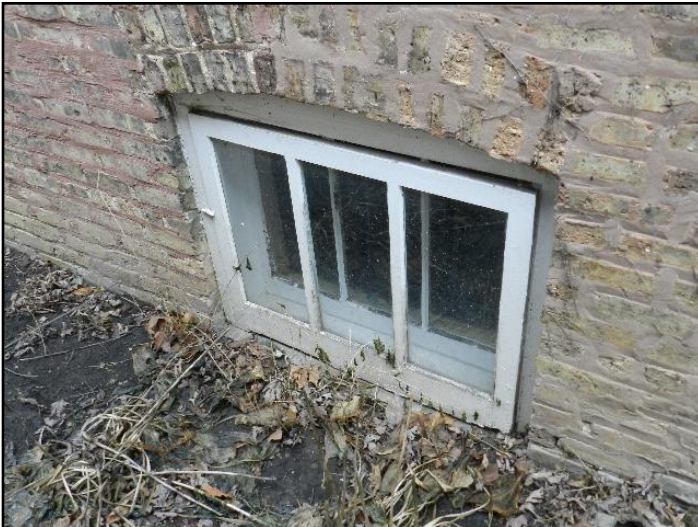
Condition: • [Air leaks](#)

14. Air leaks

Task: Replace

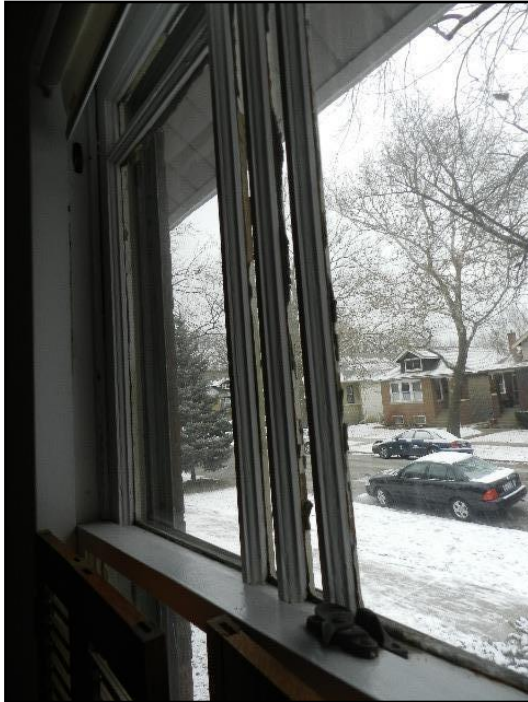
16. Air leaks

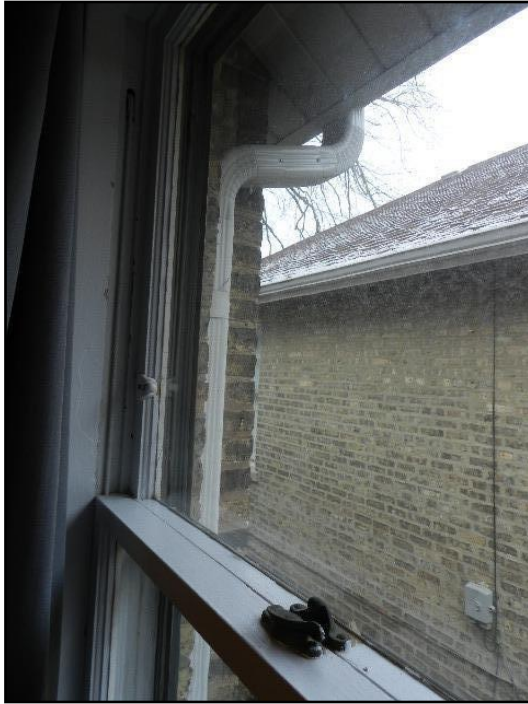
20. Air leaks

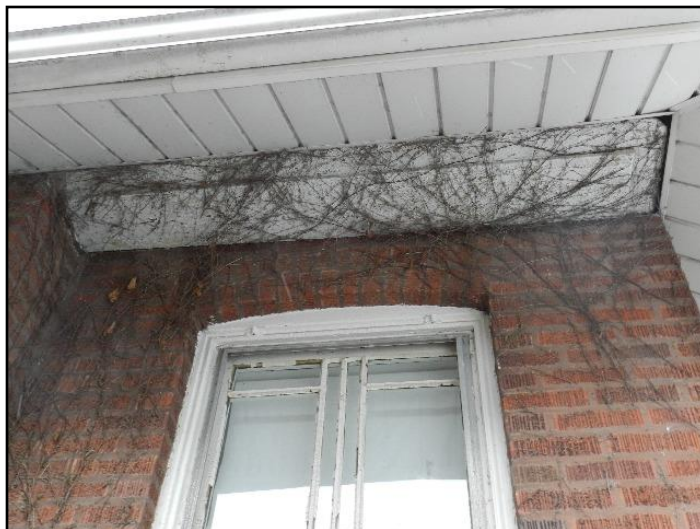
14. Condition: • Vines on building

Implication(s): Chance of damage to finishes | Chance of pests entering building

27. *Vines on building*

Task: Clean Remove

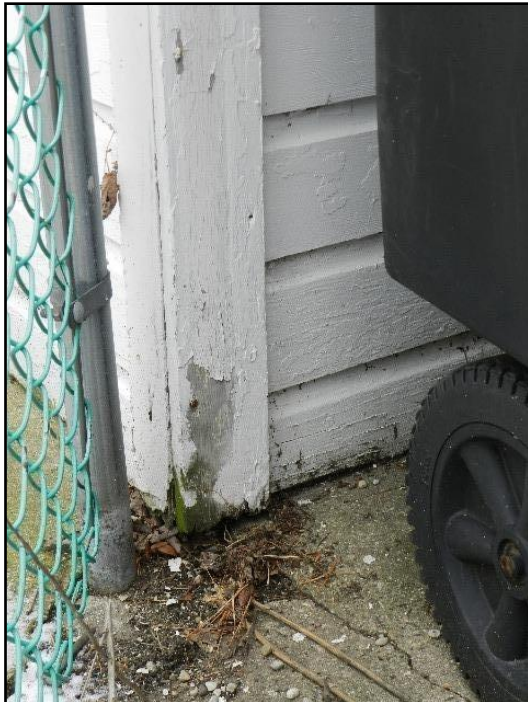
31. Rot

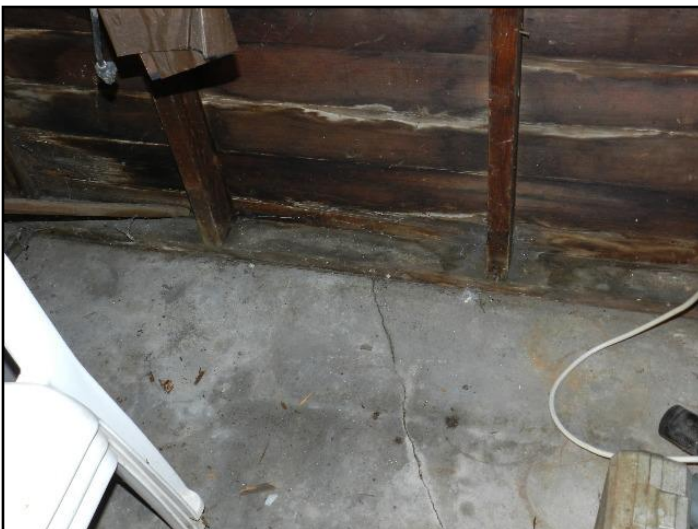
33. Rot

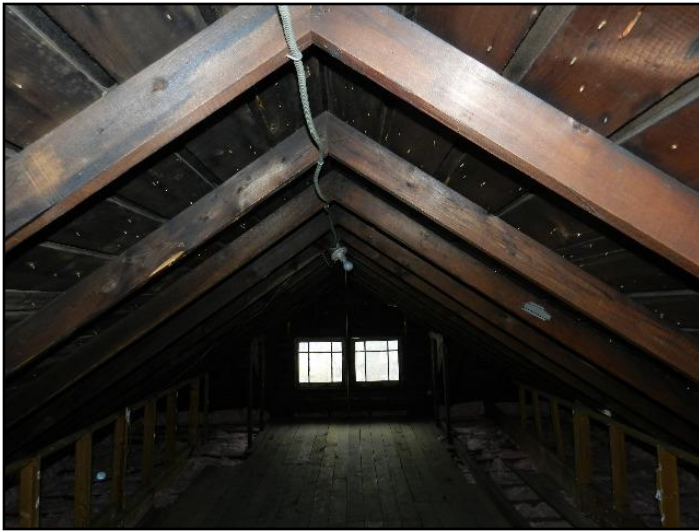
36. No ridge beam, no collar ties

Task: Repair or replace

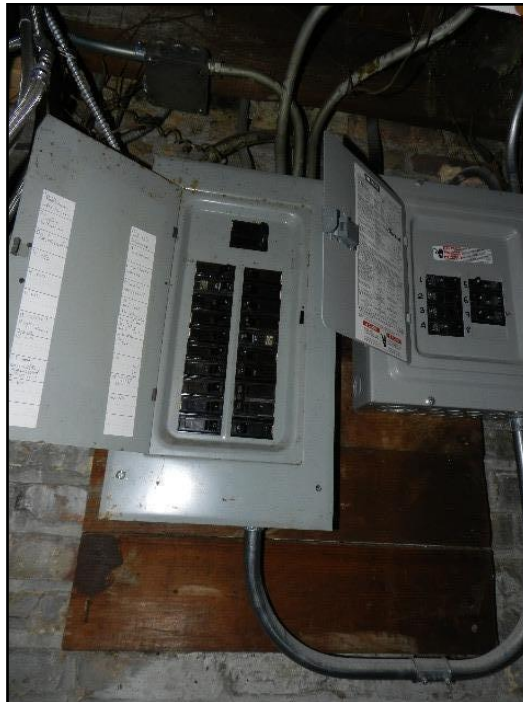
38. 100 Amps

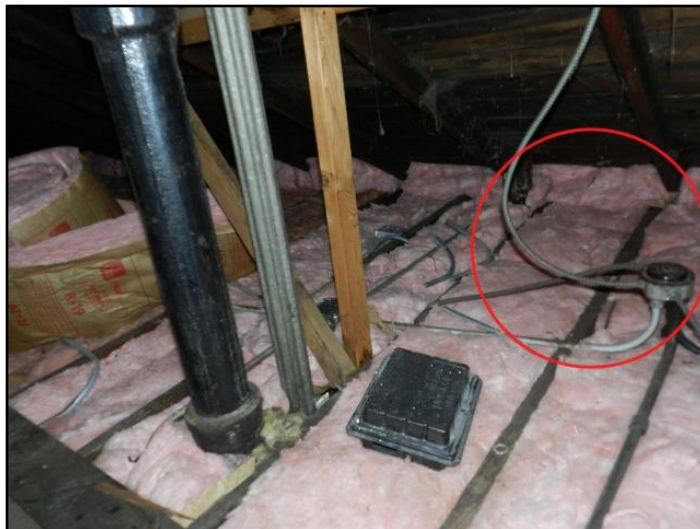
45. Wrong type, Romex

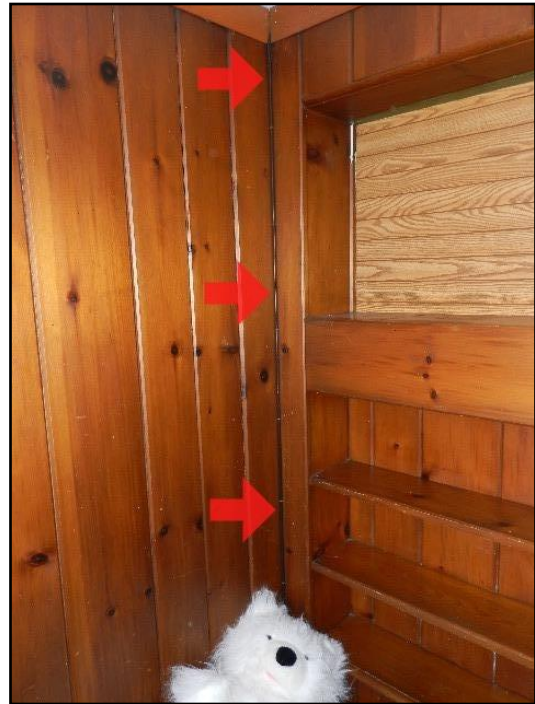
47. Exposed on walls or ceilings

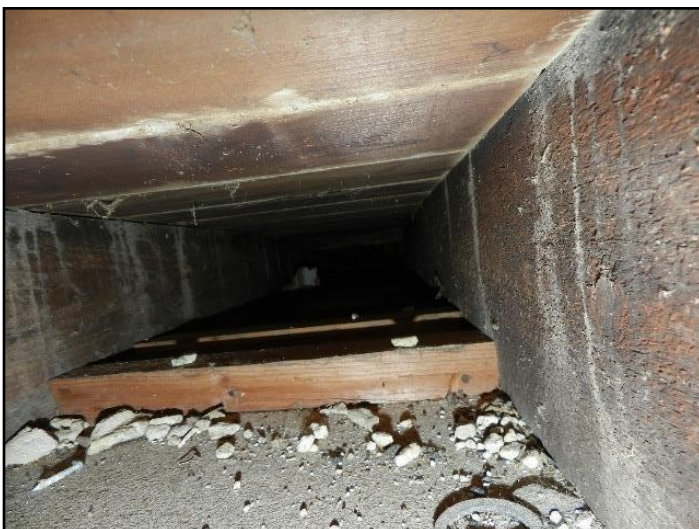
57. Condition: • [Dirty](#)

Implication(s): Increased cooling costs | Reduced comfort

55. Dirty

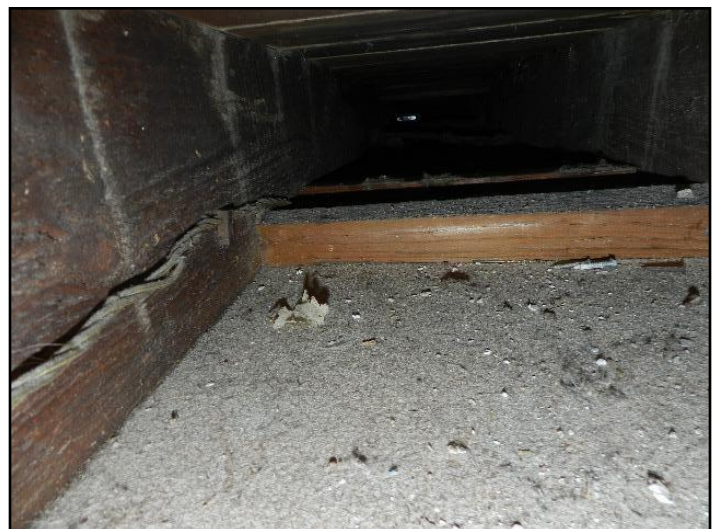
56. Dirty

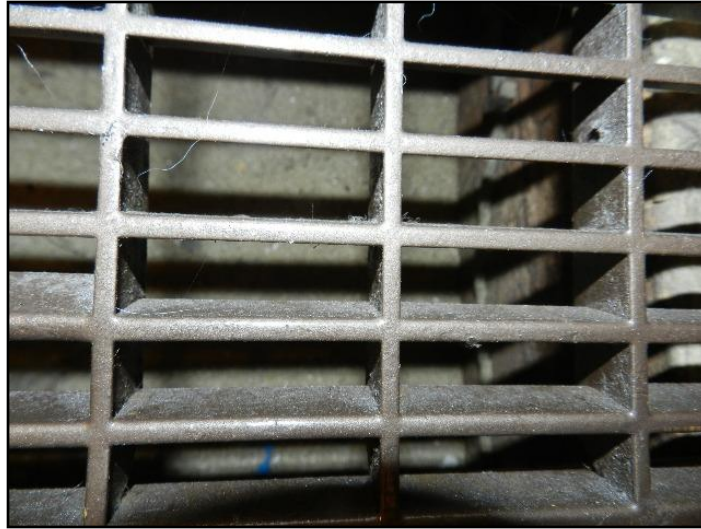
57. Dirty

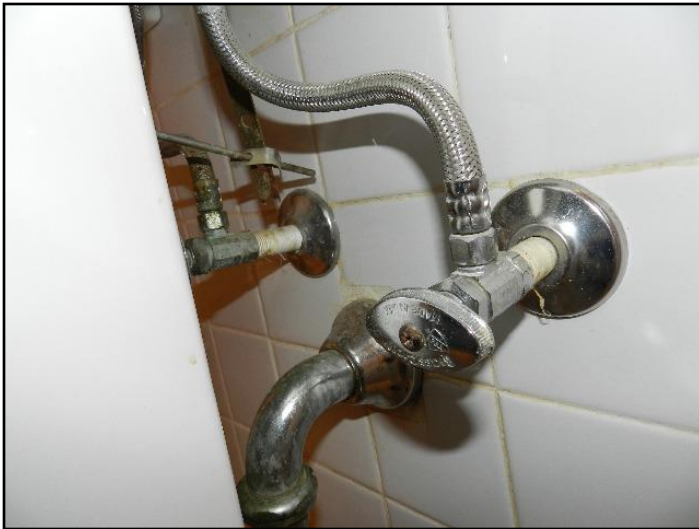
70. Condition: • [Galvanized steel](#)

rusting of galvanized pipe can greatly reduce water pressure and will eventually cause leaks as rust creates holes in the pipe walls

problems are likely to occur soonest on pipes carrying hot water, horizontal pipes and at threaded (thinner) sections

71. Galvanized steel

Task: Replace Upgrade

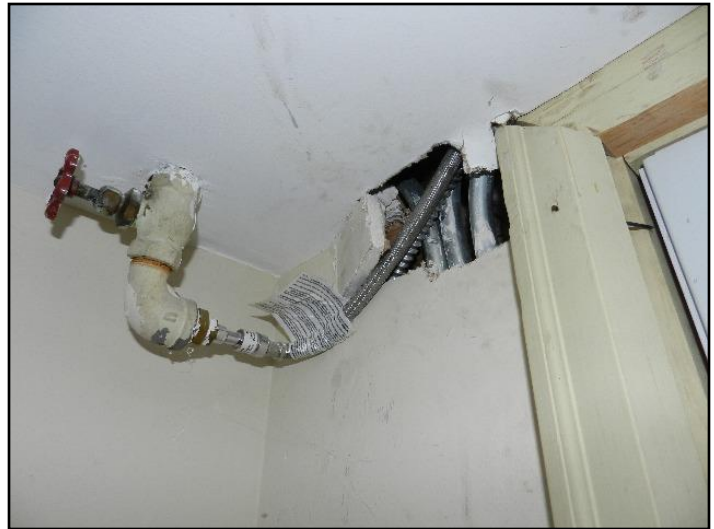
72. Galvanized steel

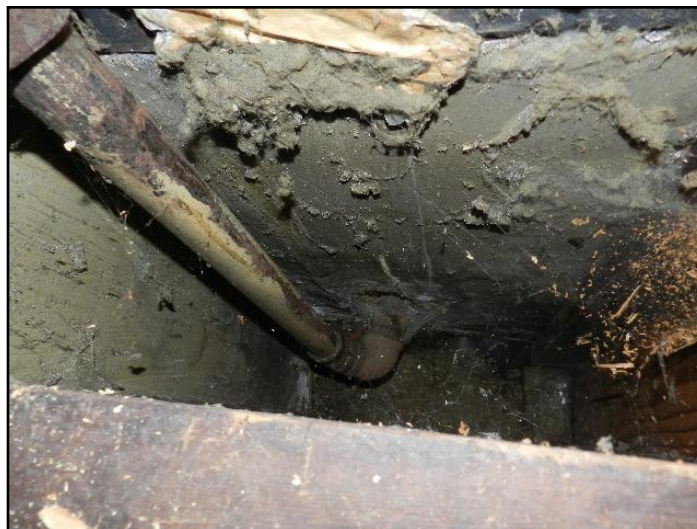
73. Galvanized steel

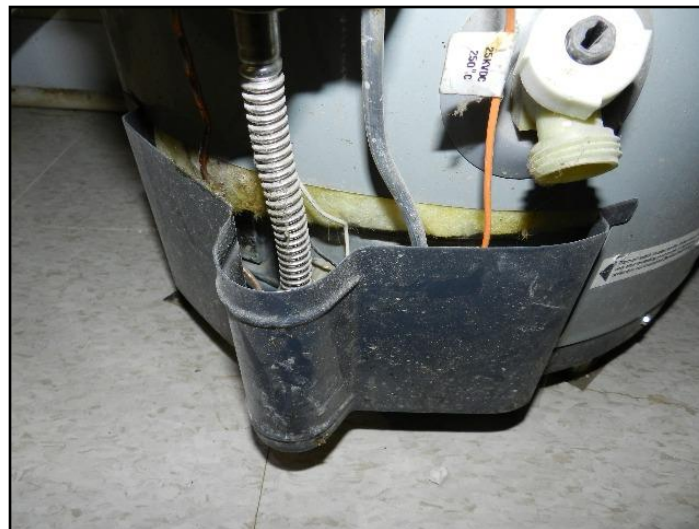
72. Condition: • [Near end of life expectancy](#)

Implication(s): No hot water

75. Near end of life expectancy

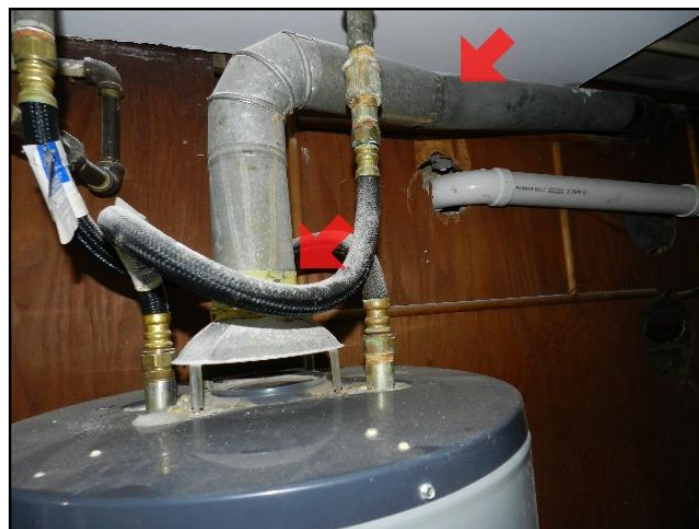
74. Condition: • [Poor connections](#)

Implication(s): Equipment not operating properly | Hazardous combustion products entering home

77. Poor connections

Task: Repair

Time: Immediate

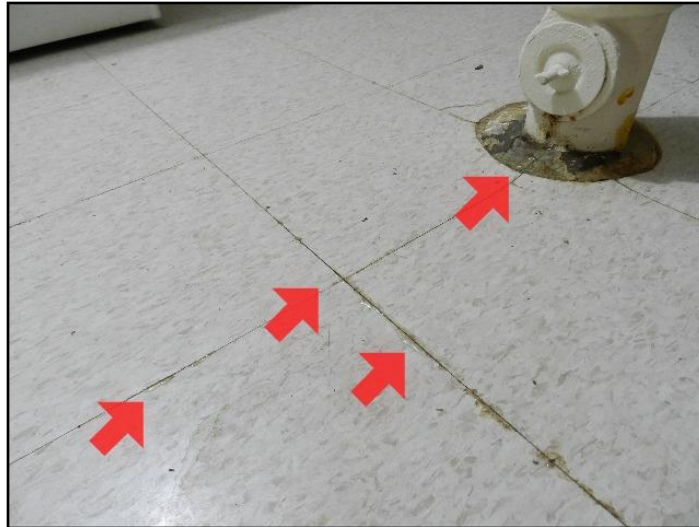
76. Condition: • [Leak](#)

79. Leak

Task: Repair Further evaluation

Time: Immediate

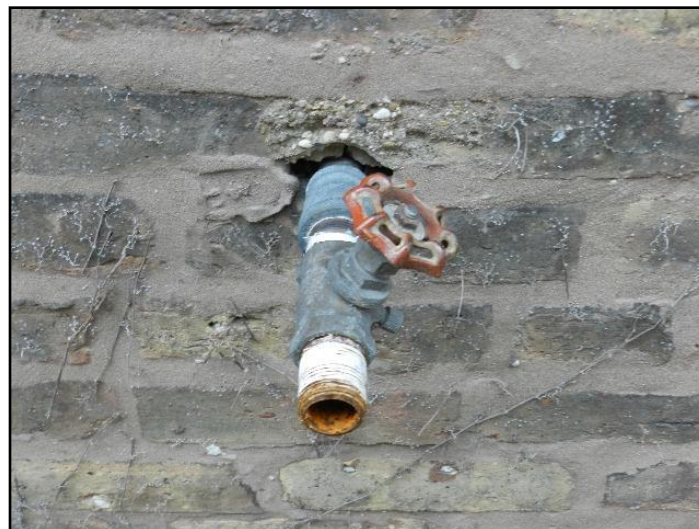
83. Condition: • [Loose](#)

Implication(s): Reduced system life expectancy

87. Loose

Task: Correct

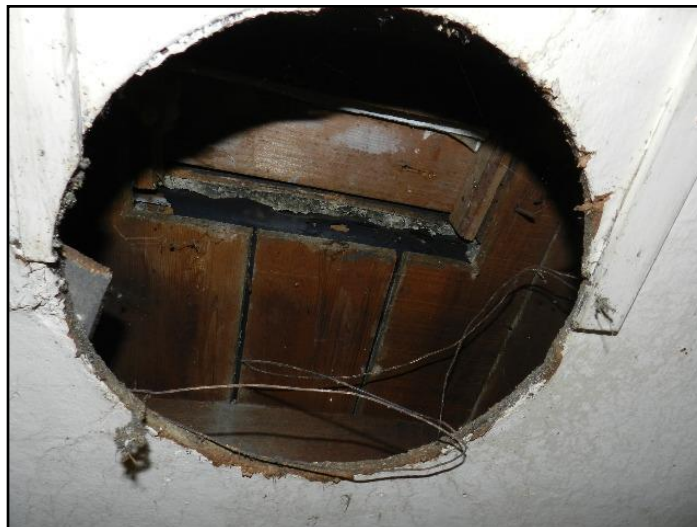
86. Condition: • [Missing sections](#)

Implication(s): Damage or physical injury due to falling materials

90. *Missing sections*

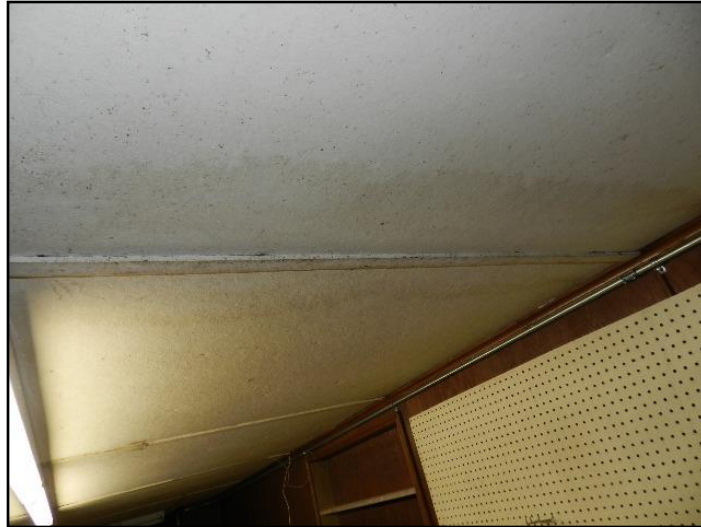
87. Condition: • Water stains

Implication(s): Chance of water damage to contents, finishes and/or structure

91. Water stains

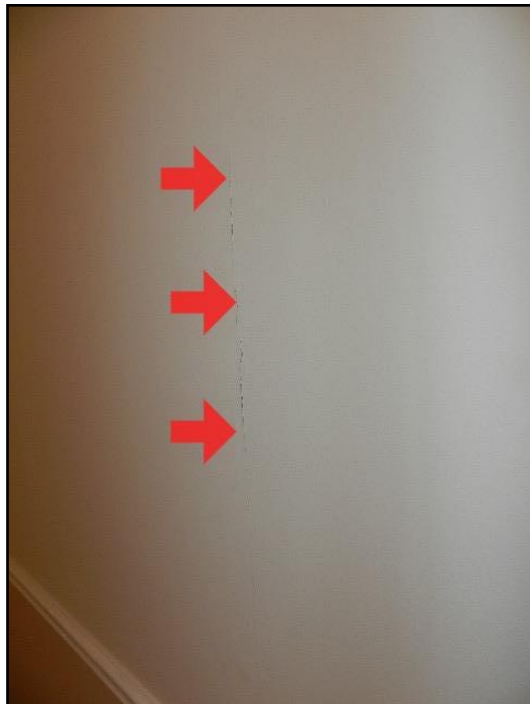
88. Condition: • [Cracked](#)

Implication(s): Damage or physical injury due to falling materials

92. Cracked

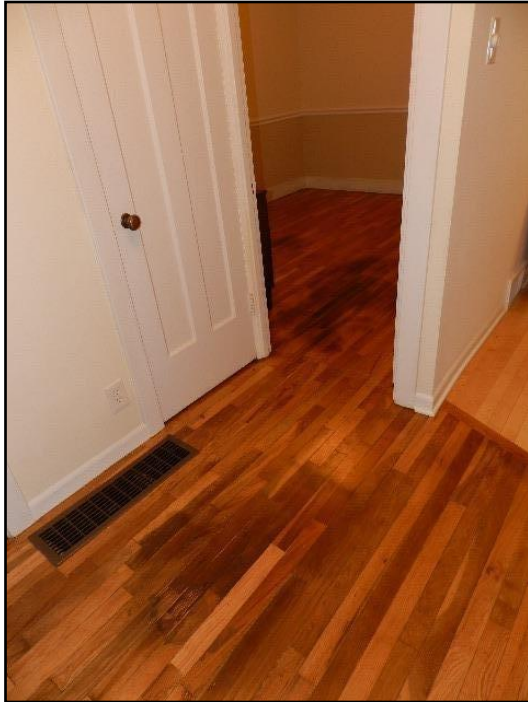
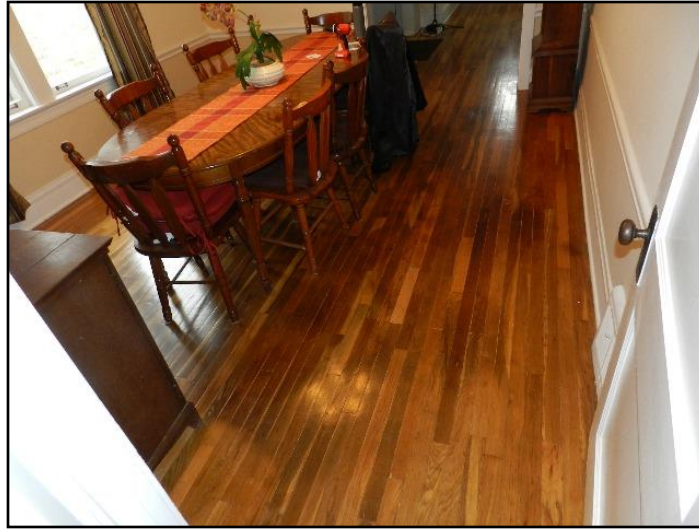
92. Condition: • [Stained](#)

Dog urine stains/damage at hardwood floors

Implication(s): Chance of water damage to contents, finishes and/or structure

97. Dog urine stains/damage

99. Dog urine stains/damage

101. Dog urine stains/damage

Task: Repair Clean Correct Protect

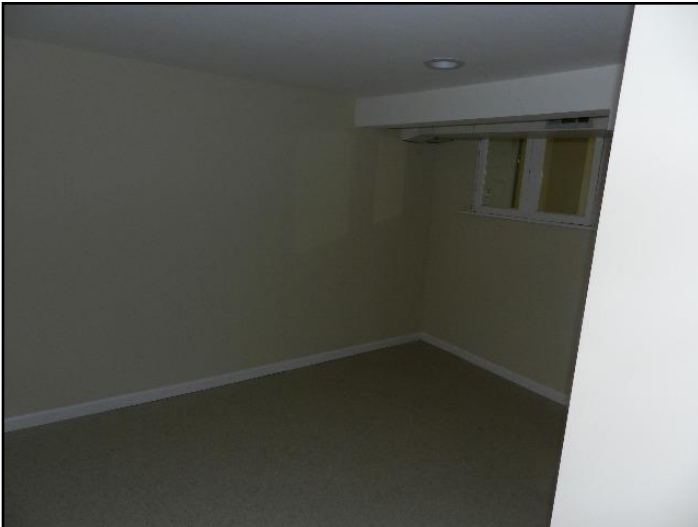
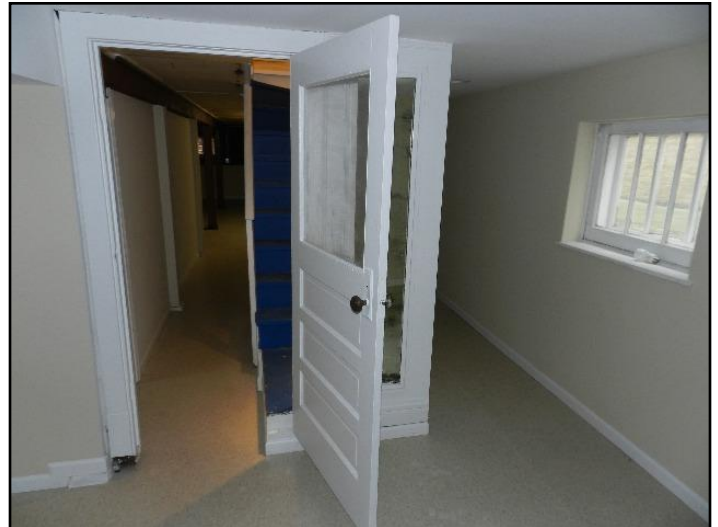
102. Not a legal 3rd bedroom

103. Not a legal 3rd bedroom

Task: Request disclosure

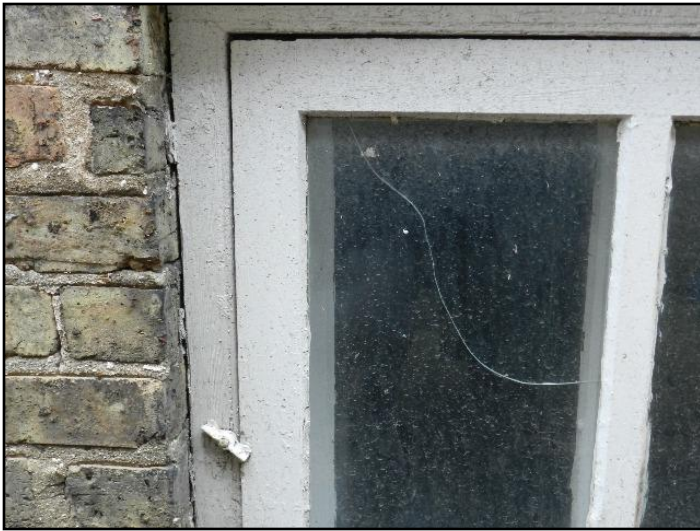
94. Condition: • [Cracked](#)

Implication(s): Physical injury

104. Cracked

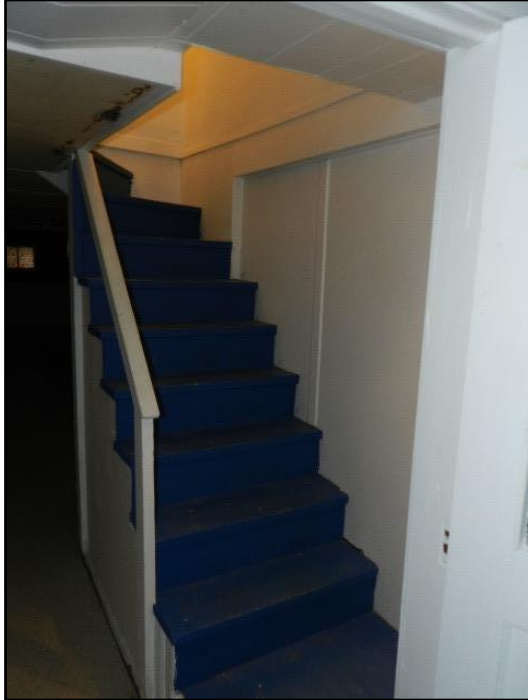
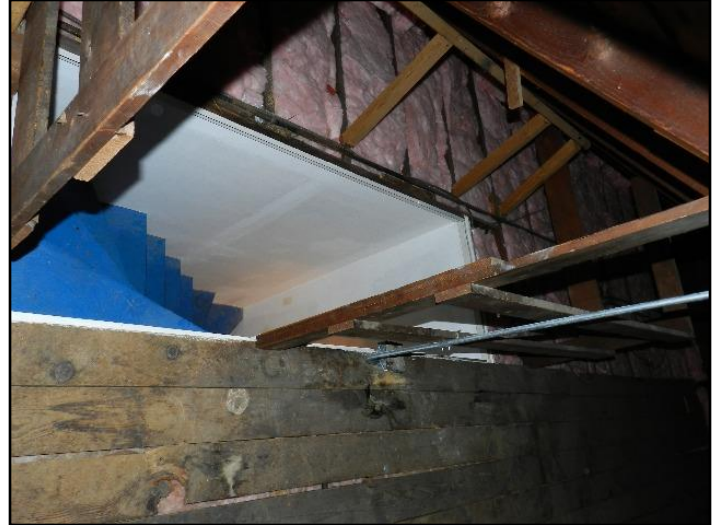
100. Condition: • [Headroom less than ideal](#)

Implication(s): Physical injury

110. Headroom less than ideal

111. Headroom less than ideal

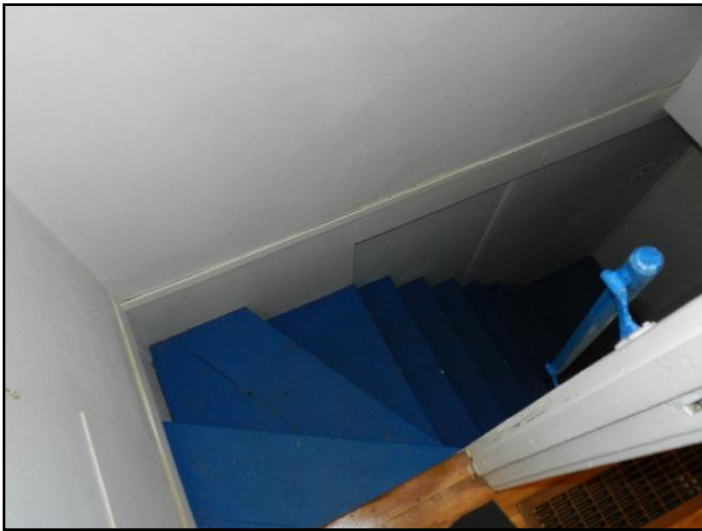
101. Condition: • [Rise excessive](#)

Implication(s): Trip or fall hazard

112. Rise excessive

Task: Demolish Upgrade

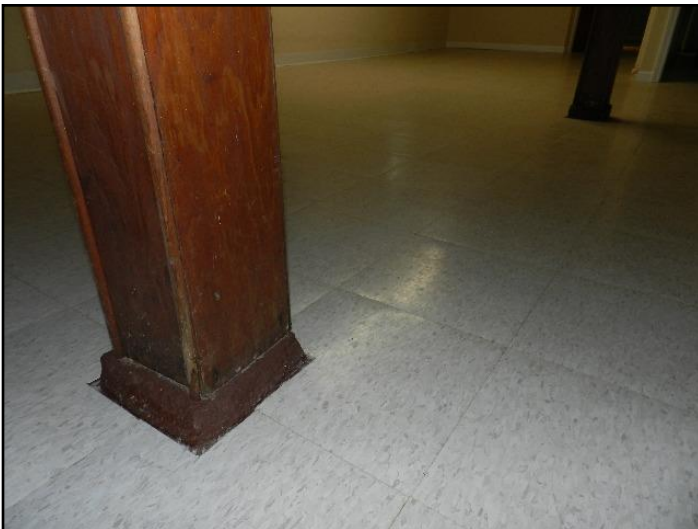
112. Condition: • [Rot](#)

Implication(s): Chance of water damage to contents, finishes and/or structure | Material deterioration

119. Rot

121. Rot

Task: Request disclosure

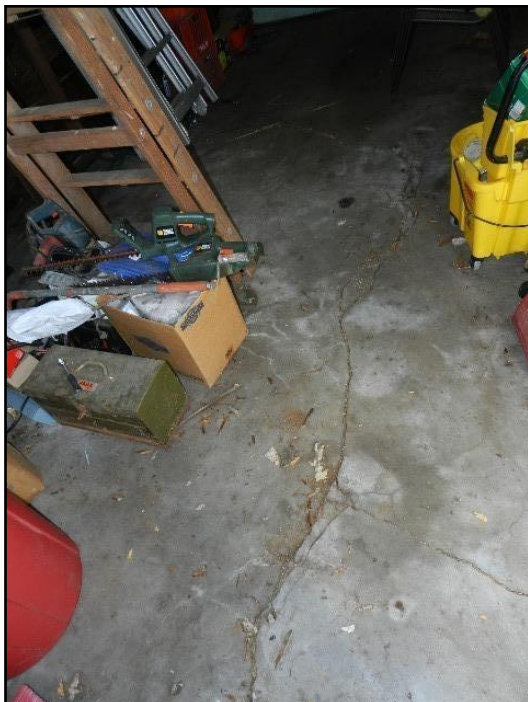
116. Condition: • [Cracked](#)

126. Cracked

128. Cracked

Task: Monitor Demolish
