# Your Inspection Report

3256 West Sample St, Suite 2  
Chicago, IL

**INSPECTION DATE:**  
Saturday, February 3, 2018

RE: Report No. 1079, v.2  
3256 West Sample St, 2  
Chicago, IL

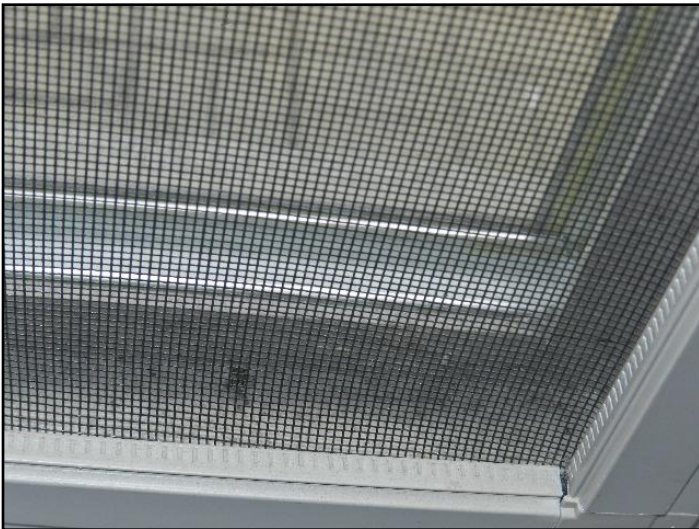
22. Lost seal on double or triple glazing

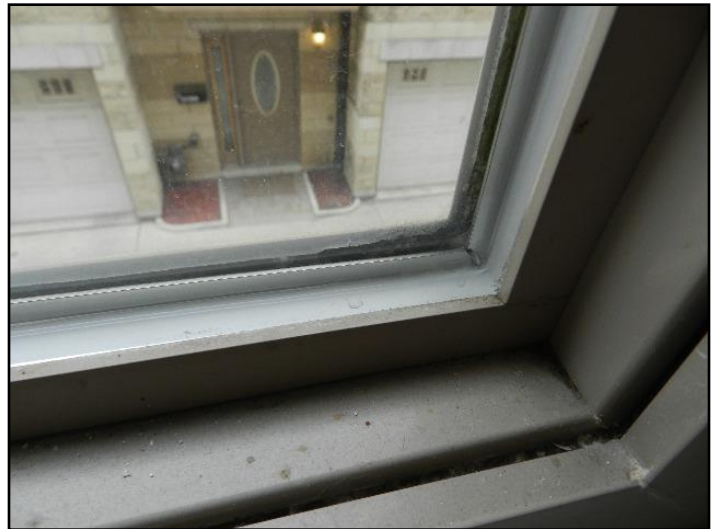
23. Lost seal on double or triple glazing

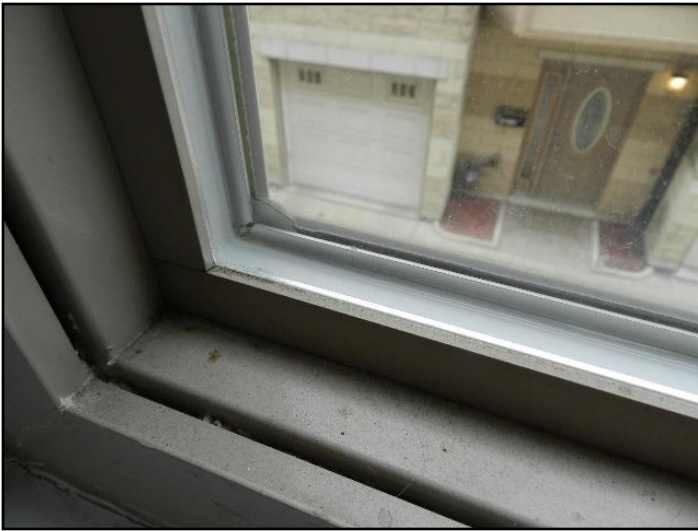
24. Lost seal on double or triple glazing

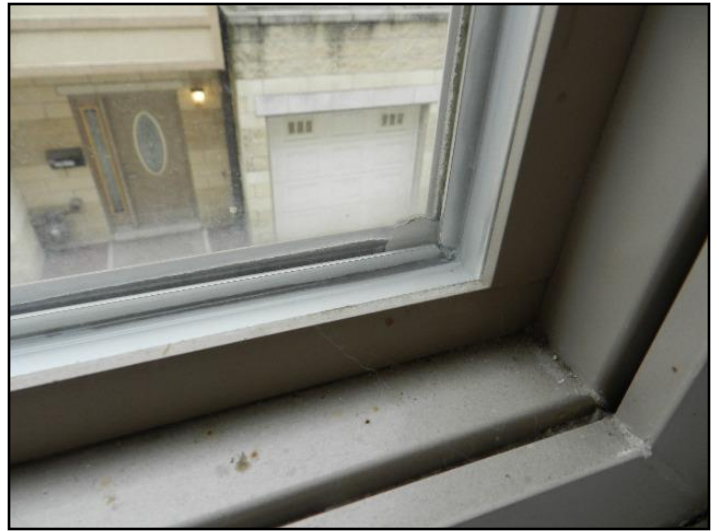
25. Lost seal on double or triple glazing

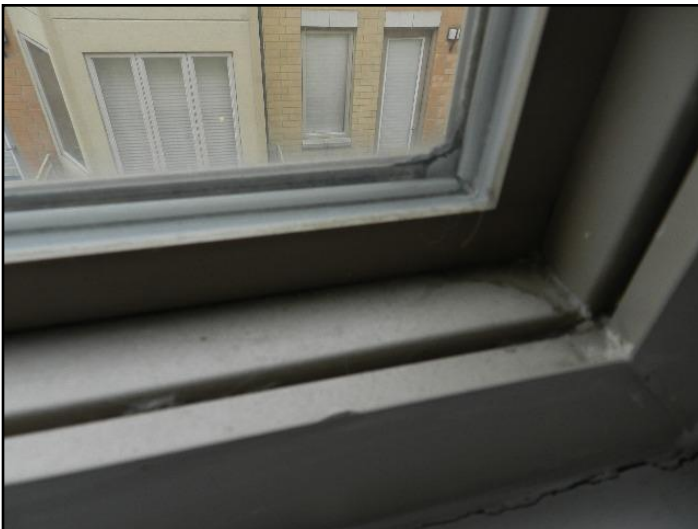
26. Lost seal on double or triple glazing

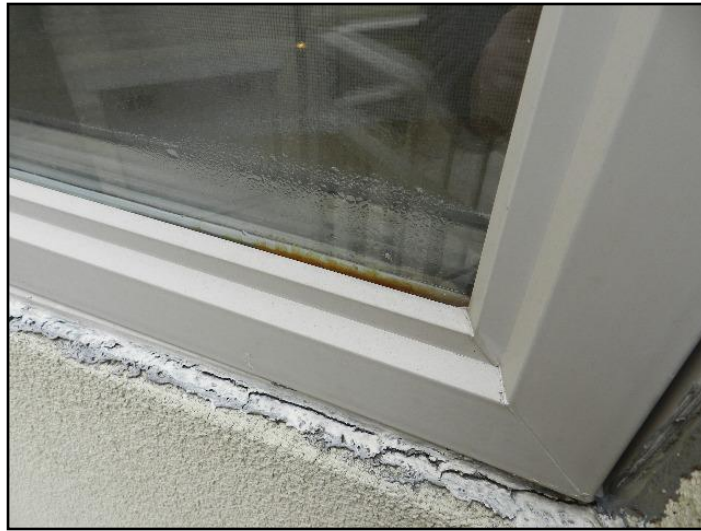
28. Excess condensation

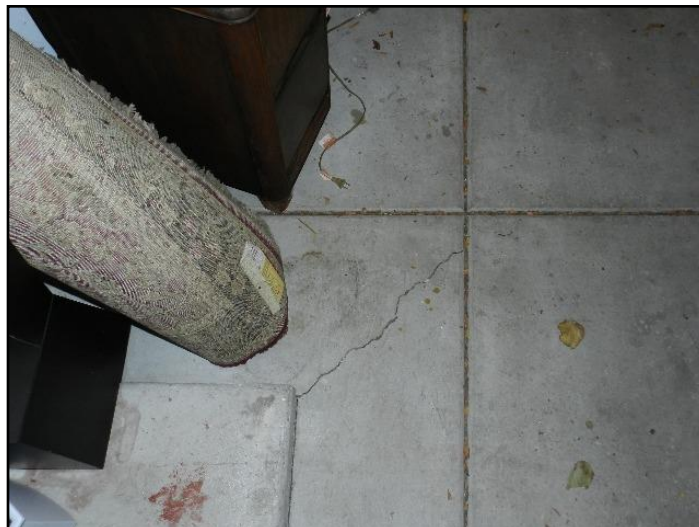
Implication(s): Uneven floors

47. Cracked

Task: Repair

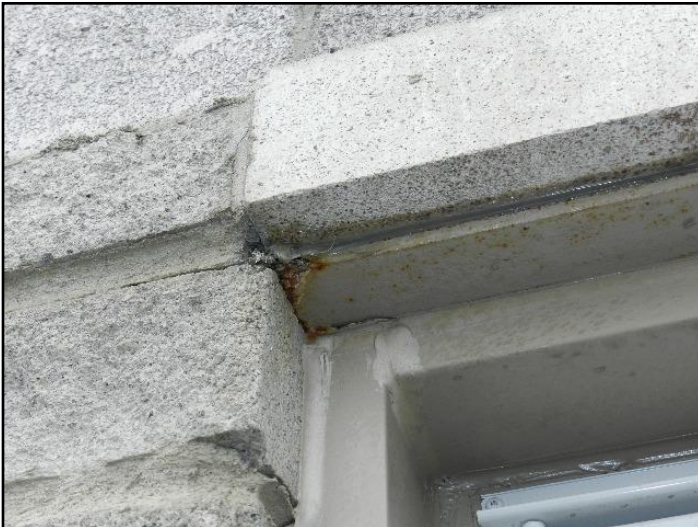
55. *Lintels rusting*

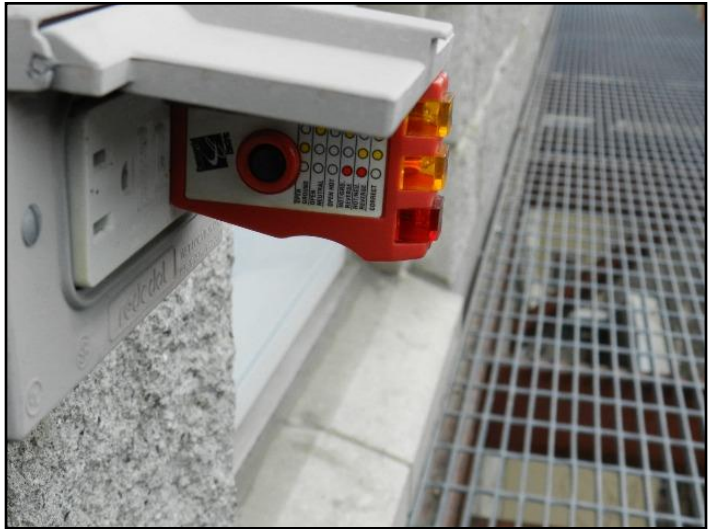
67. Reversed polarity

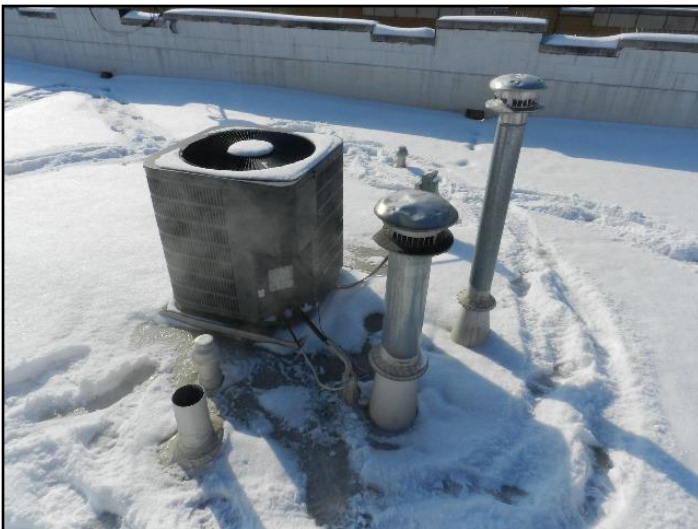
**31. Condition:** • [Near end of life expectancy](#)

**Implication(s):** Equipment failure | Reduced comfort

73. Near end of life expectancy

**Task:** Request disclosure

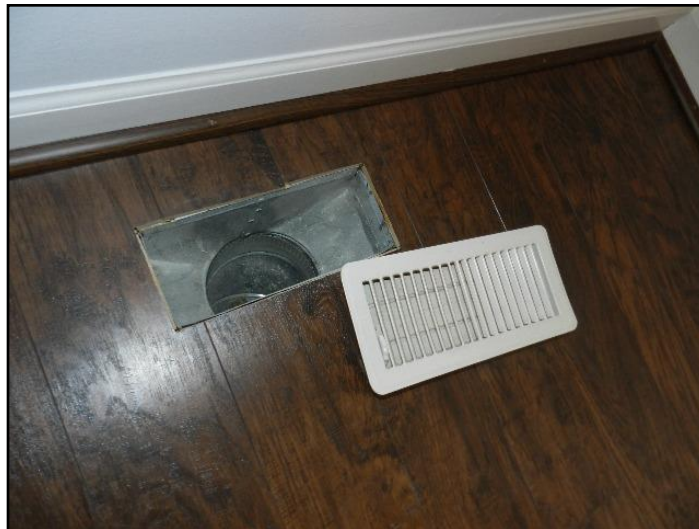
33. Condition: • [Obstructed registers](#)

78. Obstructed registers

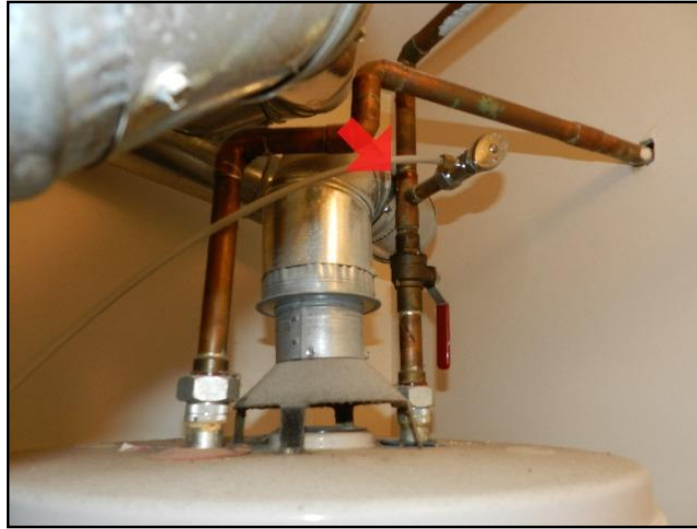
**35. Condition:** • [Rust](#)

**Implication(s):** Equipment failure | Reduced system life expectancy | Leakage | Chance of water damage to contents, finishes and/or structure

80. *Rust*

**Task:** Clean Isolate Protect

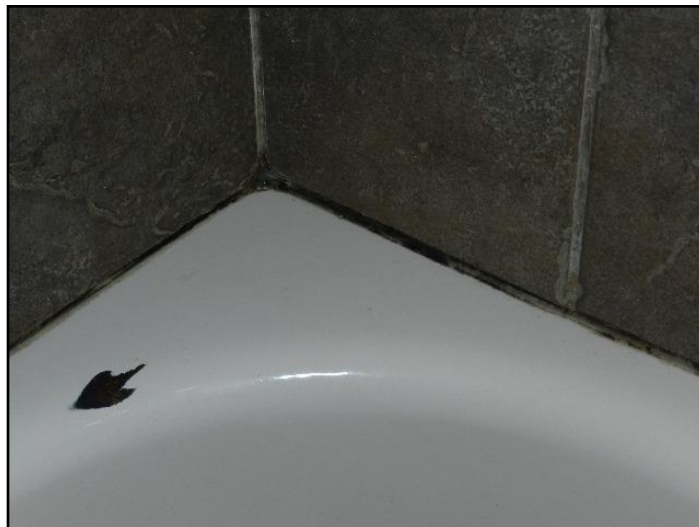
40. Condition: • [Surface defects](#)

Implication(s): Physical injury

85. Surface defects

Task: Repair

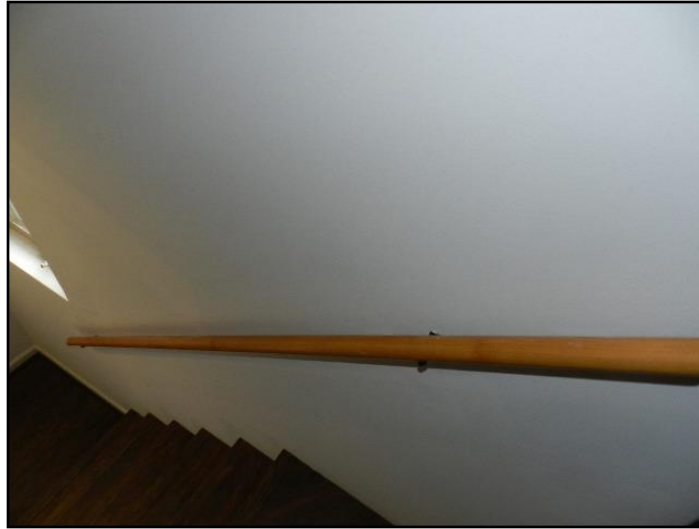
46. Condition: • [Loose](#)

Implication(s): Fall hazard

108. Loose

Task: Repair or replace
